**WELLINGTON
REGIONAL
WATER
BOARD**

**REPORT ON STORM OF
20 December, 1976**

3 February, 1977

STORM OF 20 DECEMBER, 1976

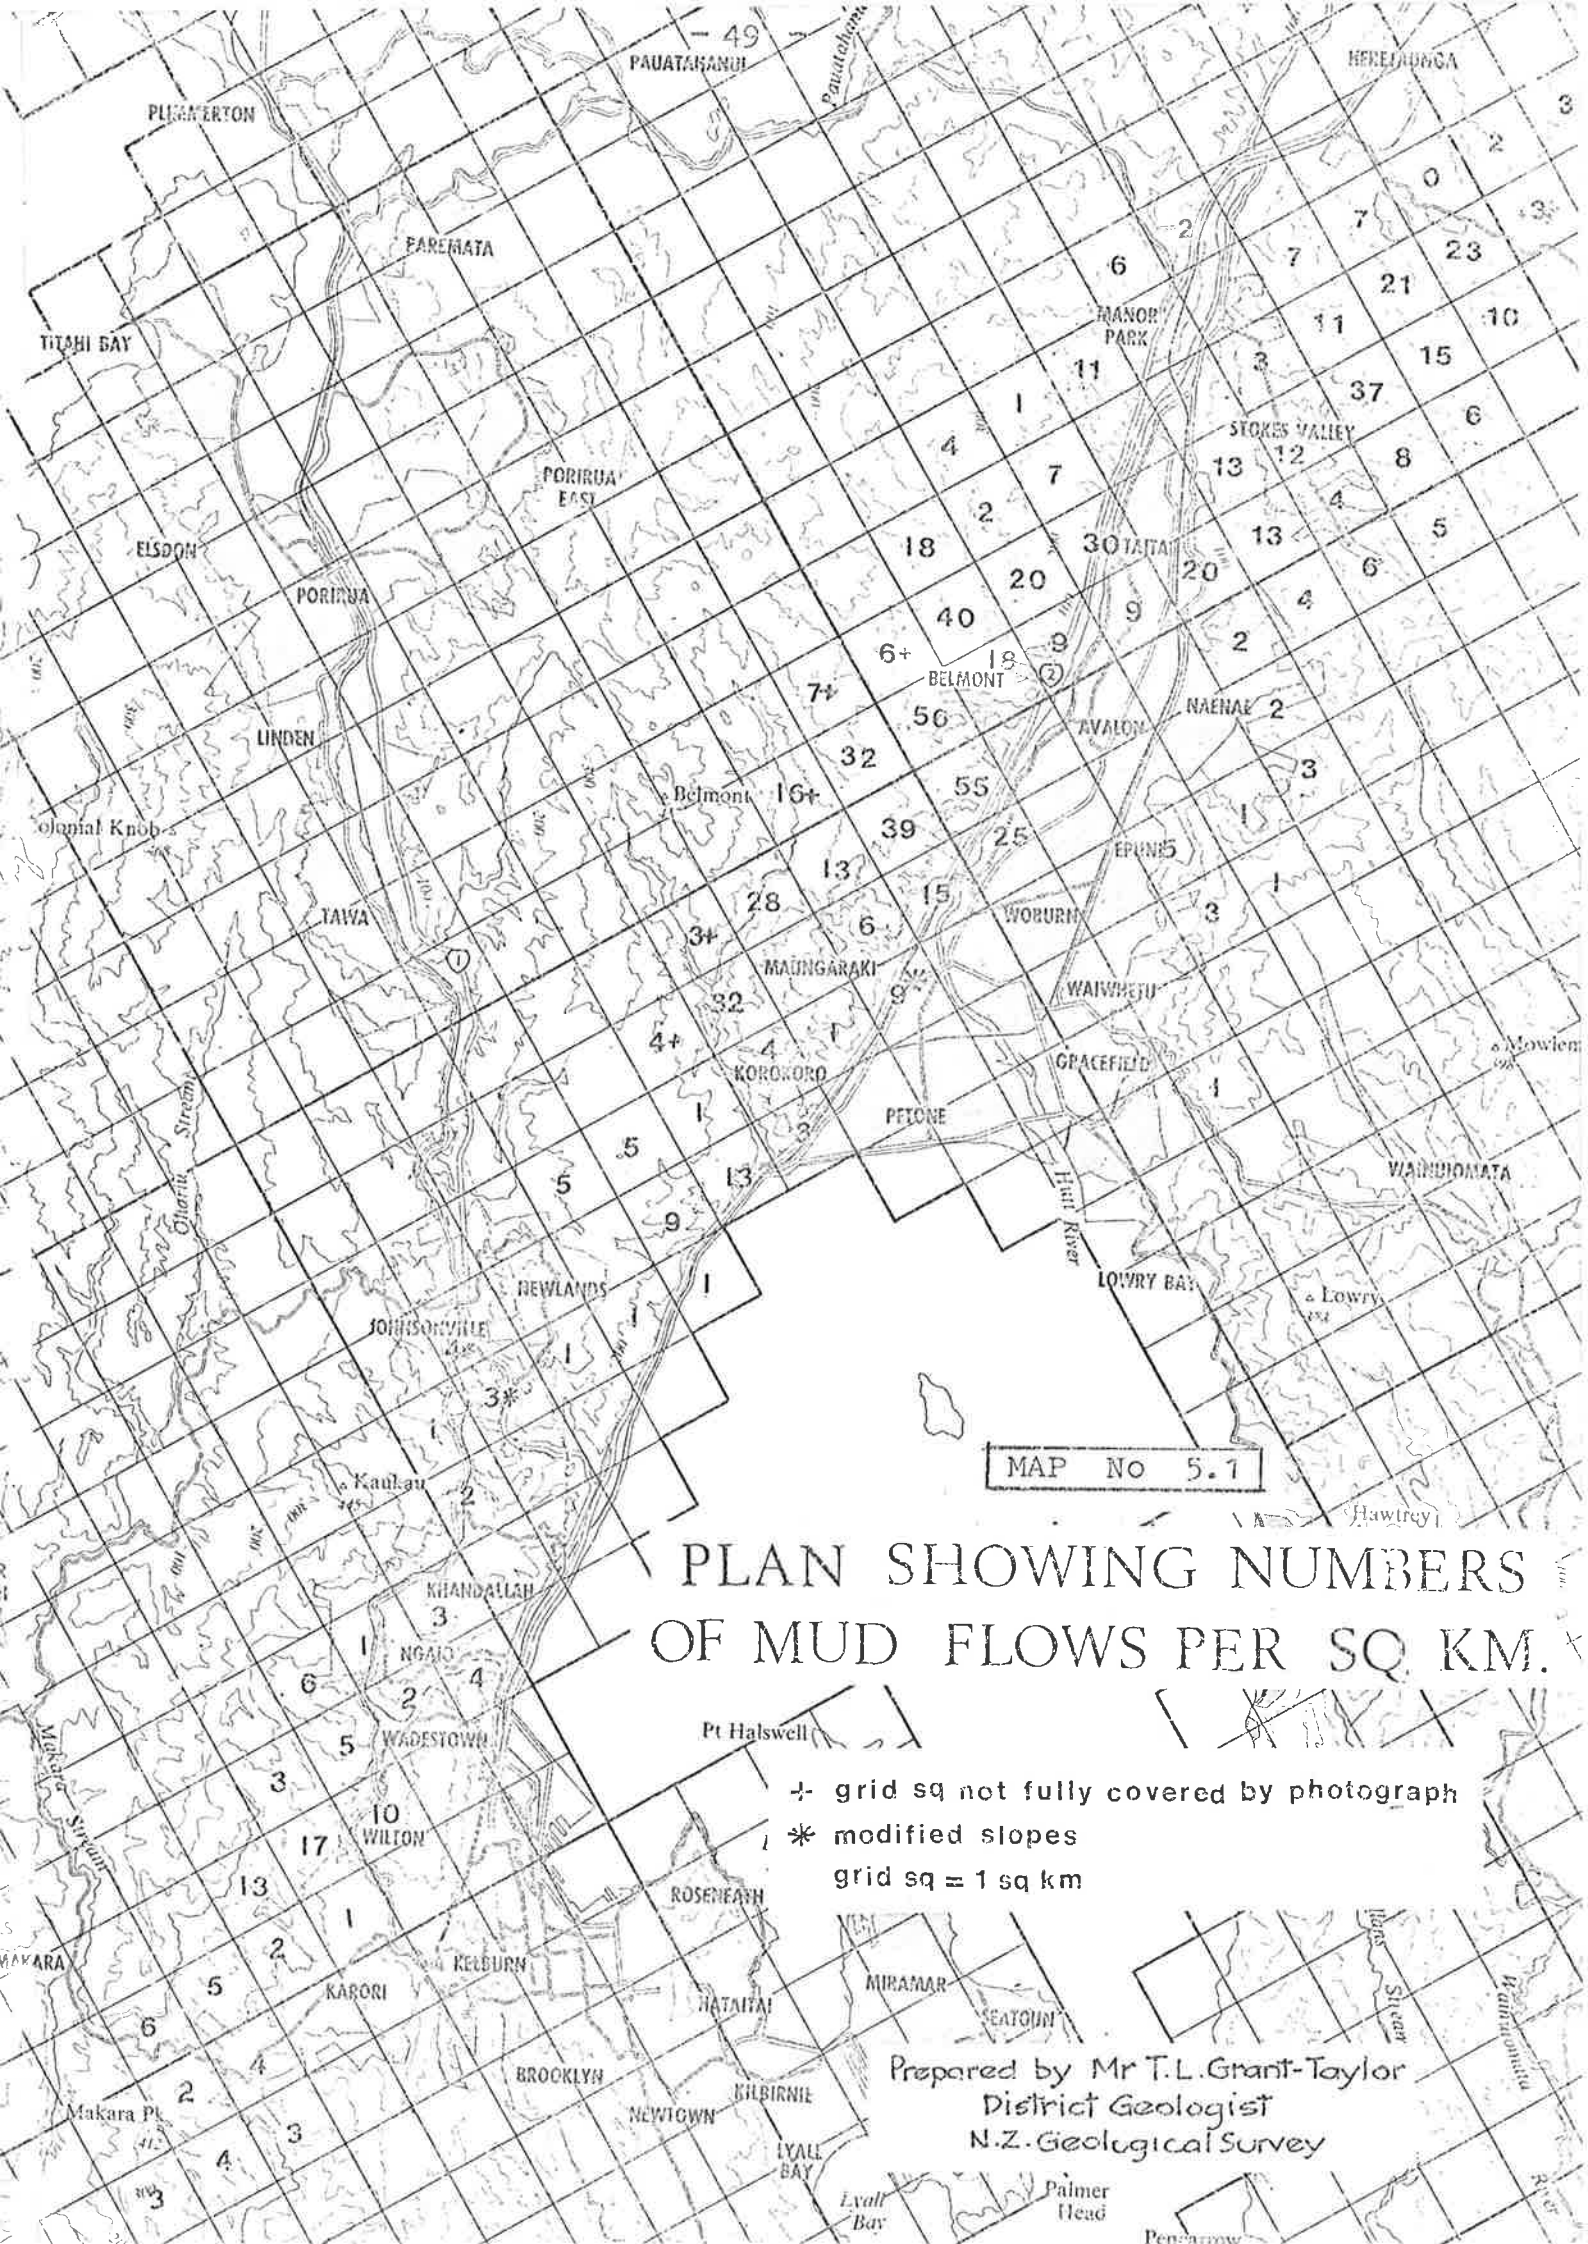
MAP No 5.1

The pattern of distribution of the sources of the mud flows not only during this storm but also from past events indicates that on natural slopes the sediments at greatest risk are poorly consolidated loess and colluvium on slopes that may be as flat as 20 degrees, and are sited in pre-existing hollows. These hollows form part of the headwaters of streams so that the debris from the mudflows in the rural setting was confined entirely to identifiable watercourses.

The collapses that led to the mud flows occurred only after a considerable degree of saturation of rather poorly permeable sediments had been reached and the water content was obviously such that the debris flowed like a liquid rather than the conventional slip. In the urban setting modification of the landscape had produced many unstable faces with unsupported incoherent sediments at the top at batter angles often unduly steep even for rock and excessively steep for

PLAN SHOWING NUMBERS OF MUD FLOWS PER SQ. KM.

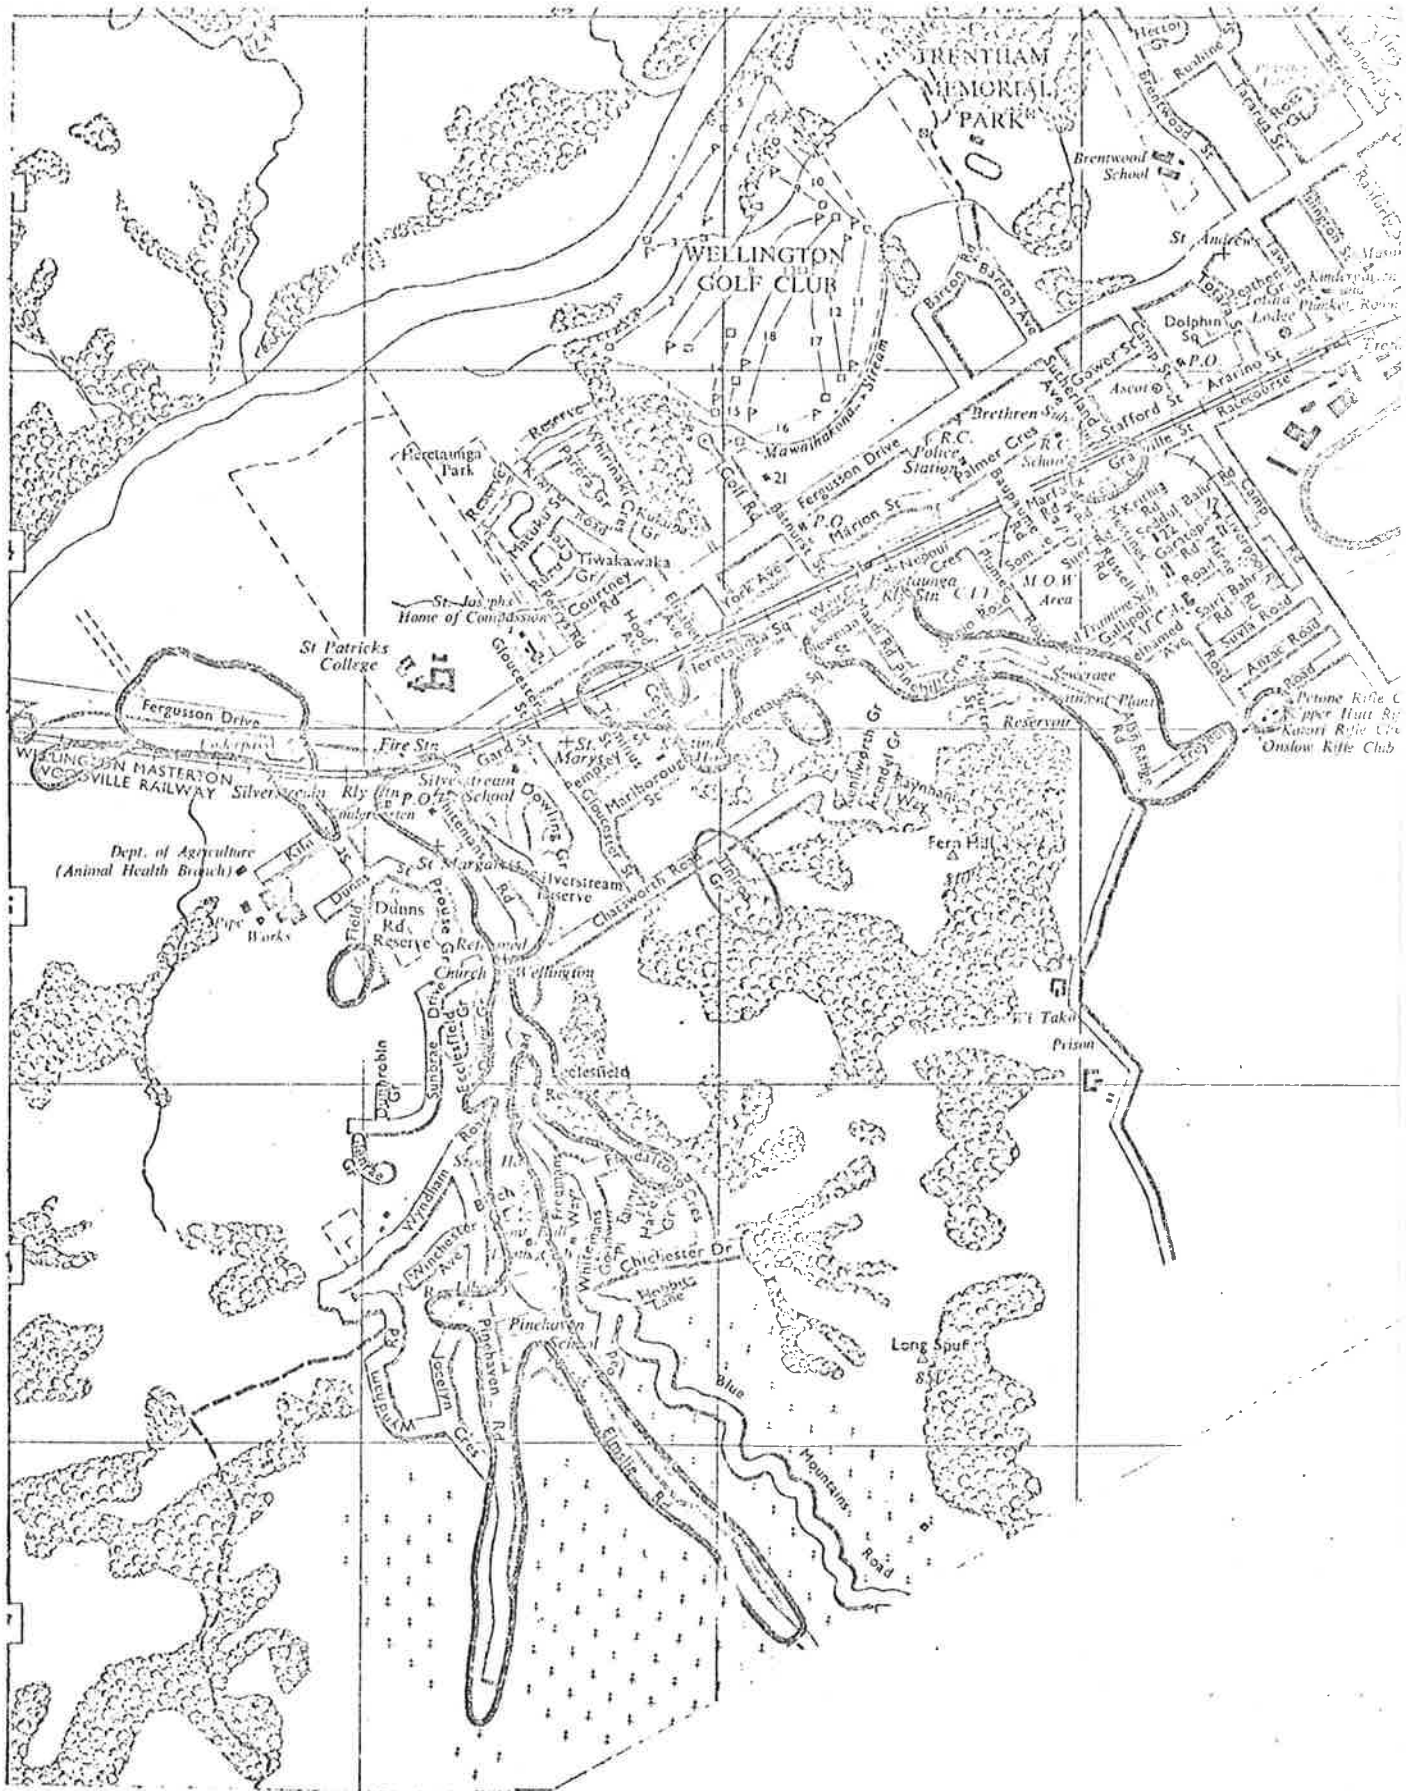
The principal areas of damage due to flooding and debris deposit were Upper Pinehaven Road, Elmslie Road and the low area near the junction of Pinehaven and Blue Mountains Road. It is apparent that the long period of high intensity rainfall resulted in the upper soil layers being saturated to such an extent that the slips mentioned above occurred. It is also apparent that these slips caused debris dams in the catchment, some of which allowed water to build up behind

them until such time as they were overtopped or gave way. This resulted in a surge of water and debris flowing down Pinehaven and Elmslie Roads causing, in the case of Elmslie Road, severe property damage. The Heretaunga Drain channel above the Pinehaven Stream confluence also proved inadequate from a capacity point of view and, although no aggradation and erosion occurred and no major property damage was suffered, the stream flowed around houses in the area as shown on Map I.

Plan showing
FLOODED AREAS
PINEHAVEN - SILVERSTREAM

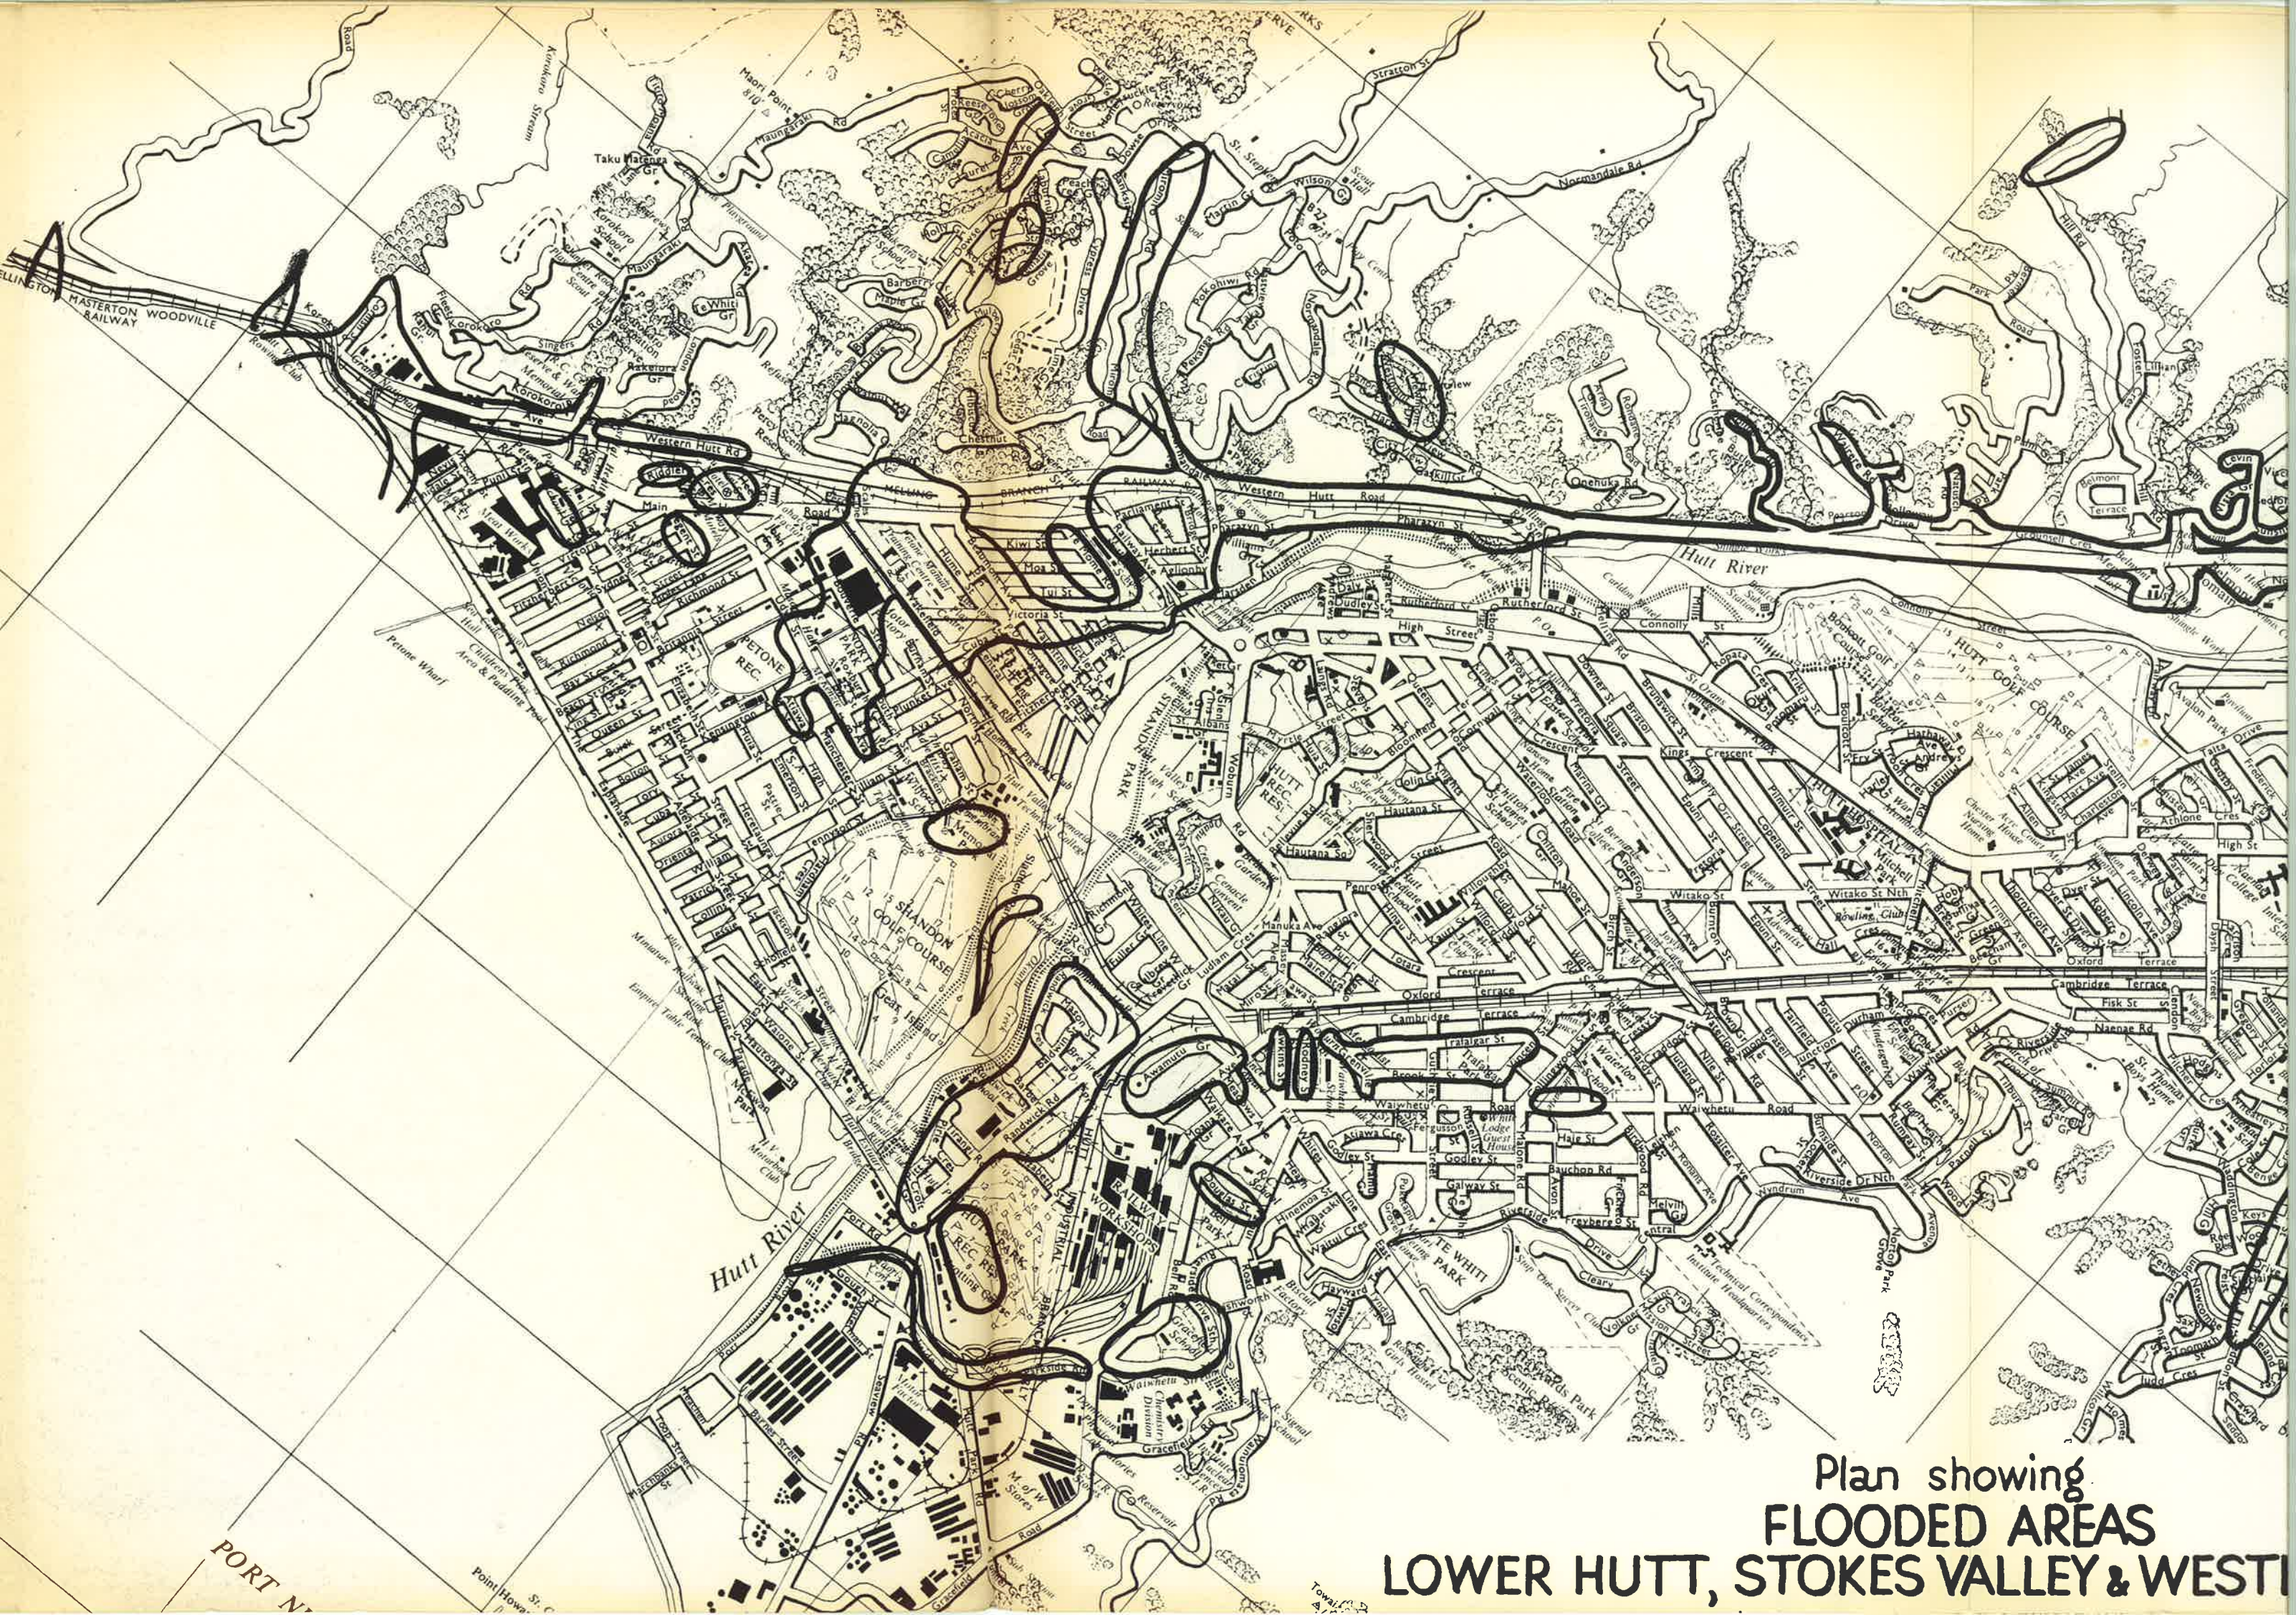
Plan showing
FLOODED AREAS
LOWER HUTT, STOKES VALLEY & WEST

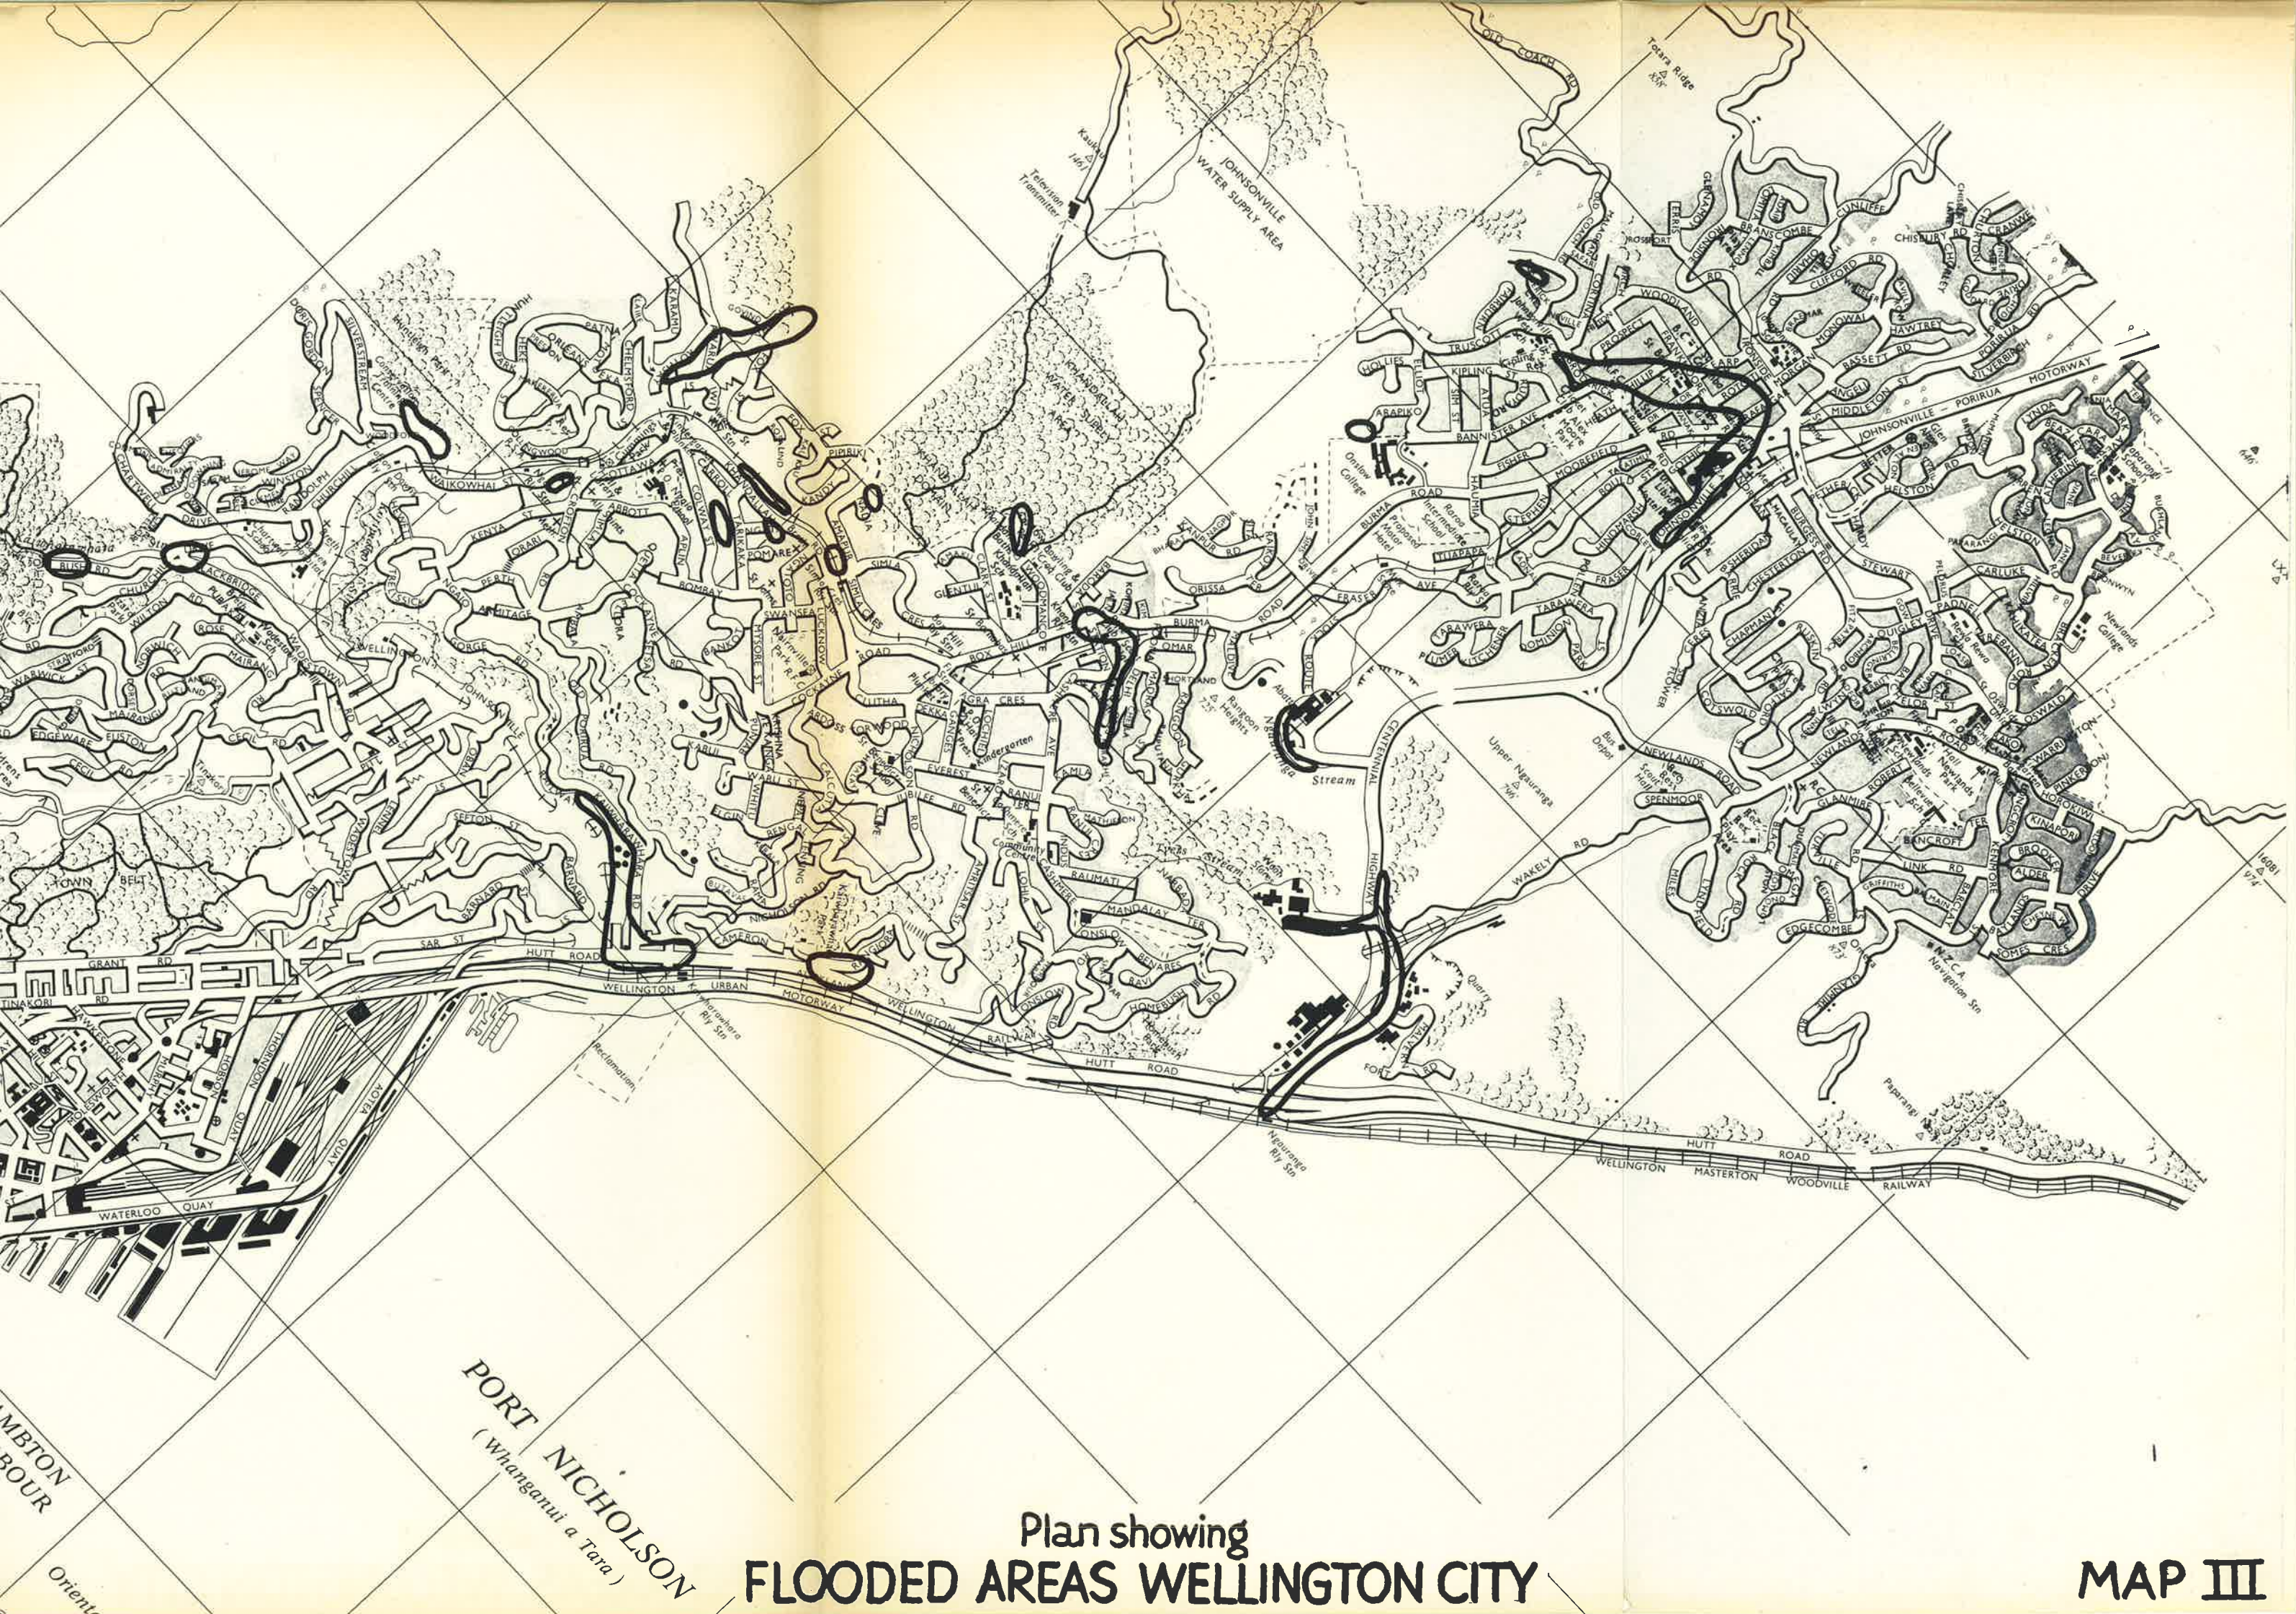
MAP III

Plan showing
FLOODED AREAS WELLINGTON CITY

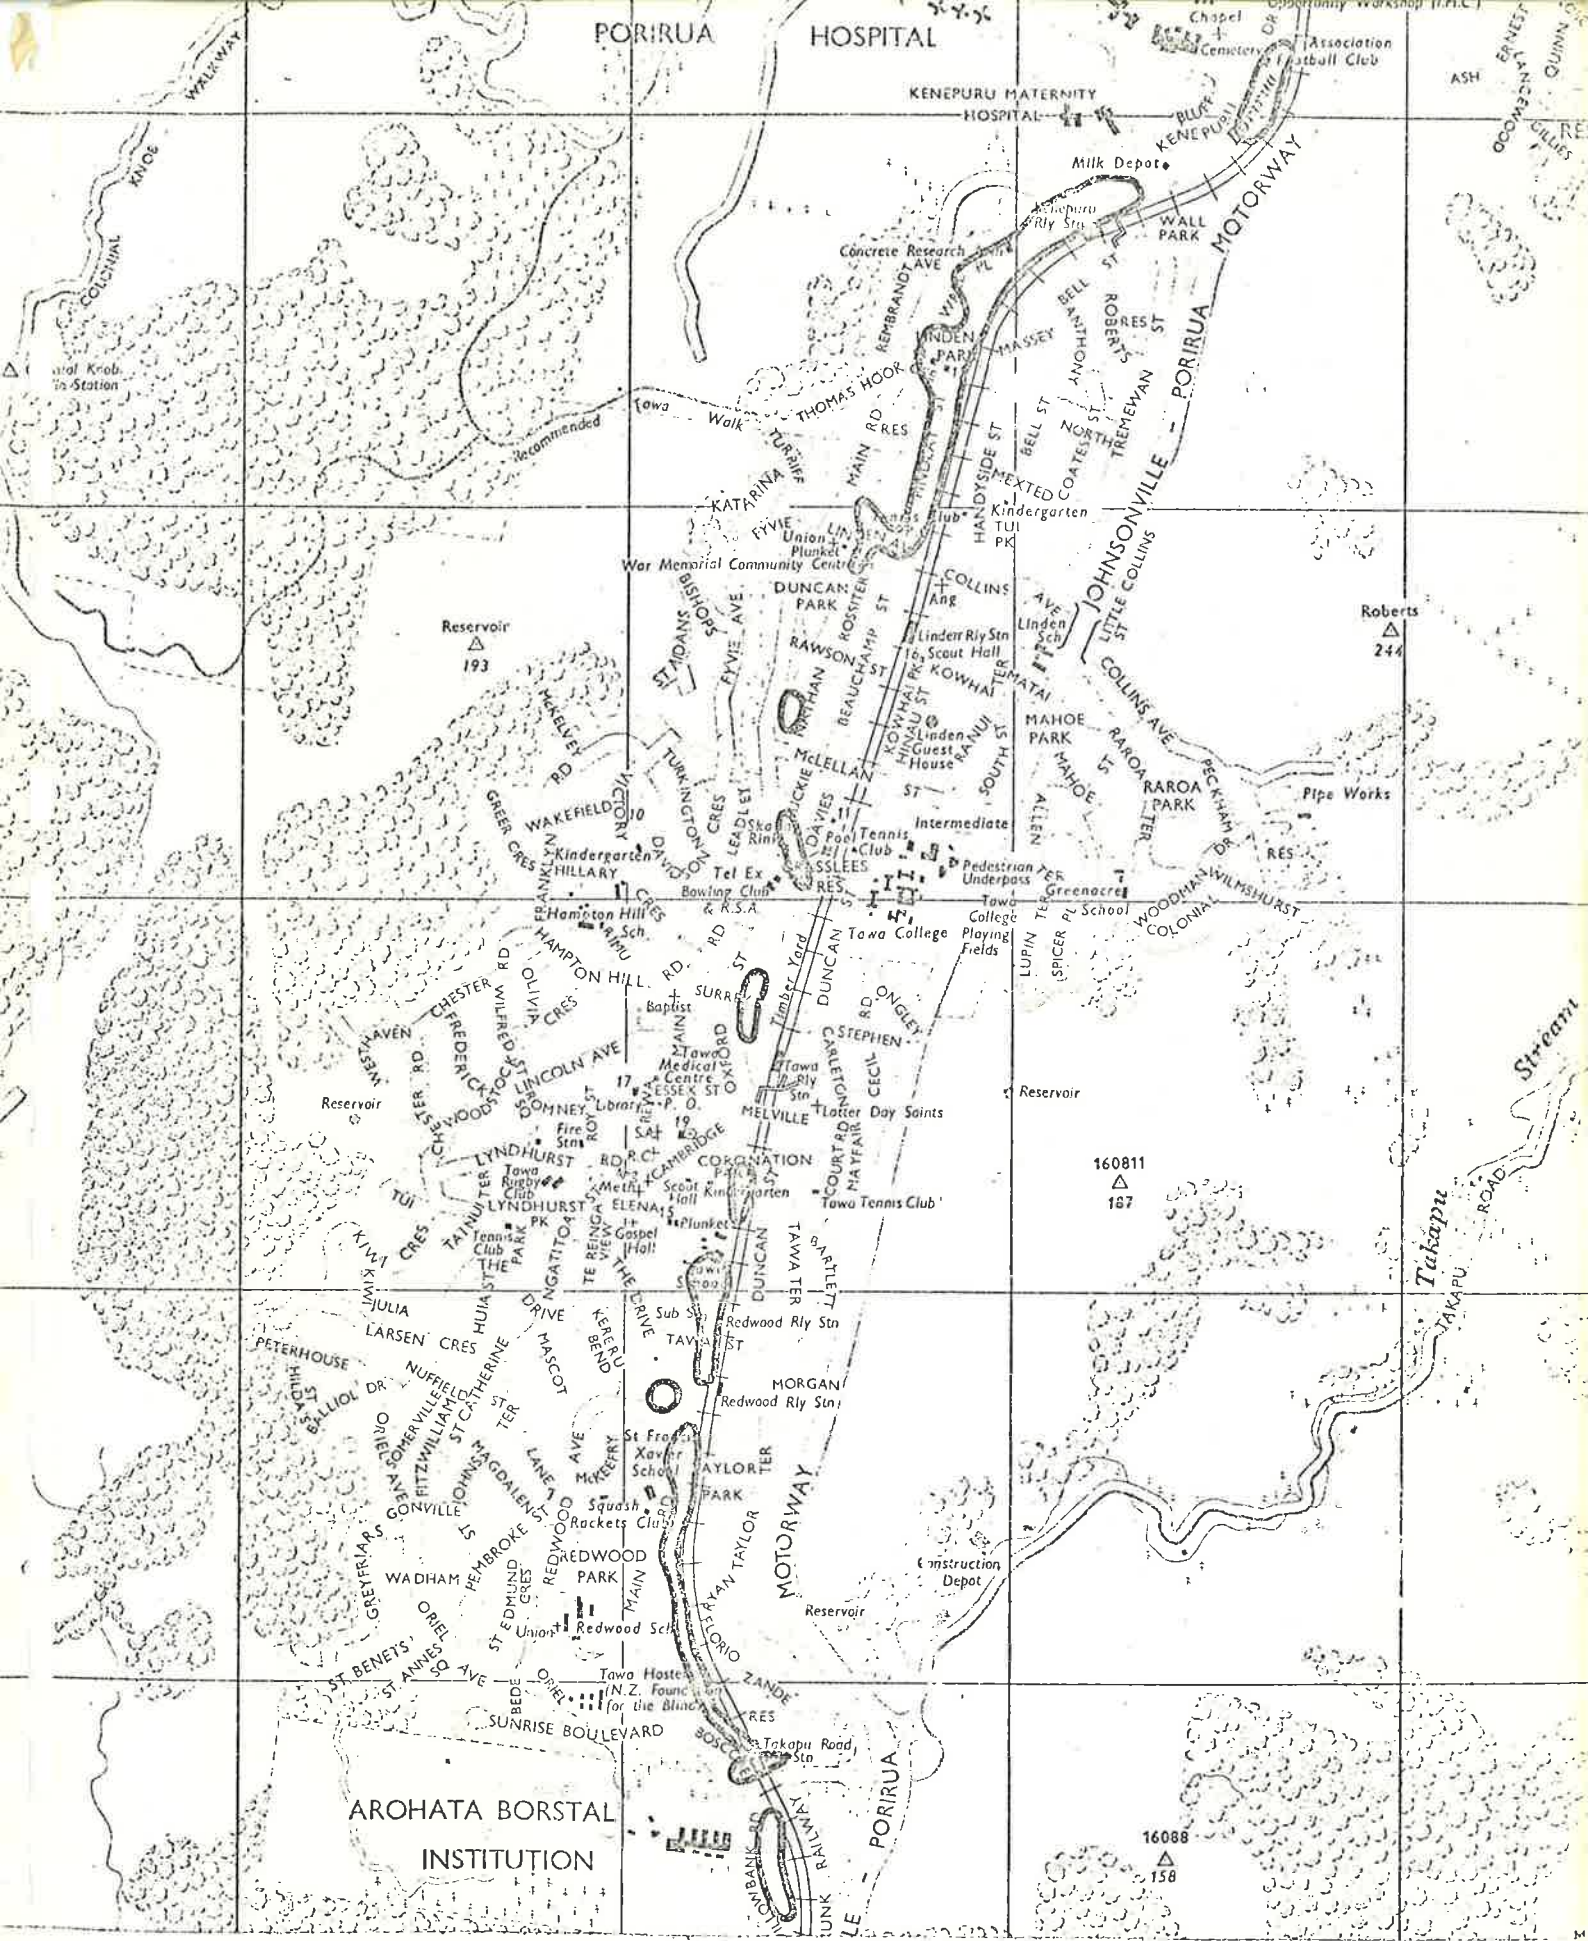
The flood waters covered Linden Park and were generally back in the channel at the Porirua City/Tawa Borough boundary. A sewer crossing of the stream adjacent to Wall Place provided some obstruction to the flood waters by accumulating debris and causing the flood waters to spill out of the channel again at the bend, behind the N.Z. Concrete Research Association's building. This flood water flooded two factories to a depth of 1 to 1½ metres and then found its way behind a private stopbank which had been constructed without authority some months before and which runs from just north of the factories mentioned above to behind the grocery warehouse of Moore Wilson & Co. This stopbank restricted the channel to some degree, particularly at its upstream end causing flood water to build behind it and flow behind the stopbank. Moore Wilson's premises were flooded to a considerable depth and much stock was damaged. The flood waters were finally diverted back into the stream by a tributary just above the Milk Supply Depot. North of this point surface flooding did not occur until the Association Football Club's Grounds. This was contributed to some extent by the choked nature of the channel below this point.

Plan showing
FLOODED AREAS
 ADJACENT TO PORIRUA STREAM
 (PORIRUA-TAWA AREAS)
