**MARLBOROUGH
CATCHMENT
BOARD**

REPORT
on the
10th JULY 1983
FLOOD

SEPTEMBER 1983

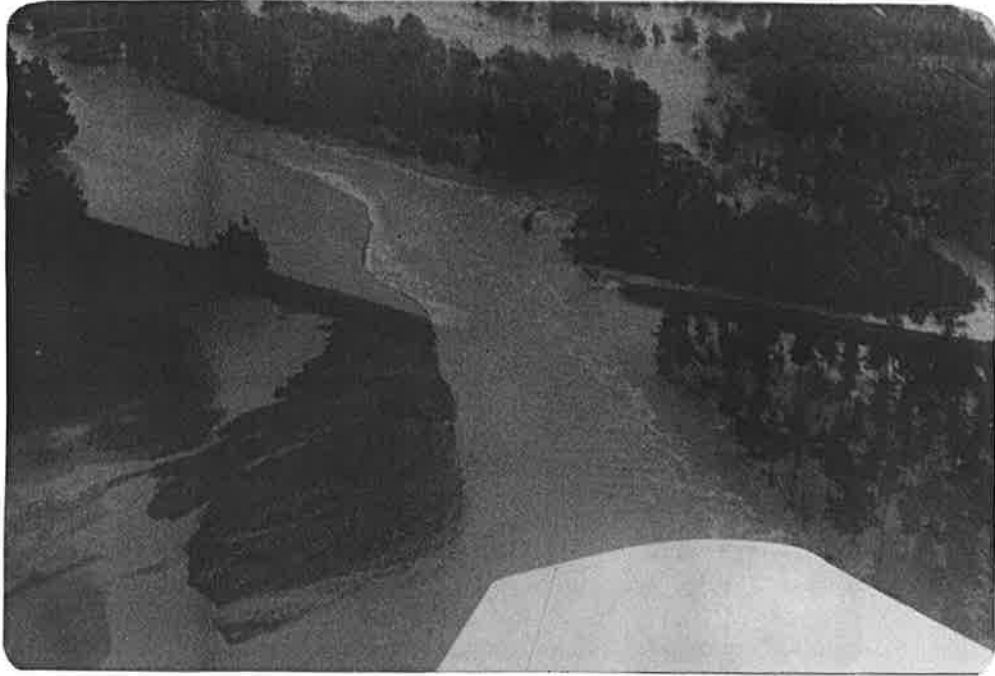
Fig. 5.

The next overflow and subsequent breach occurred at Lower Conders. Water from here passed through the Conders plantation down the old Opawa River bed where it caused damage to the Zoological Park.

The stopbank breach at lower Conders upstream of State Highway 6 about 7 hours after the peak which overtopped the stopbank. (Sunday)

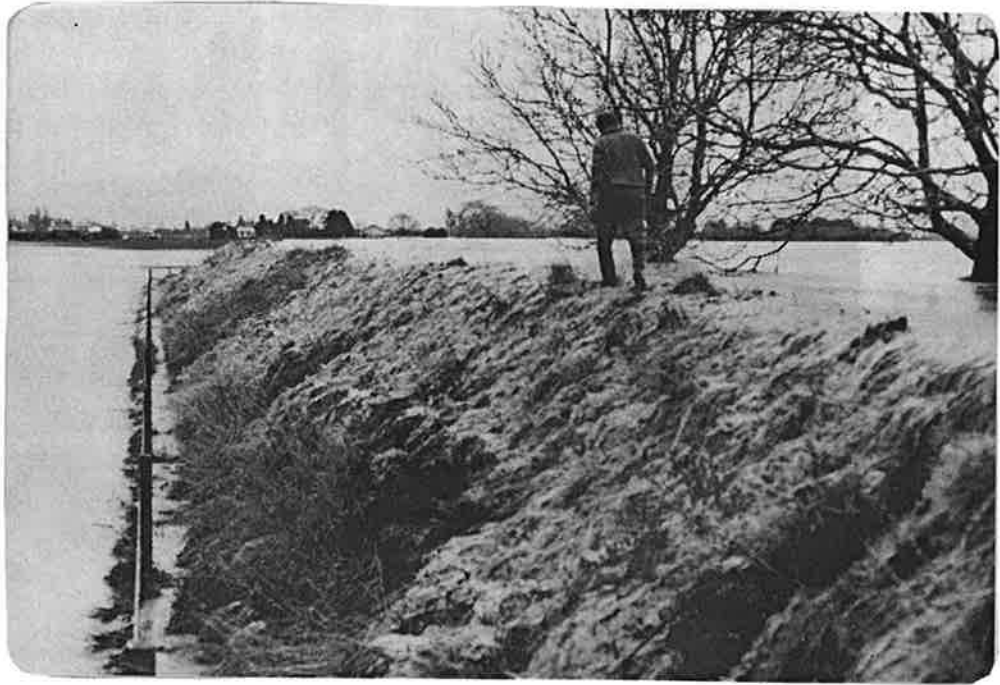
Fig. 6. Typical overflow in the Lower Wairau River. Some overflows were 0.3m deep.

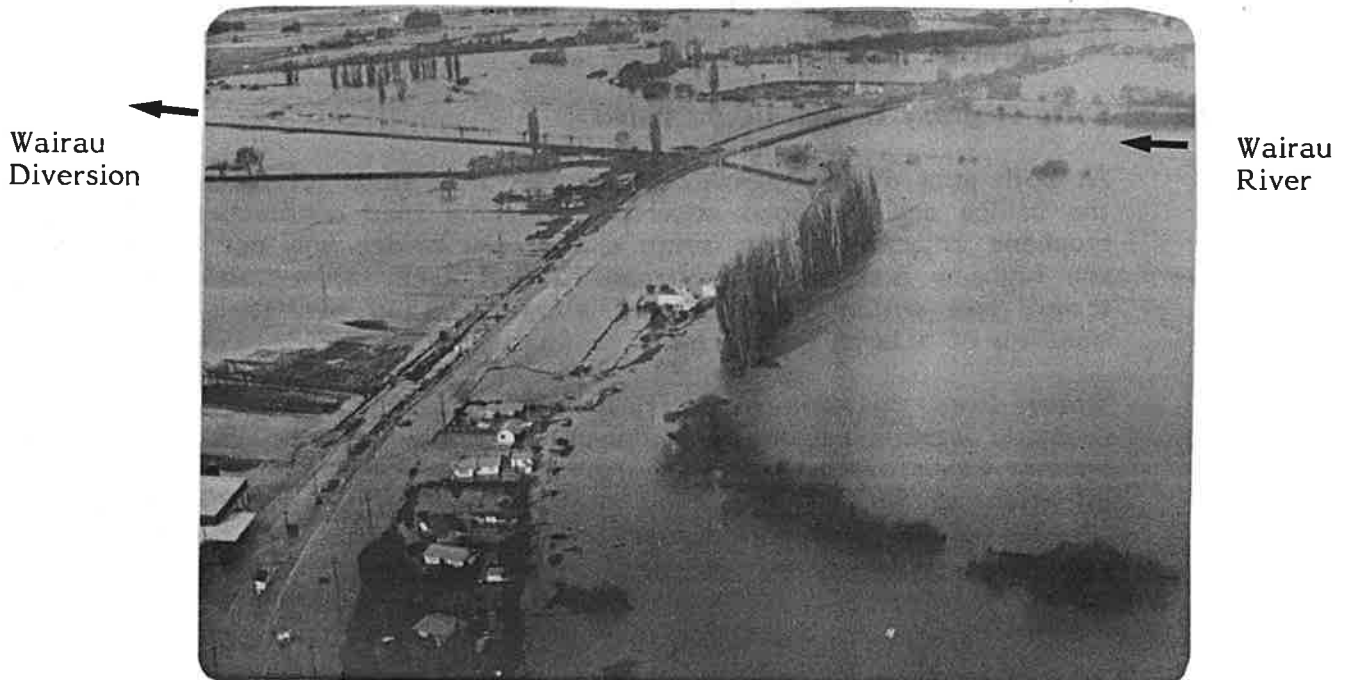
Fig. 7. Stopbanks overflowing at Tuamarina. The Wairau River and road and rail bridges in the background.

These overflows were made worse by the failure of the upper end of Barnetts Training bank. This failure occurred quickly with what seems to have been a relatively shallow overflow. The bank had previously been fairly heavily grazed, and the lack of a good grass cover may have accelerated the failure. In other overflows, the value of a good grass cover to reduce scouring has been very apparent.

- e) That the upper 800 m of Barnettts training bank be rebuilt to the same levels as the south stopbank. Figure 1 shows the recommended works.

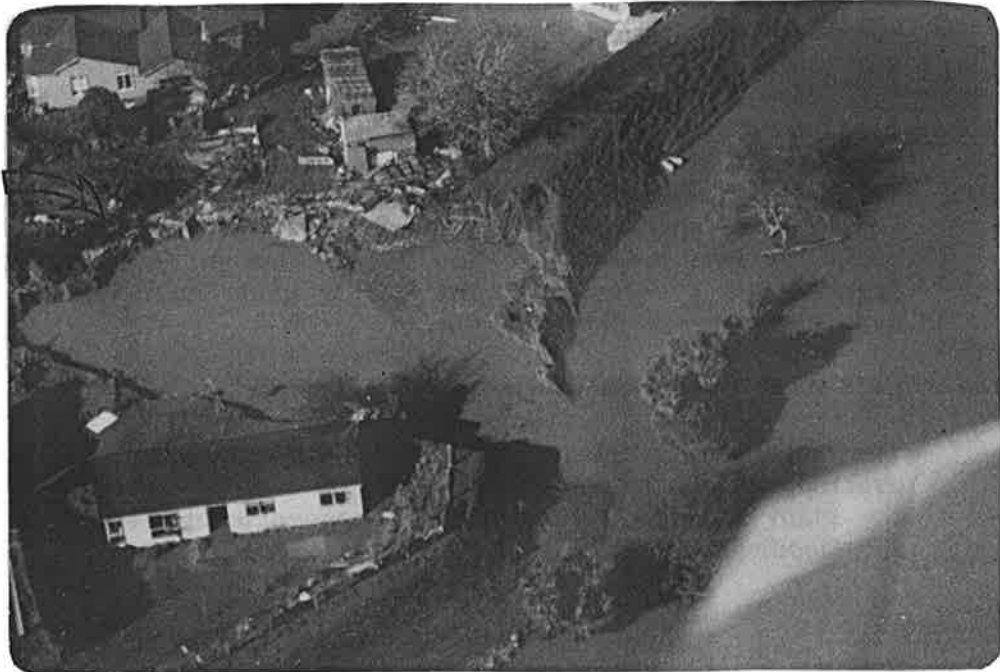
Fig. 8. The Stopbank Breach at Tuamarina on Tuesday

When overflows ceased at Tuamarina, the pondage levels were below those of the 1962 flood. However, about 8.15 a.m. a breach occurred in the stopbank at Tuamarina on a road reserve near the 'Incident' site. Initially the breach was not significant, but it widened to cause a second wave of floodwater which flowed until about 11.30a.m. on Monday when the remaining small flow was sandbagged. Unfortunately, during the events at Tuamarina information about the breach did not reach Civil Defence, the Board, or residents in the Pembers Road-Thomas Road area until the afternoon, at which time it was too late to remove stock.

a)	<u>Tuamarina Stopbanks</u>		
	Repair Breach	\$12 000	
	Restore Scoured Batters	<u>\$ 3 000</u>	\$15 000
b)	<u>Wairau Bridge - Tuamarina</u>		
	Rebuild breached stopbank		\$ 5 000

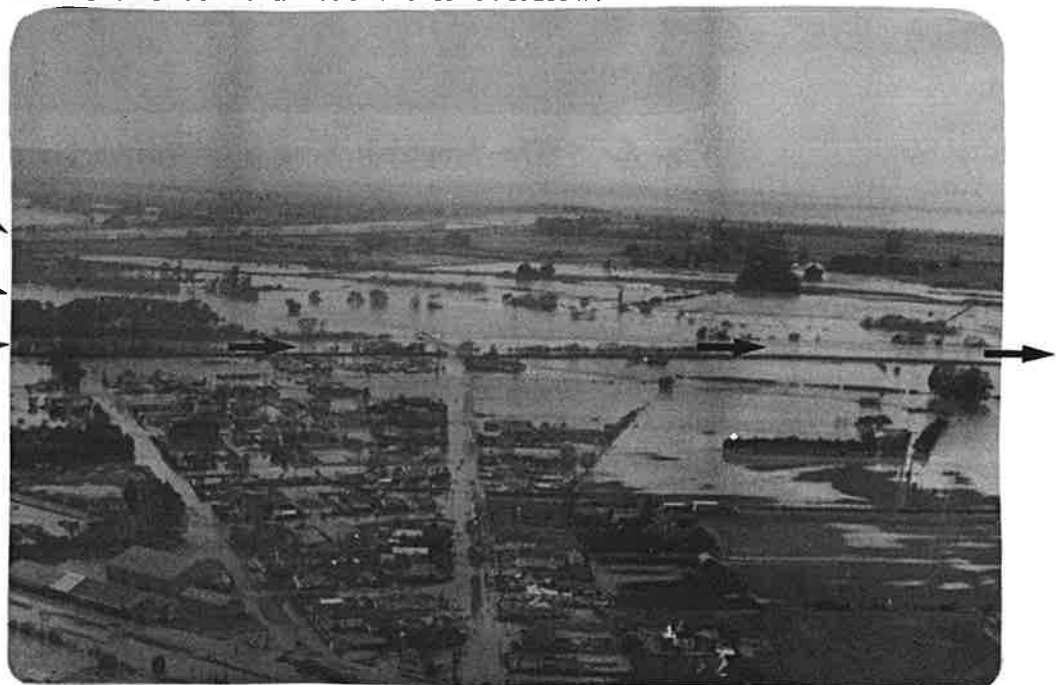
Fig. 9. Floodwater from the overflow of Spring Creek stopbanks passing through the township of Spring Creek. (Sunday)

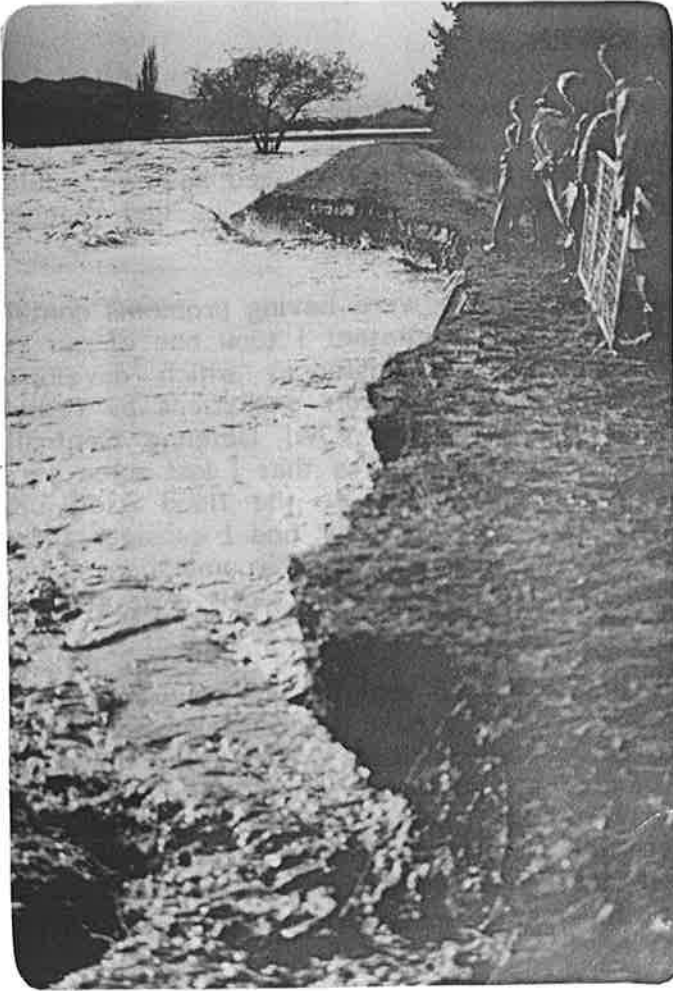
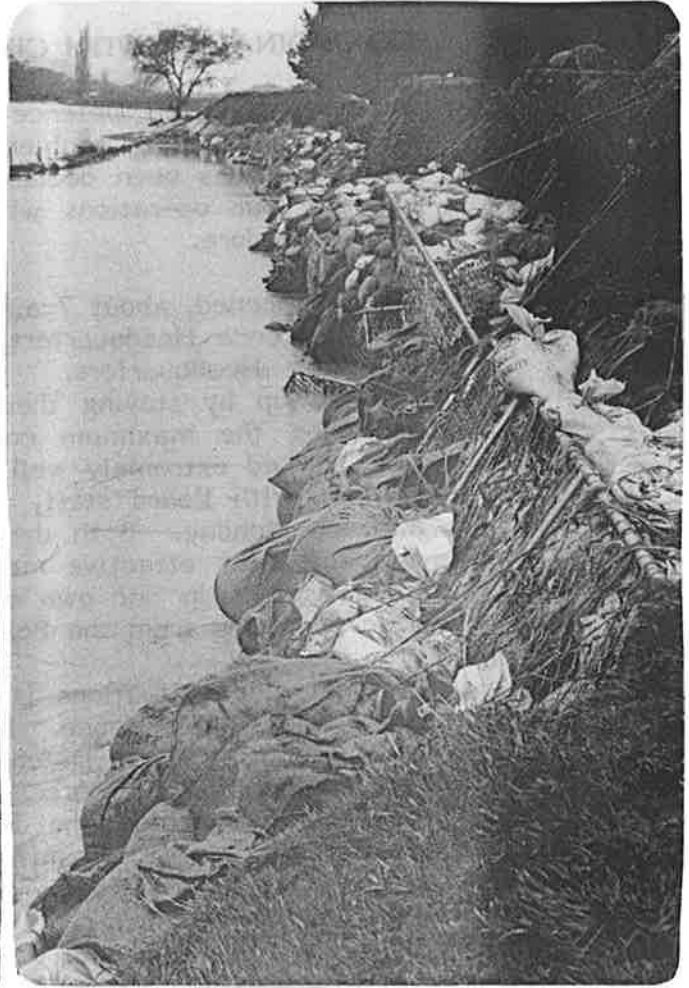
This section of stopbank had been overtopped without damage before daylight. Later in the morning the failure of two wing banks that had been severely overtopped caused raw scars on the side of the stopbank in two places. These areas commenced to erode, and about 10 a.m. the stopbank was being quickly eroded and evacuation of residents commenced. The lower erosion was being partially held back with gates and sand bags. At that time it was not thought possible to avoid a breach at the other point, a short distance downstream of Wratts Road, where erosion had nearly reached the back batter. However, by using gates and sand bags the erosion through the bank was reduced. By 10.25 hours there was some hope and by 11.00 hours it was apparent that the bank might be held, but with substantial effort. When erosion was stopped at one place it progressed downstream, so eventually a substantial length of stopbank was held using a combination of wired gates and sand bags.

On occasions the stopbank was nearly lost, and the potential for failure continued until Tuesday. This work strained local and Board resources and was continued using volunteers in shifts throughout Sunday night. At 13.45 hours on Sunday these volunteers were called for by the Police and Civil Defence over Radio 2ZE, and the response was overwhelming. In all, over 300 people worked until 4 a.m. on Monday morning and Board staff and others continued through until Tuesday.

Fig. 12. 10.25 a.m. Sunday erosion starts
Wratts Road

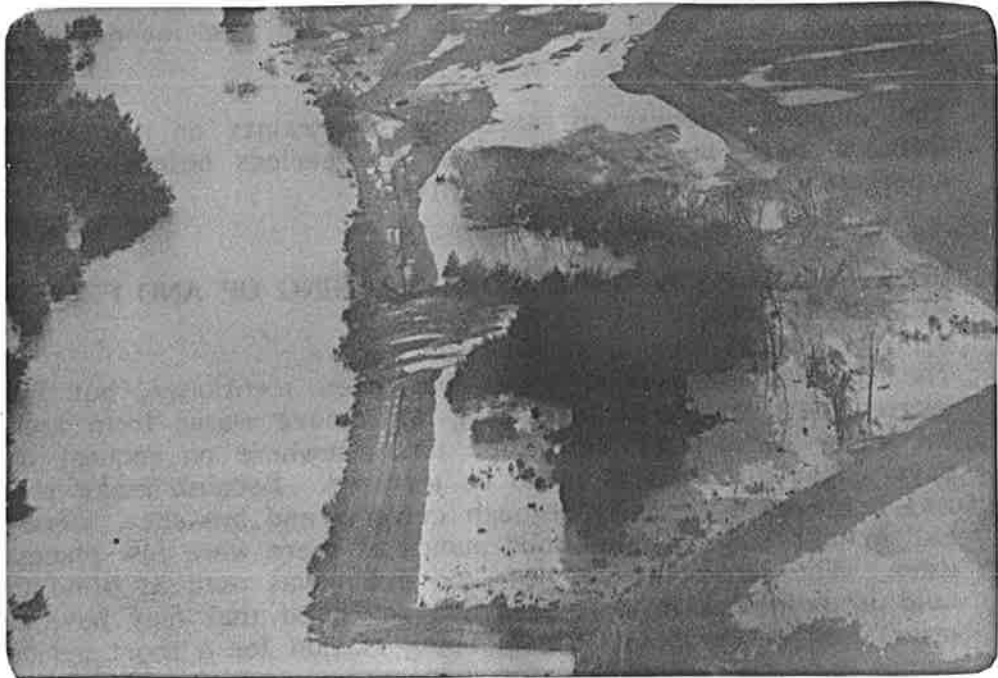
Fig. 13. Failure of a river training bank with the flood control
stopbank to the right. (Monday).

Destruction of sections of training banks was apparently due to overtopping or extreme pressure on the downstream lengths of bank. There appears to be little damage, other than the loss of rock protection just upstream of Timms Creek, which cannot be attributed to these two factors.
