**CAUSEWAYS IN ESTUARIES:
THEIR IMPACTS AND PROCEDURES FOR
ENVIRONMENTAL PROTECTION**

**Investigation No. S996
Output No. 3.1**

Prepared for
**Director, Science and Research
Department of Conservation**

*Consultancy Report No. 6137/A
August 1993*

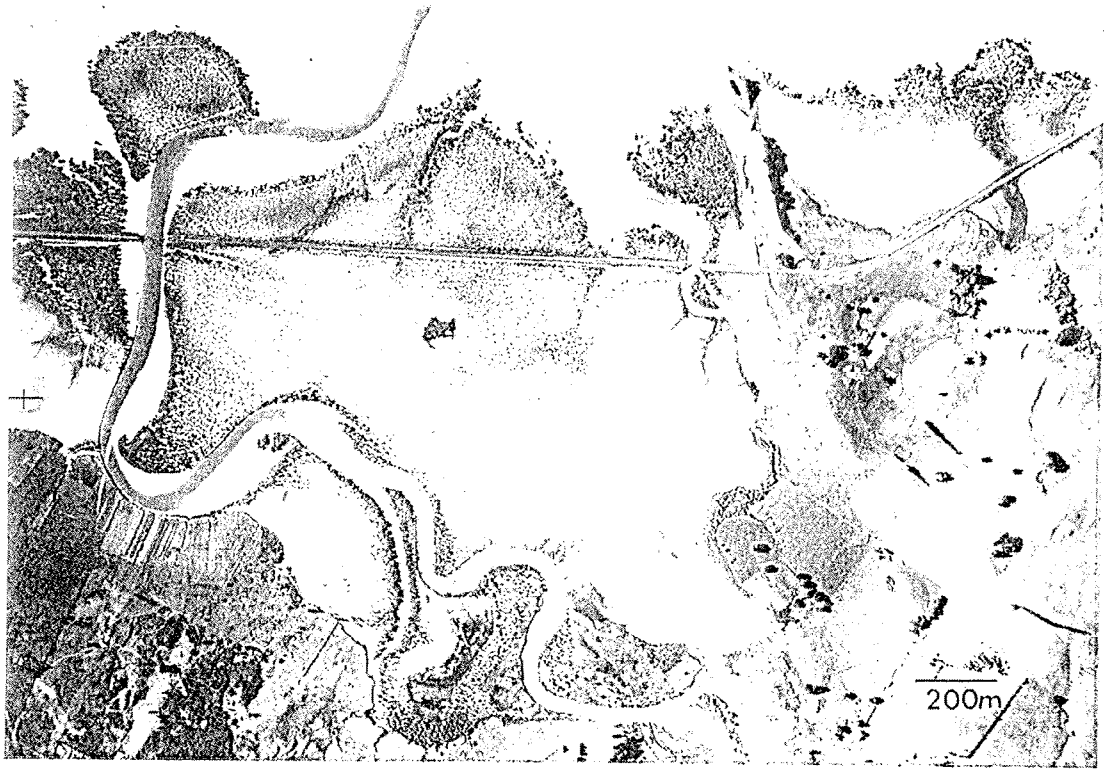
Figure 3.3: The railway causeways at Otaika, Whangarei Harbour, in 1942 (above) and 1982 (below). The only changes associated with this major structure are a slight increase in the density of mangroves, especially along the flanks of the causeway. Drainage channels and overall coverage of mangroves have remained virtually unchanged over this period.

1942-1982: Two very long stretches (400 and 1100 m) of causeway for rail with relatively small stretches of bridge (150 m), cut off mangroved embayments in the upper Whangarei Harbour. The only changes associated with this major structure are a slight increase in the density of mangroves, especially along the flanks of the causeway. Drainage channels and overall coverage of mangroves have remained virtually identical over a forty year period.

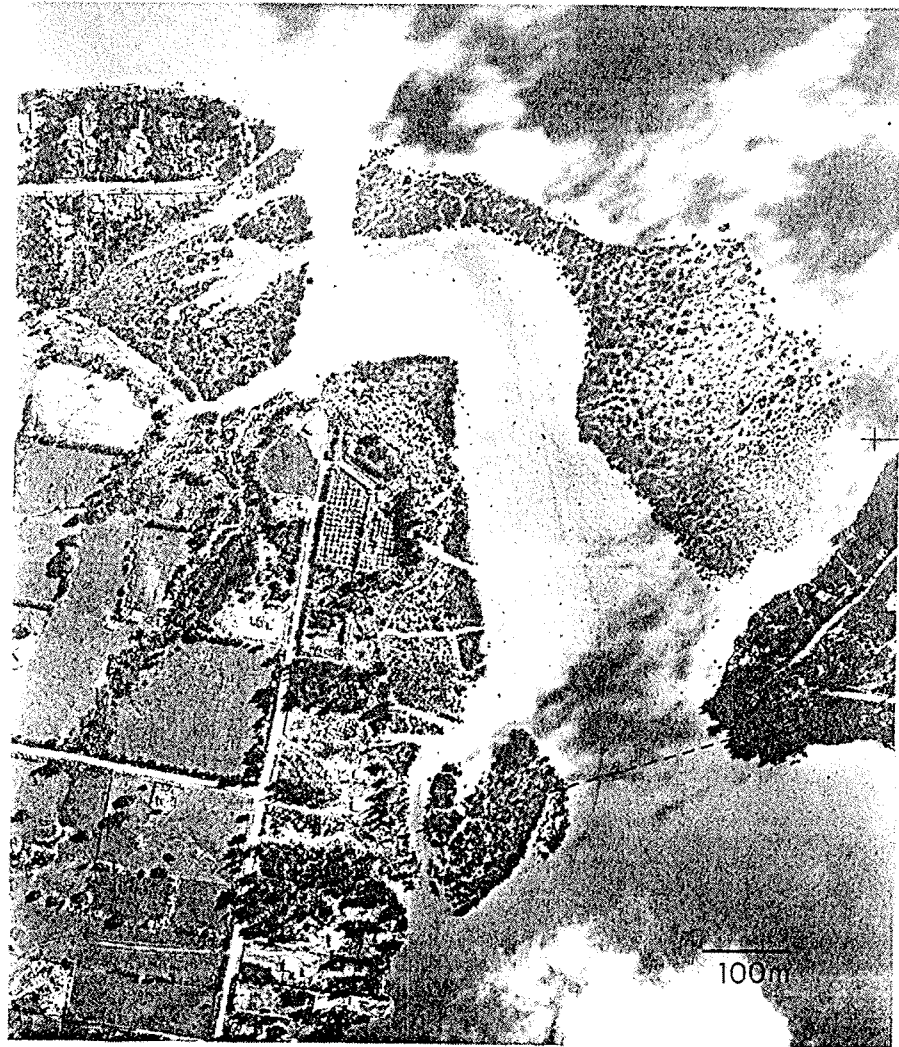
Figure 3.5: Mangroves in the vicinity of Herald Island in 1950 (above) and 1988 (below). Construction of the causeway has caused little overall change. Mangroves in the general area are slightly denser and have grown in narrow bands flanking the causeway. There is no perceivable change in channel morphology or sedimentation.

1950-1988: A 350 m long causeway crosses muddy tidal flats to Herald Island in the upper Waitemata Harbour. Limited tidal exchange is achieved through the structure using culverts. Construction of the causeway has caused little overall change. Mangroves in the general area are slightly denser and have grown in narrow bands flanking the causeway. The small changes in mangroves have occurred away from the causeway as well as close to it. There is no perceivable change in channel morphology or sedimentation visible from the aerial photographs.

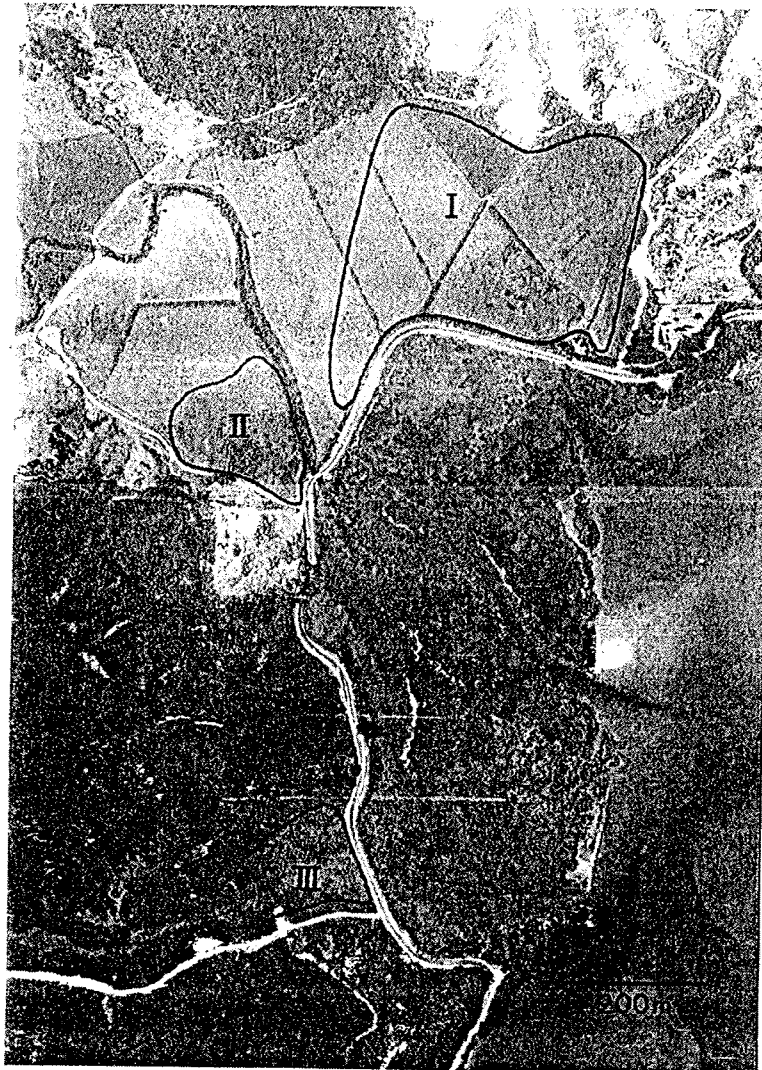
Figure 3.7: The estuary associated with Oturu Stream, Tairua Harbour, in 1944 (above) and 1983 (below). The causeway was constructed through what appeared to have once been wetland. Differences in the vegetation in areas labelled A, B, and C in the 1944 photo suggest these were probably wetland originally. In 1983 wetland vegetation in these same areas (shown as I, II, and III) appears to have virtually disappeared, leaving only the estuarine area to the right of the road. This represents a loss of about 36% of the original wetland area.

1944-1983: Although the road was built when the earliest photos were taken, the road, with small bridges over the two creeks, was constructed through what was once wetland. Upstream the wetland vegetation has now virtually disappeared, being replaced by pasture. It is conservatively estimated that at least 36% of the original wetland has been destroyed.

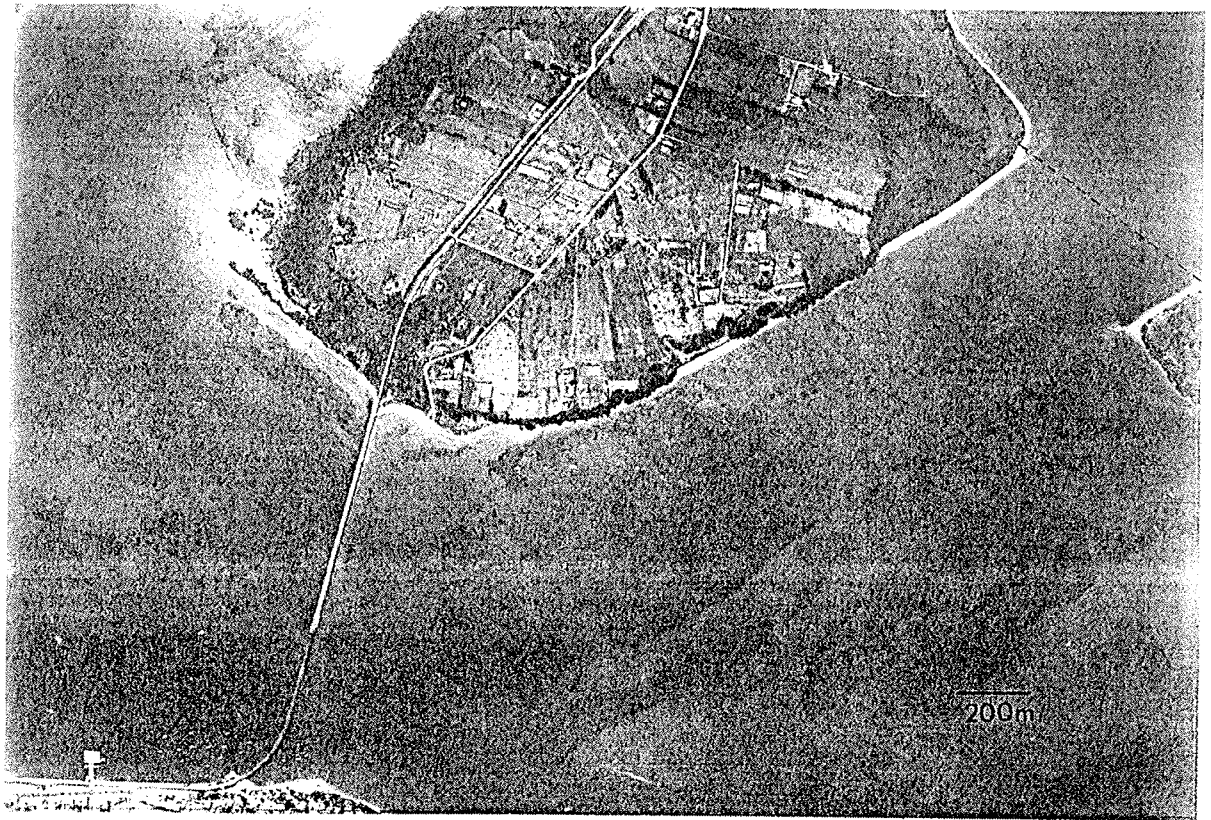
Figure 3.8: Tauranga Harbour in 1948 (above) and 1986 (below) showing the Maheka Point causeway on the left and the Maungatapu causeway on the right. These long causeways (700 & 1100 m) cut across channels and sand flats in the upper harbour. Despite the causeways lengths, the large bridges over the main channel have ensured that there has been no effect on the surrounding estuary. Channels have remained stable and there is no evidence of increased sedimentation.

1948-1986: These 3 long causeways (700, 700, & 1100 m) cut across channels and sand flats in the central and upper harbour. Despite their length they are well bridged over the channels and do not appear to have had any effect on the surrounding estuaries. Channels have remained stable and there is no evidence of increased sedimentation in the vicinity of the causeways.

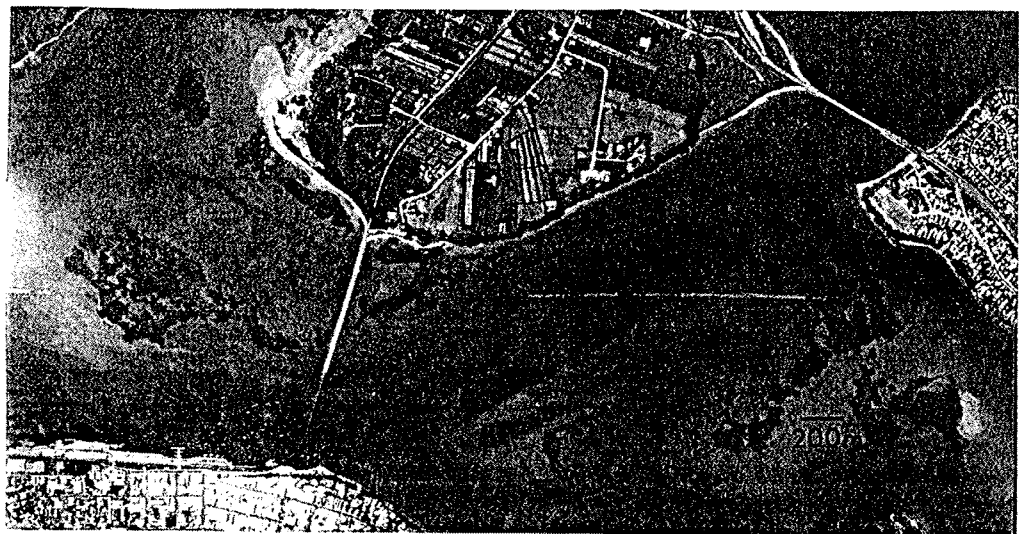
Figure 3.9: In Ahuriri Estuary the Watchman Road causeway divides Westshore Lagoon from North Pond. This 1988 photo shows the changes in habitat that have resulted from the restricted water circulation.

In Napier's Ahuriri Estuary, a causeway constructed between Westshore Lagoon and North Pond has resulted in the two water bodies developing distinctly different salinity and algal growth characteristics, and habitats. In this case the habitat changes are generally regarded as being beneficial, in that they now provide contrasting habitats for wildlife (AETC 1979). A more recent study of the Ahuriri Estuary (Hume et al. 1990) demonstrated that, despite popular belief and assertions to the contrary, construction of bridge and causeway crossings had not increased sedimentation, nor contributed to formation of large shoals and islands in the Outfall Channel. These features were, in fact, relics of the original estuary which had been raised about 2 m by an earthquake in 1931.

1936-1988: A short (150 m) culverted causeway severely restricts water exchange and has resulted in major changes in habitat and water quality upstream of the causeway. (Refer Section 1: Causeway impacts - New Zealand).

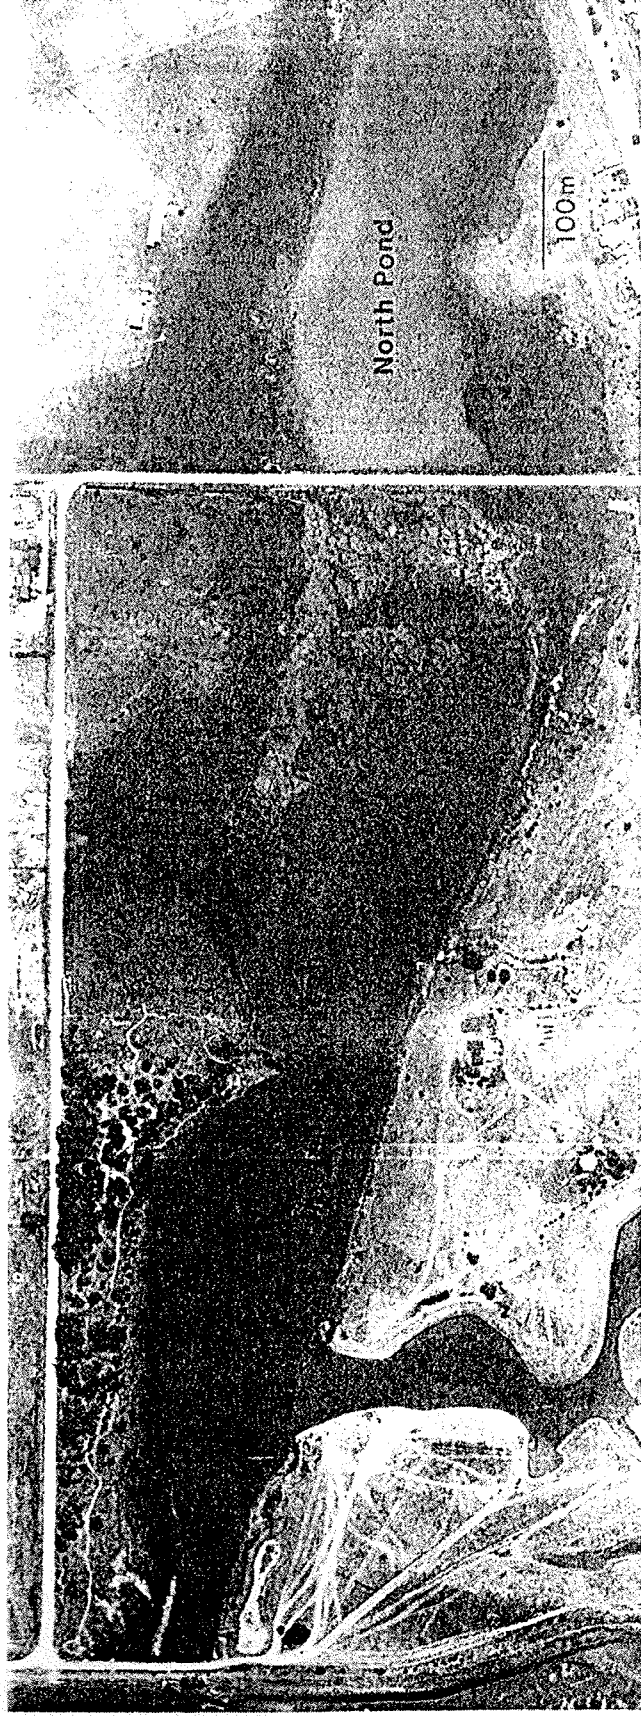
Figure 3.10: Pahurehure Inlet, Manukau Harbour, in 1960 (above) and 1991 (below) showing the two causeways of the southern motorway of SH1. Mangroves in the general area have spread over the past 30 years, however this spread has been dramatically hastened near the causeways. Although the causeways seem to have had a marked effect, there has been considerable land development which could have increased sedimentation and encouraged mangrove colonisation. There do not appear to have been significant changes in channel morphologies.

1960-1991: Two sections of causeway (400 & 100 m) of the southern motorway cut across muddy intertidal areas and small channels in the headwaters of the Pahurehure Inlet. Mangroves in the general area have spread over the past 30 years, however this spread has been dramatically hastened near the causeways. The Pahurehure tidal creek upstream of the SH1 (1) causeway has completely filled with mangroves, and they have also become established outside the causeway. Although the causeway seems to have had a marked effect, there has been considerable land development which could have increased sedimentation and encouraged mangrove colonisation. There do not appear to have been significant changes in channel morphologies.

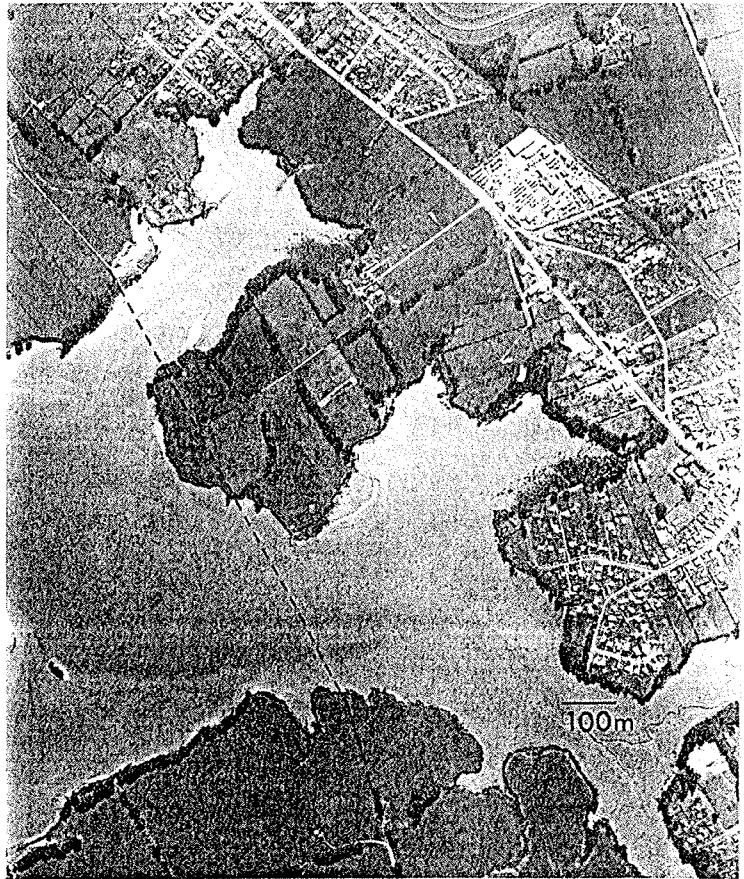
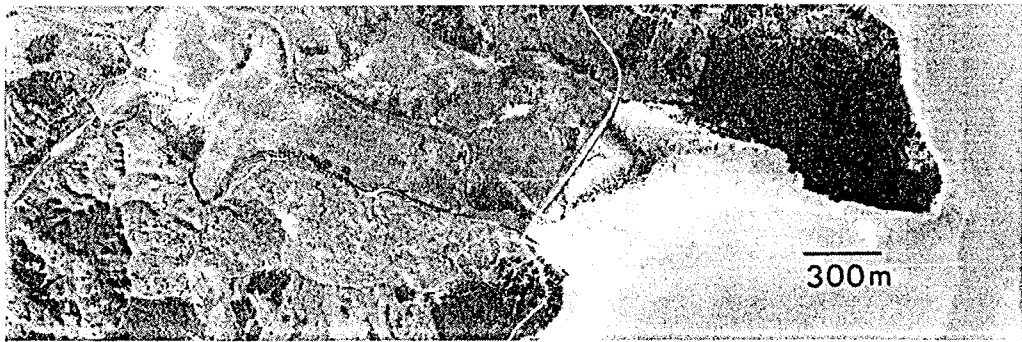
Figure 3.11: Waireia Creek, Hokianga Harbour, in 1960 (above) and 1984 (below) showing the changes which occurred after a causeway was constructed across the entrance. In 1960 the creek contained sparse mangroves, but these have been replaced by what appears to be pasture or rushes. This substantial change in habitat type has probably resulted from flood gates in the causeway impeding tidal flushing.

1960-1984: Before a 400 m long causeway was constructed across the entrance of Waireia Creek, Hokianga Harbour, the area contained sparse mangroves. The causeway and its floodgate have completely changed the area, which now appears to contain either pasture or rushes.

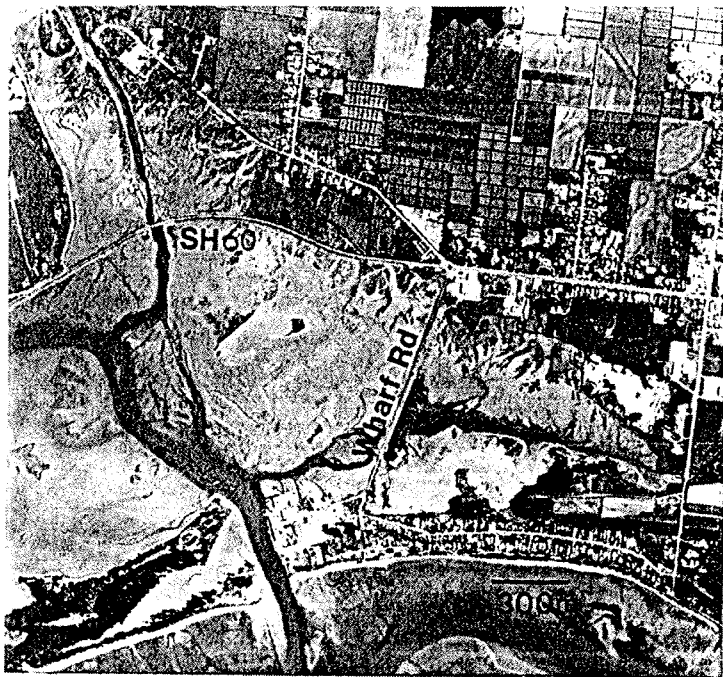
Figure 3.12: Moutere Inlet in 1947 (above) and 1985 (below) showing effects of the Wharf Road and SH60 causeways. The more recent photo shows slight changes in channel morphology downstream of Wharf Road. The SH60 causeway traverses tidal flats at the mouth of Moutere River. By restricting river flows to one channel this causeway has caused major changes in channel configuration, both upstream and downstream, and large shifts in sandbank positions downstream. In addition to any effects of causeway construction, there has been extensive shoreline infilling behind the causeway.

1947-1985: A 700 m long roading causeway traverses tidal flats at the mouth of the Moutere River. In addition to any effects of causeway construction, there has been extensive shoreline infilling along the northern shore for pasture. However, the causeway has caused major changes in channel configuration of the Moutere River, both upstream and downstream, and large shifts in sandbank positions downstream.

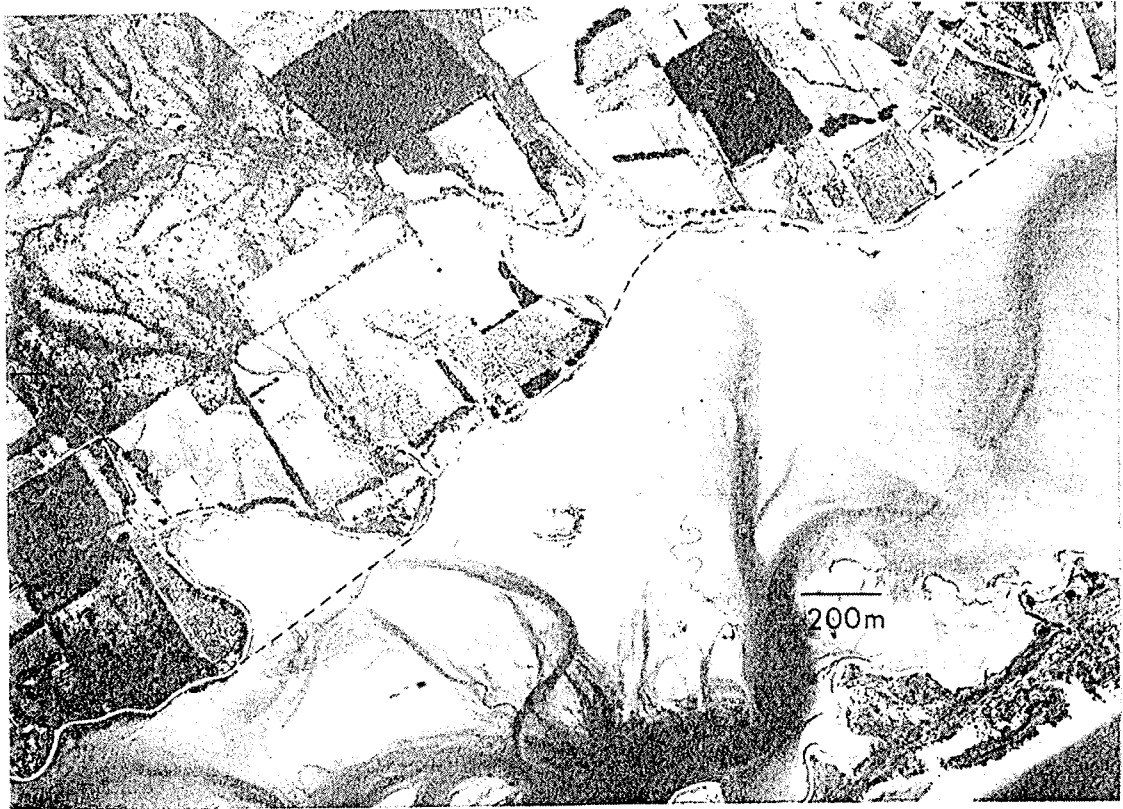
Figure 3.13: Moutere Inlet in 1947 (above) and 1985 (below) showing effects of causeways associated with SH60. These three small causeways appear to have caused only minor changes, with increases in saltmarsh vegetation.

1947-1985: A series of small causeways occur along the indented southwestern shore of Moutere Inlet as part of road straightening. Overall the changes that have occurred due to the causeways are minor, and mainly involve small increases in saltmarsh vegetation. One embayment (SH60 (6)) appears to have limited tidal exchange and retains ponded water at high tide.

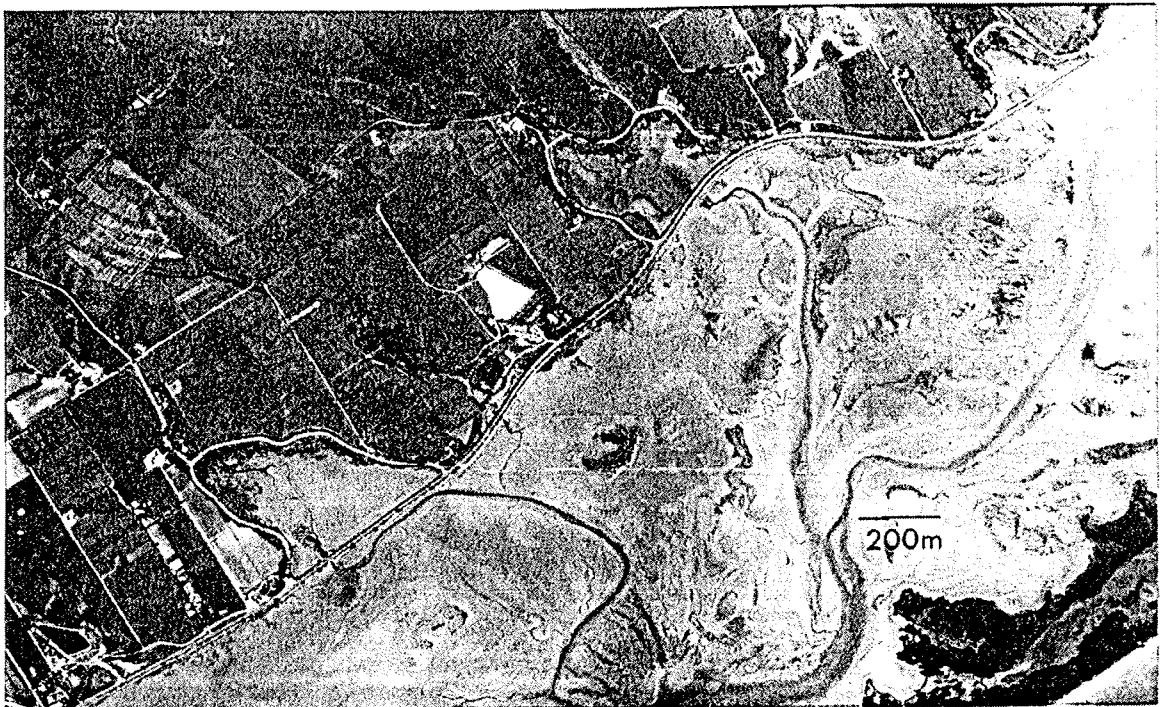
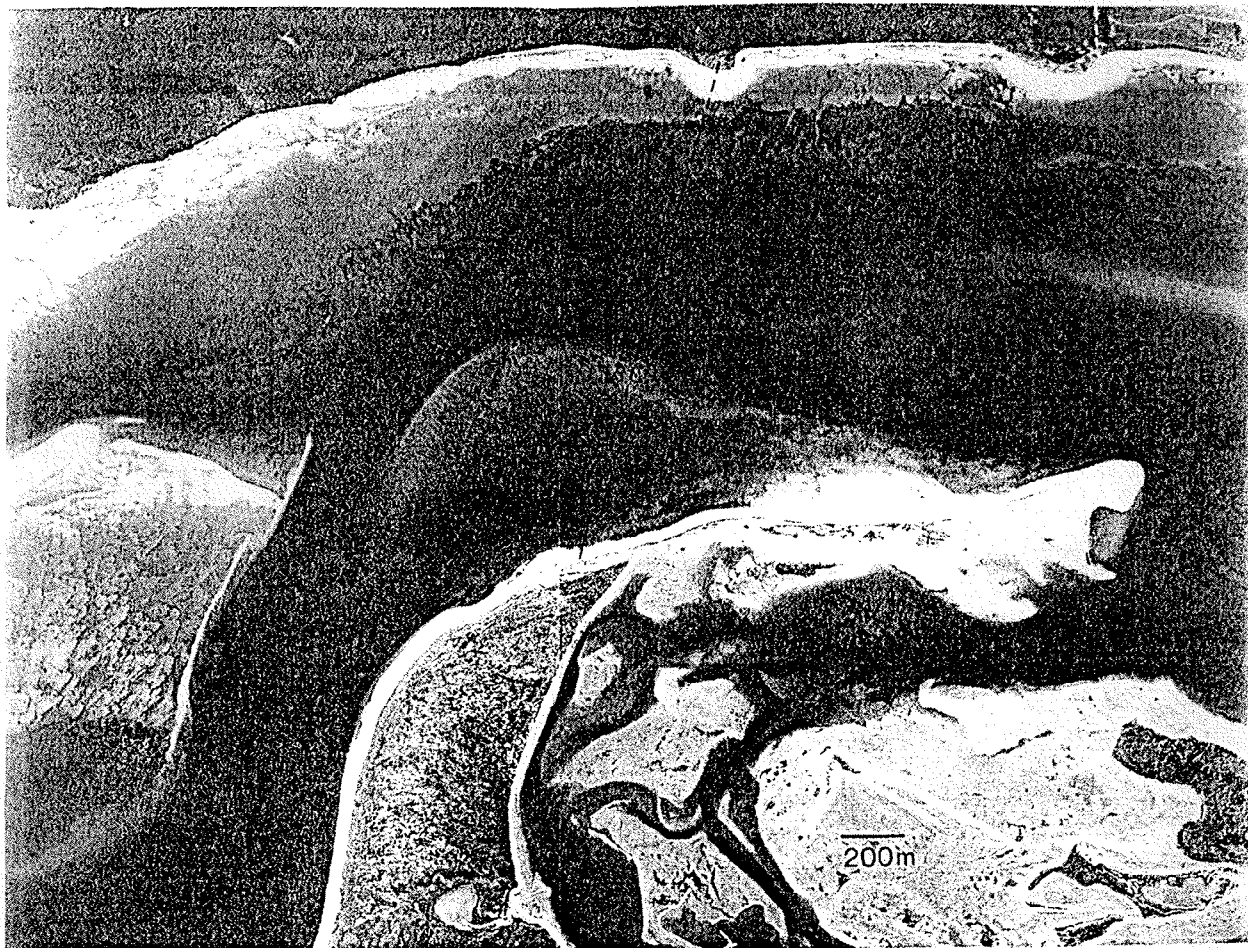
Figure 3.14: Awarua Bay, Southland, in 1951 (above) and 1985 (below) showing the Tiwai Road causeway. This long (1200 m) causeway cuts across the channel and intertidal area of the bay, but has had no obvious effects on channel morphology or sedimentation patterns.

1951-1985: A very long (1200 m) road causeway cuts across the channel and intertidal area of the bay. There have been no obvious changes in channel morphology, shoals, or sandbanks and no evidence of changed sedimentation patterns associated with the causeway.
