**Lyttelton Harbour  
potential contaminant  
sources study, 2007**

Report No. U08/17

Report prepared by Resource Care  
Section of Environment Canterbury

April 2008

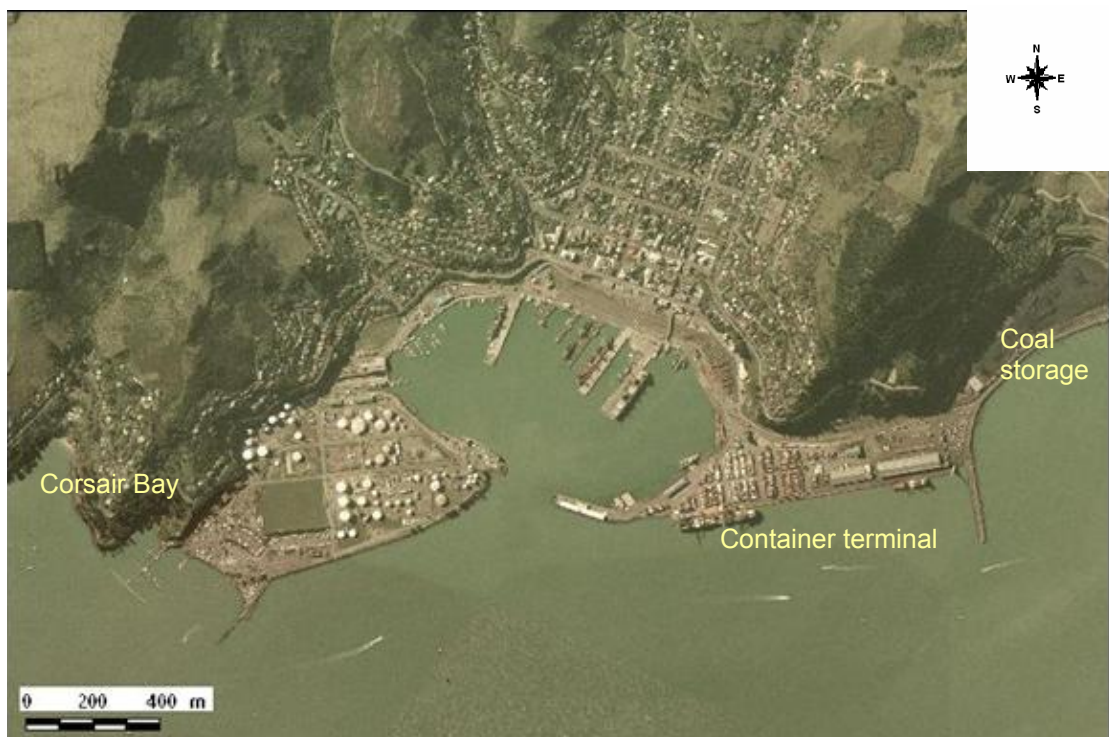
Figure 4.6 Port of Lyttelton

Port activities occur within and north east of the breakwaters protecting the Port of Lyttelton (Figure 4.6). Port activities include loading and unloading of cargoes such as a diversity of dry goods, timber, coal and petroleum products. These cargoes are transferred to and from ships via container, hook, pump, manual labour and roll on/roll off. Adjacent to the water front are storage area for timber (inner Port area), coal (east of the container terminal) and petroleum products (South Western end). Within the port there are mooring for fishing boats, passenger ferries and tourist boats while outside and south west of the breakwaters is the marina complex (between the petroleum storage tanks and Corsair Bay). There is a dry dock on the south western shore of the port with the seabed in the immediate vicinity of the dry dock being the only know Lyttelton Harbour contaminated site. This contaminated site is monitored and managed.

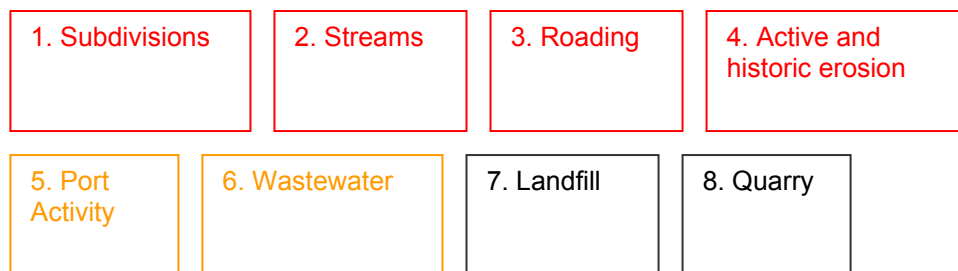
Figure 6.3 Sources of sediment and other contaminants from Gollans Bay, Port Lyttelton and Corsair Bay

Lyttelton township has the largest network of wastewater infrastructure (connections and pipeline) in the Harbour. The wastewater treatment facility is located adjacent to the container terminal area with the outfall located south of this facility (Figure 6.3).

There are subdivisions to the North East of Lyttelton Township at Hyllton Heights, and to the West at Walkers Road (Figure 6.3).

In Gollans Bay the quarry site and landfill site are in the same area (Figure 6.3).
