Physical and ecological impacts associated with
mangrove removals using *in situ*
mechanical mulching in Tauranga Harbour

Carolyn Lundquist, Sarah Hailes, Katie Cartner, Kelly Carter, Max Gibbs

NIWA Technical Report No.137

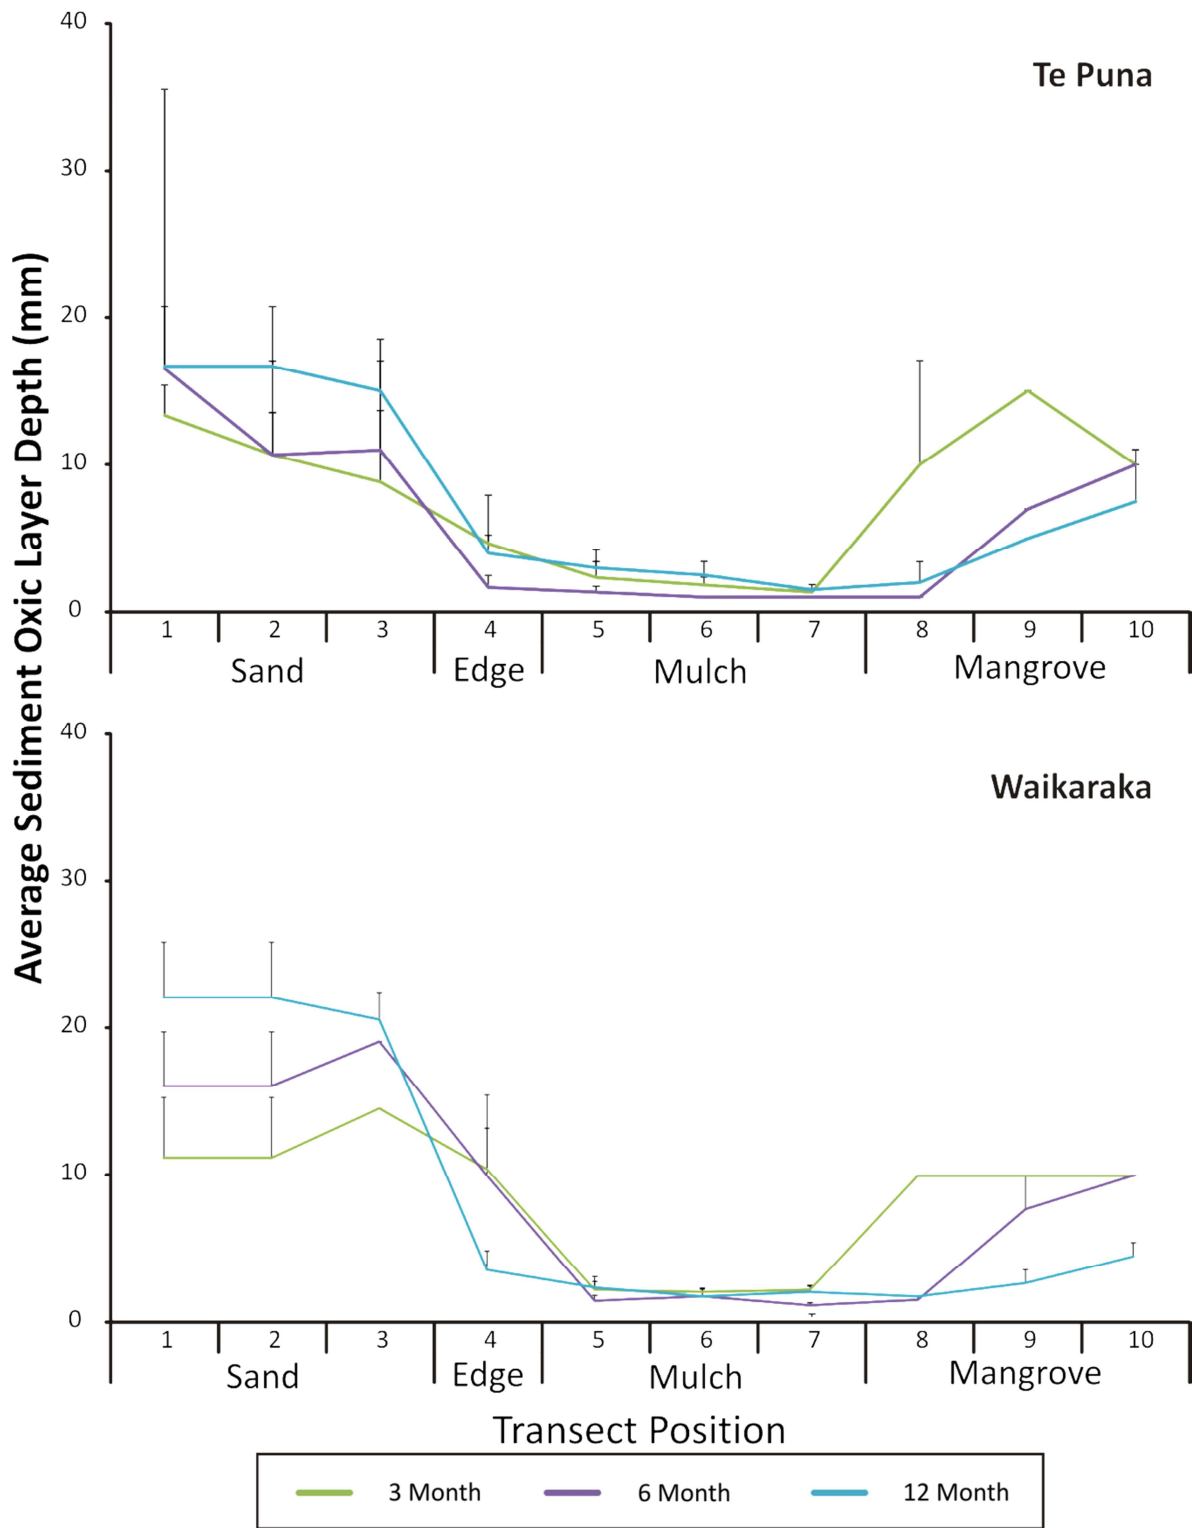
Figure 3-6: The mean depth (+SE) of the oxic layer (mm) sampled at Te Puna and Waikaraka estuaries prior to mulching, and at approximately 3 months, 6 months and 12 months post mulching. Transect number and habitat zones are denoted on the x axis.

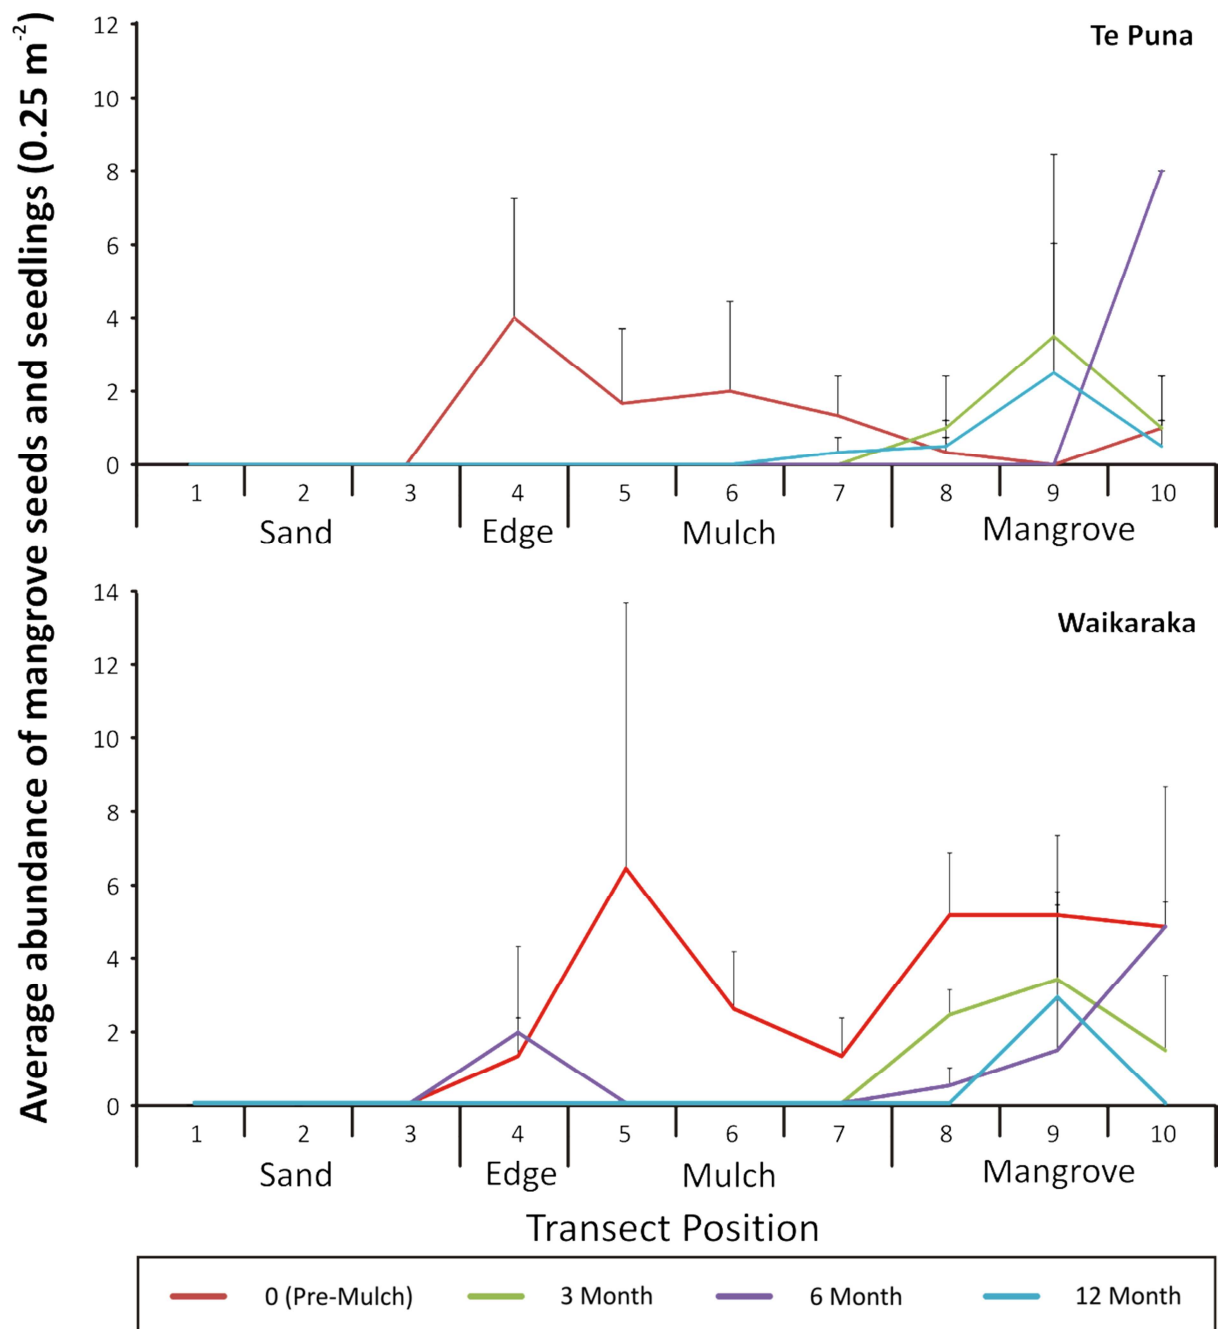
Figure 3-10: The mean abundance of mangrove seeds and seedlings (combined) (+SE), sampled at Te Puna and Waikaraka estuaries prior to mulching, and at approximately 3 months, 6 months and 12 months post mulching. Transect number and habitat zones are denoted on the x axis.

Mangrove seeds and seedlings were common throughout mangrove habitats including the mulched area in the baseline survey (Figure 3-10). After mulching, seeds and seedlings were rare in the mulched area and adjacent sandflat during the 12 month survey period. Seeds and seedlings were rarely seen colonising the survey sites outside the remaining mangrove zone in the post-mulch surveys, with mean of < 1 seed or seedling observed at all transects in each estuary, whereas seedling abundance was ranged between 2-4 mangrove colonists per 0.25 m² quadrat at Te Puna, and 2-8 mangrove colonists per 0.25 m² at Waikaraka during the baseline survey prior to mangrove mulching (Figure 3-10).

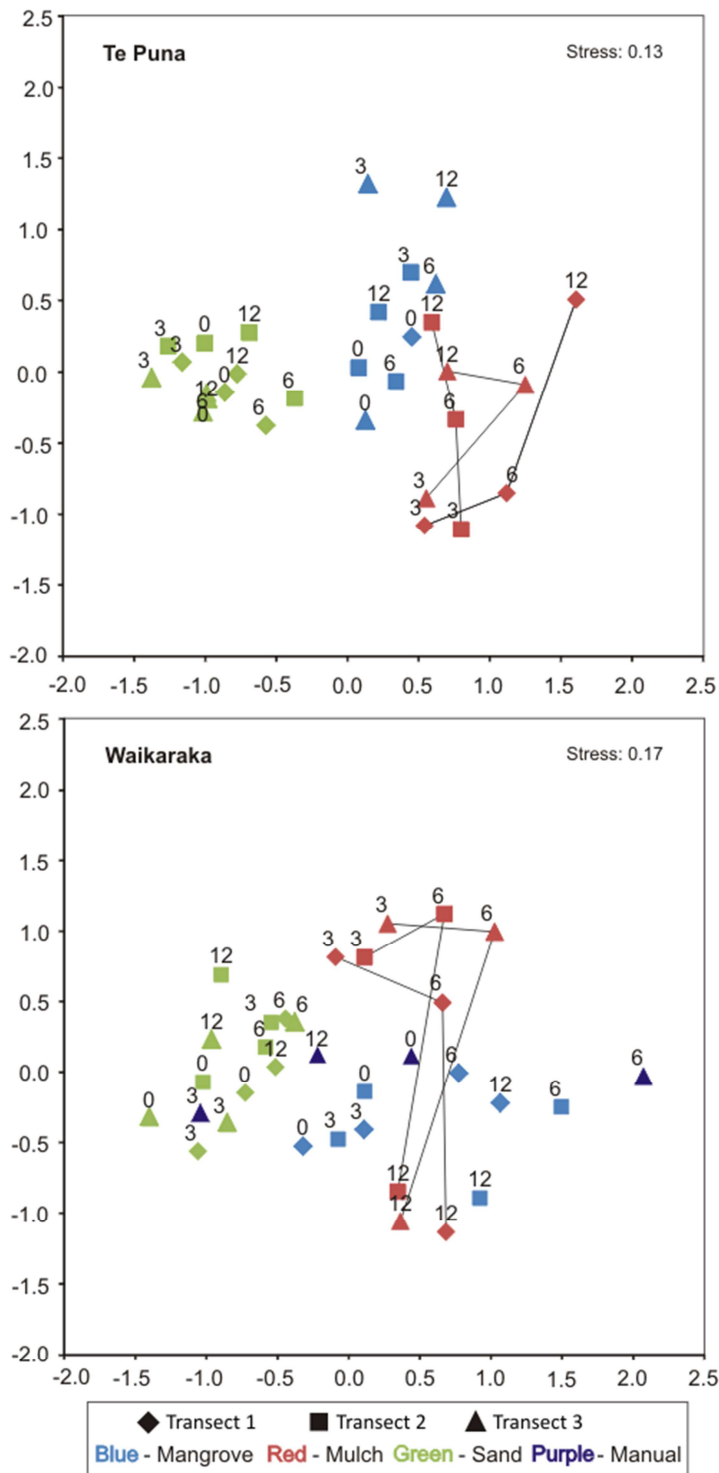
Figure 3-15: Multivariate analysis (MDS) of macrofaunal community structure at Te Puna and Waikaraka estuaries, prior to mulching, and at 3 months, 6 months and 12 months post mulching, in sandflat, mulch and mangrove habitat zones, and in opportunistically sampled manual clearing area.

Multivariate analyses, based on abundance of individual macrofaunal species found at each site, showed high similarity between transects in sandflat zones within an estuary over all sampling times (Figure 3-15). Sandflat samples were tightly clumped for both Te Puna and Waikaraka (Figure 3-15), with no indication of change over time in sandflat community structure, and similarity across all three sandflat sites.

Mangrove samples showed very loose clustering of communities across both time and sites within each estuary, and clear dissimilarities with communities found in sand and mulch zones (Figure 3-15). Over time, the communities sampled at Te Puna mangrove site 2 were more similar to those sampled at Te Puna mangrove site 3, though the site 3 community appears to be shifting further from the mangrove cluster over time (Figure 3-15). The mangrove sites in Waikaraka estuary were loosely clustered, with some overlap with mulch sites but minimal overlap with sandflat zones (Figure 3-15).

We opportunistically sampled a 'manual' removal location at Waikaraka site 3, showing that these samples (anecdotally suggested by community group to be cleared 1-2 years prior to the mulching inshore of this site) generally clustered near the sandflat sites in Waikaraka estuary, with clustering near sandflat samples at 3 and 12 months, and within the loose mangrove site cluster at 0 and 6 months (Figure 3-15).
