**SOUTH CANTERBURY CATCHMENT
and
REGIONAL WATER BOARD**

**REPORT ON FLOOD
13th MARCH 1986**

Prepared by: F. Scarf, R. S. Keys, R. J. Connell,
J. R. I. Cuff and J. R. Waugh

MAY 1987 – S.C.C.B. Publication No.47
ISSN. 0111 – 7335

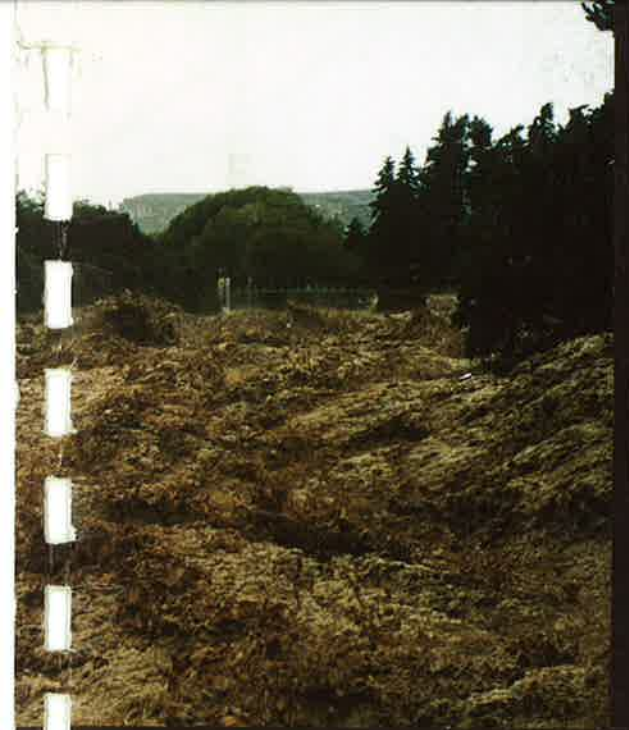
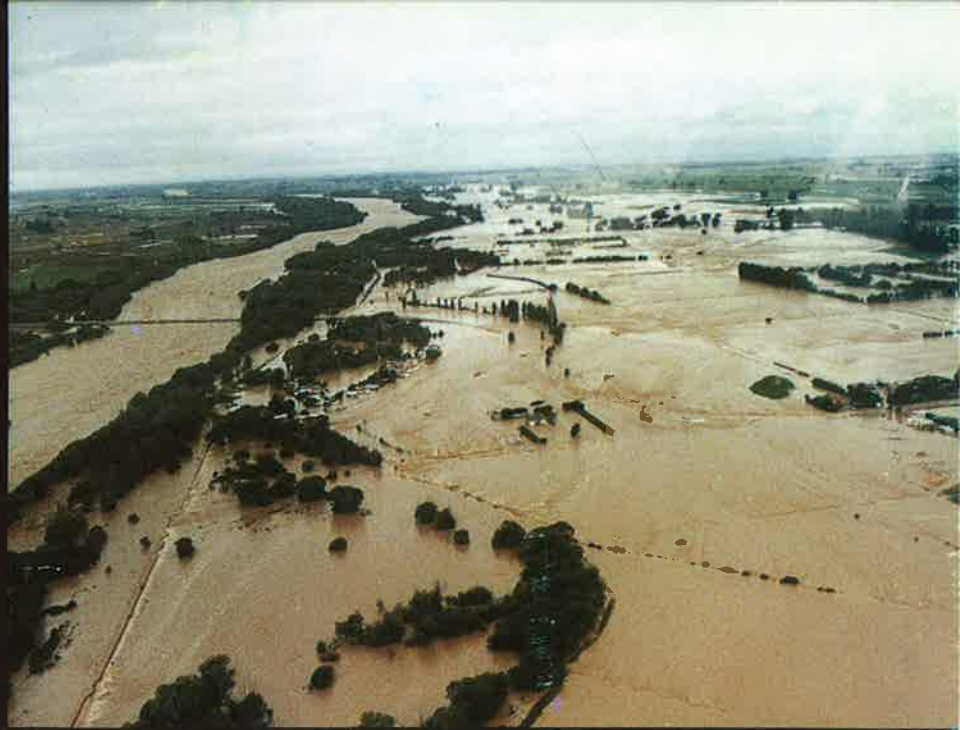
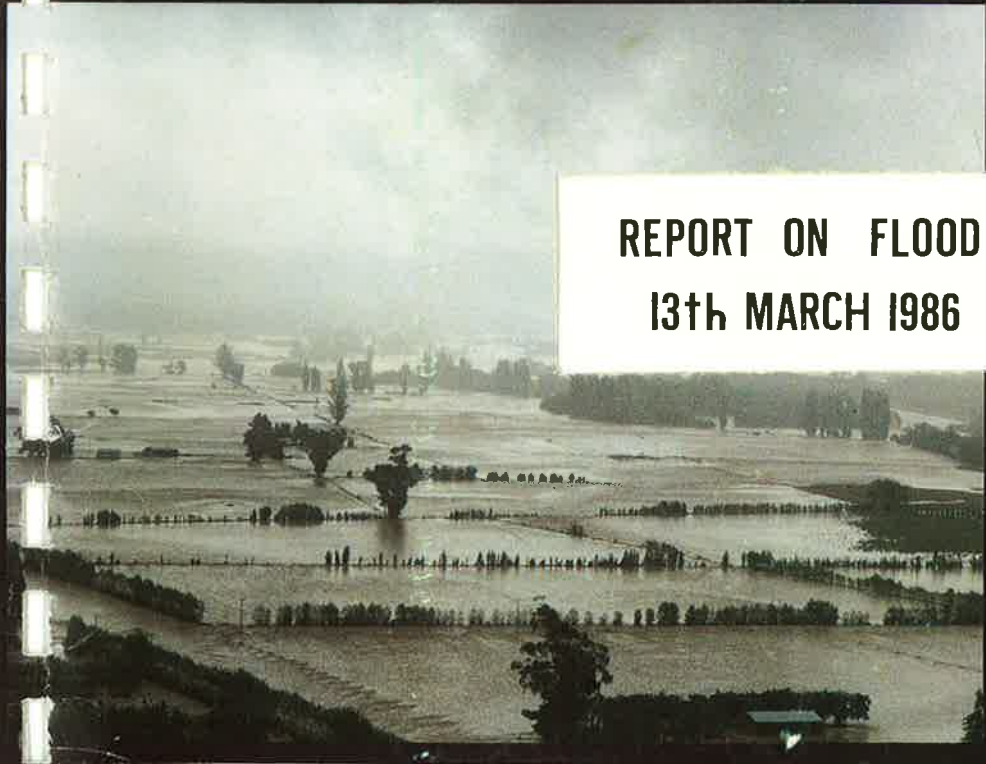
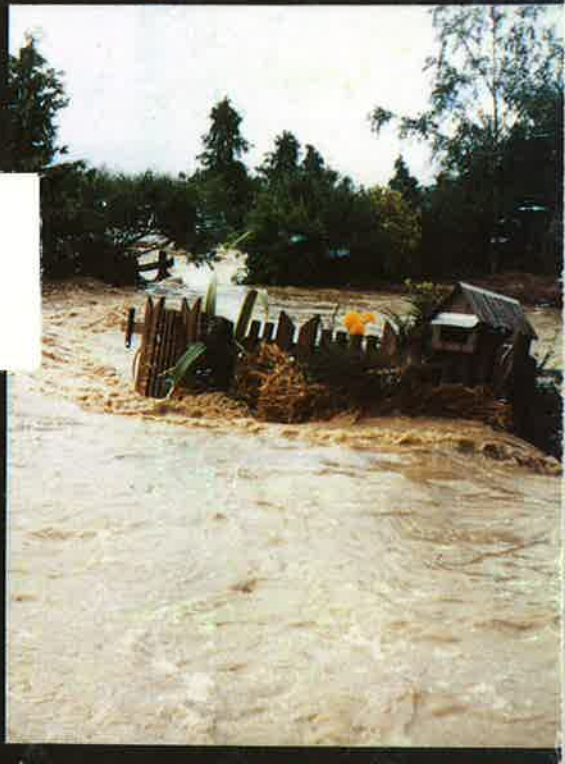
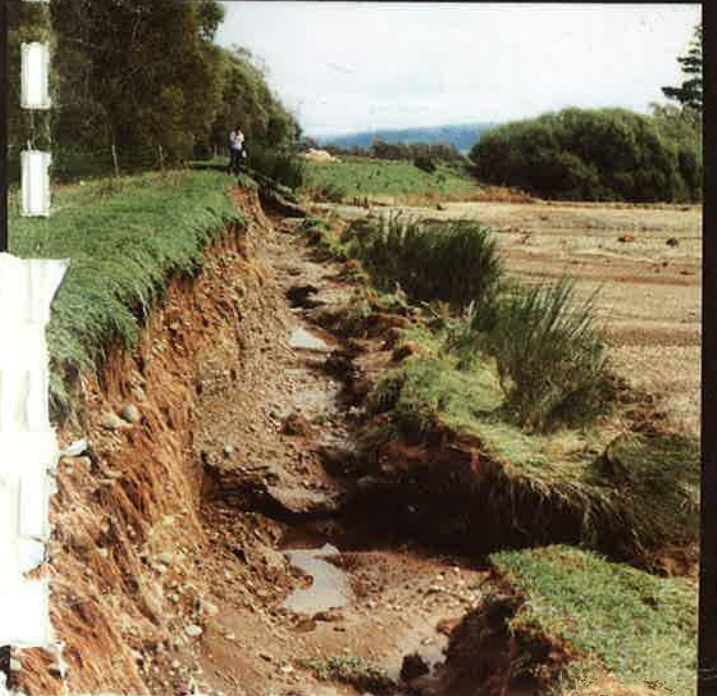
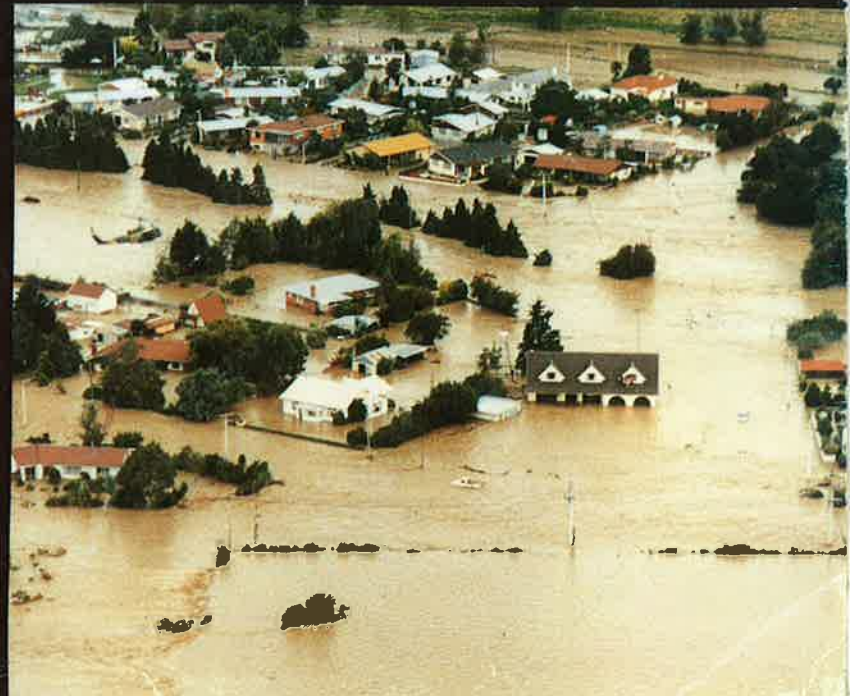
Front Cover

- Top left: Tengawai River at Manahune at height of flood.
- Top right: Opihi River looking towards the coast. Stratheona Huts and Saleyards Bridge in centre left of photo. Note the overtopping of the stopbank extending from left foreground and following the true right bank of the river.
- Centre left: Levels Plains where approximately 3000 ha were inundated. Photograph taken from region of State Highway 1 looking west.
- Centre right: No post today!
- Bottom left: Stopbank failure on Waihao River near Lundy's Ford. Note flow over the bank has eroded the landward toe of the bank.
- Bottom right: Pleasant Point township near the height of the flood.

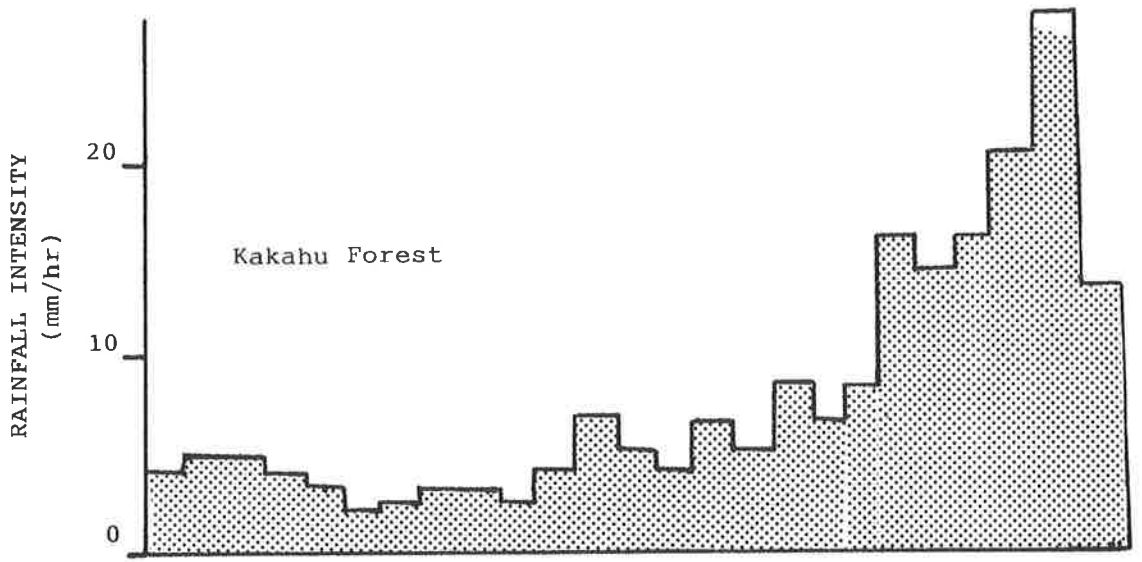
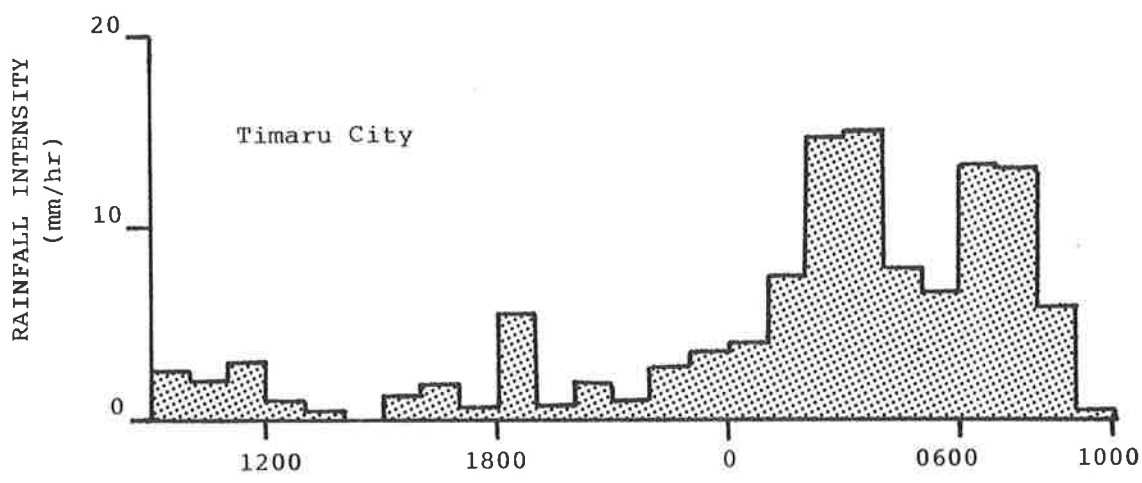
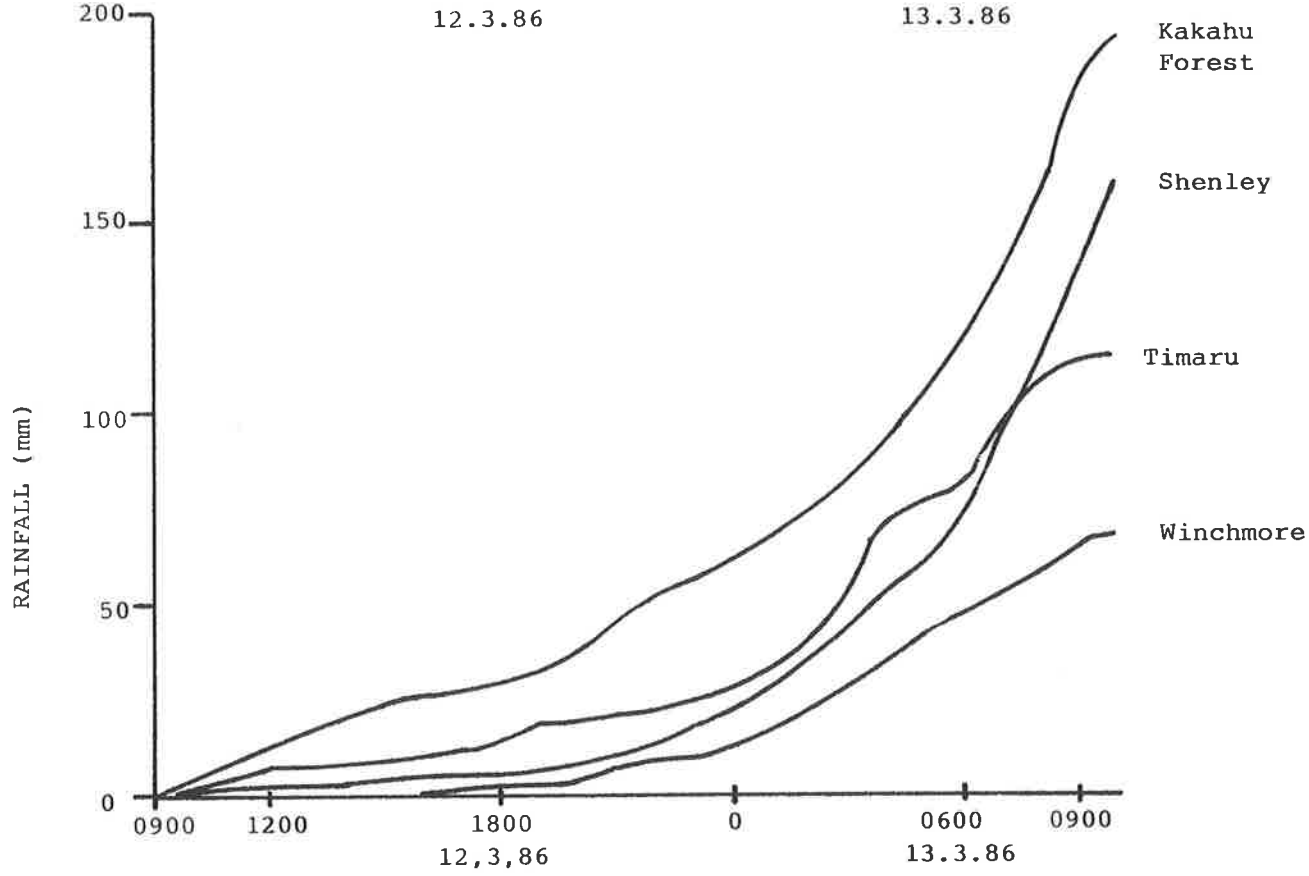
FIGURE 3 : ACCUMULATIVE EVENT RAINFALL AND RAINFALL INTENSITIES FOR RAINFALL RECORDER STATIONS.

Figure 3 shows the rainfall intensities recorded at Winchmore, Kakahu Forest, Rocky Gully, Gleniti and Timaru. Two other automatic rainfall recorders located at Waimate and Shenley (headwaters of Tengawai catchment) malfunctioned during the storm event and failed to give a complete record.

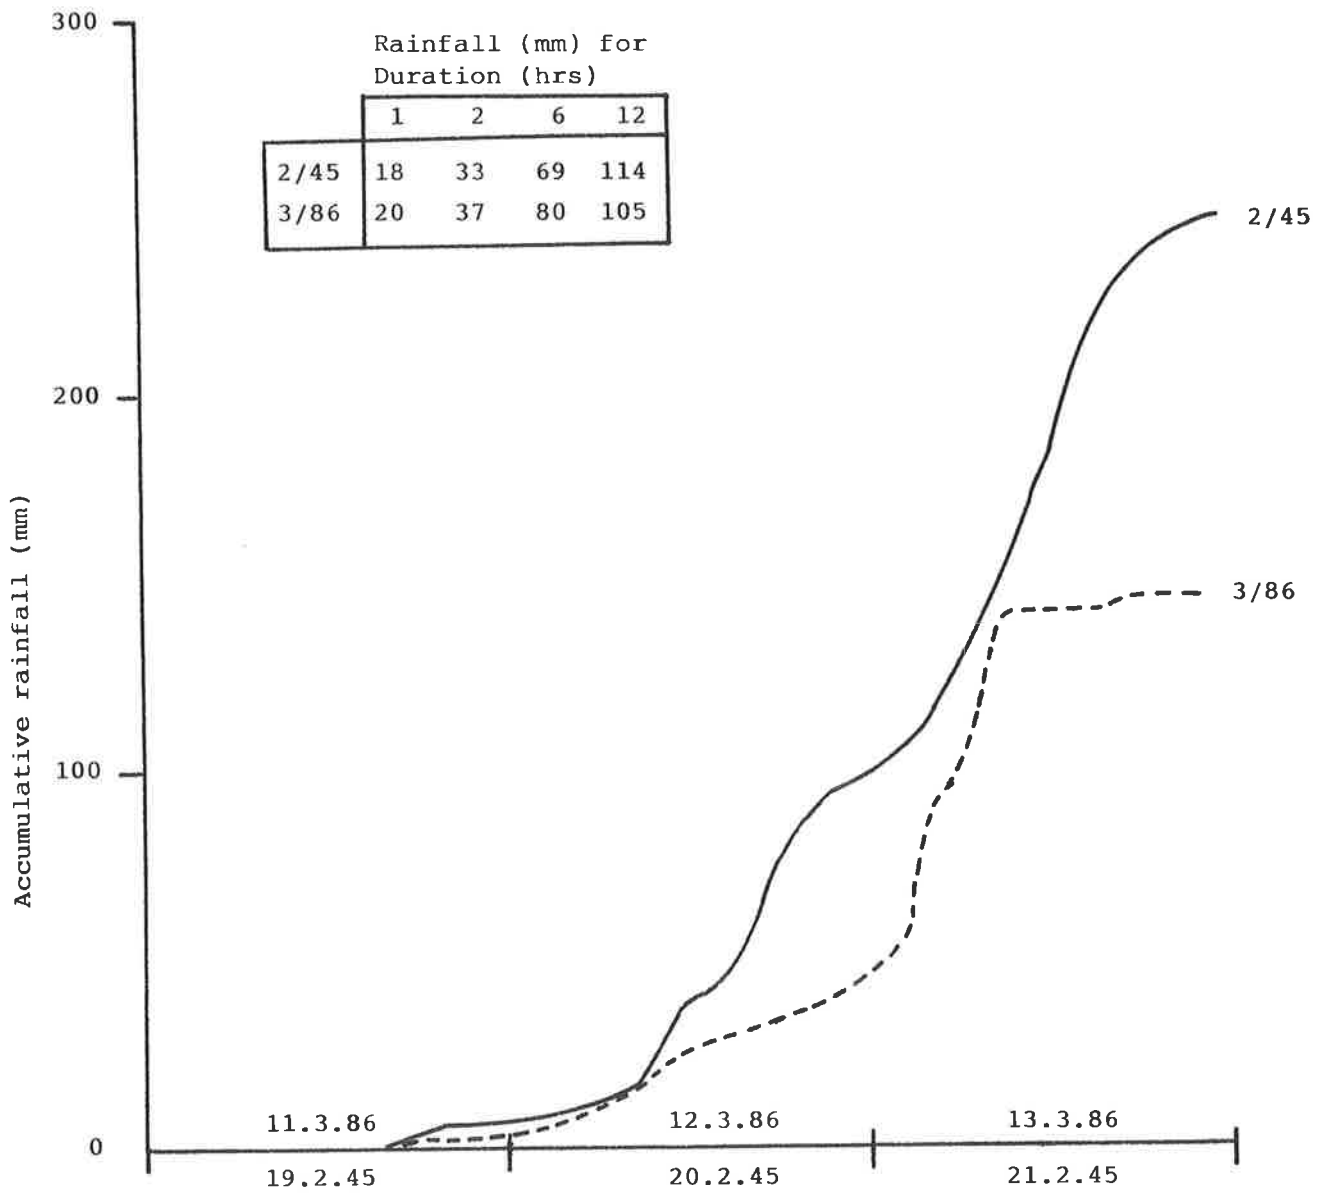
FIGURE 4 : ACCUMMULATIVE EVENT RAINFALL FOR GLENITI RESERVOIR FOR FEBRUARY 1945 AND MARCH 1986 FLOODS.

Figure 4 shows the accumulative event rainfall for Gleniti Reservoir and compares the March 1986 flood with the February 1945 flood. Unlike the rainfall pattern for the recent flood, in 1945 the high rainfall areas were centred close to the coast and not on the physical barriers presented by the Hunters Hills and Two Thumb Ranges. While the rainfall event appears to have been more prolonged in 1945, the March 1986 flood is noted for its higher rainfall intensities; in particular the 2-6 hour rainfall totals.

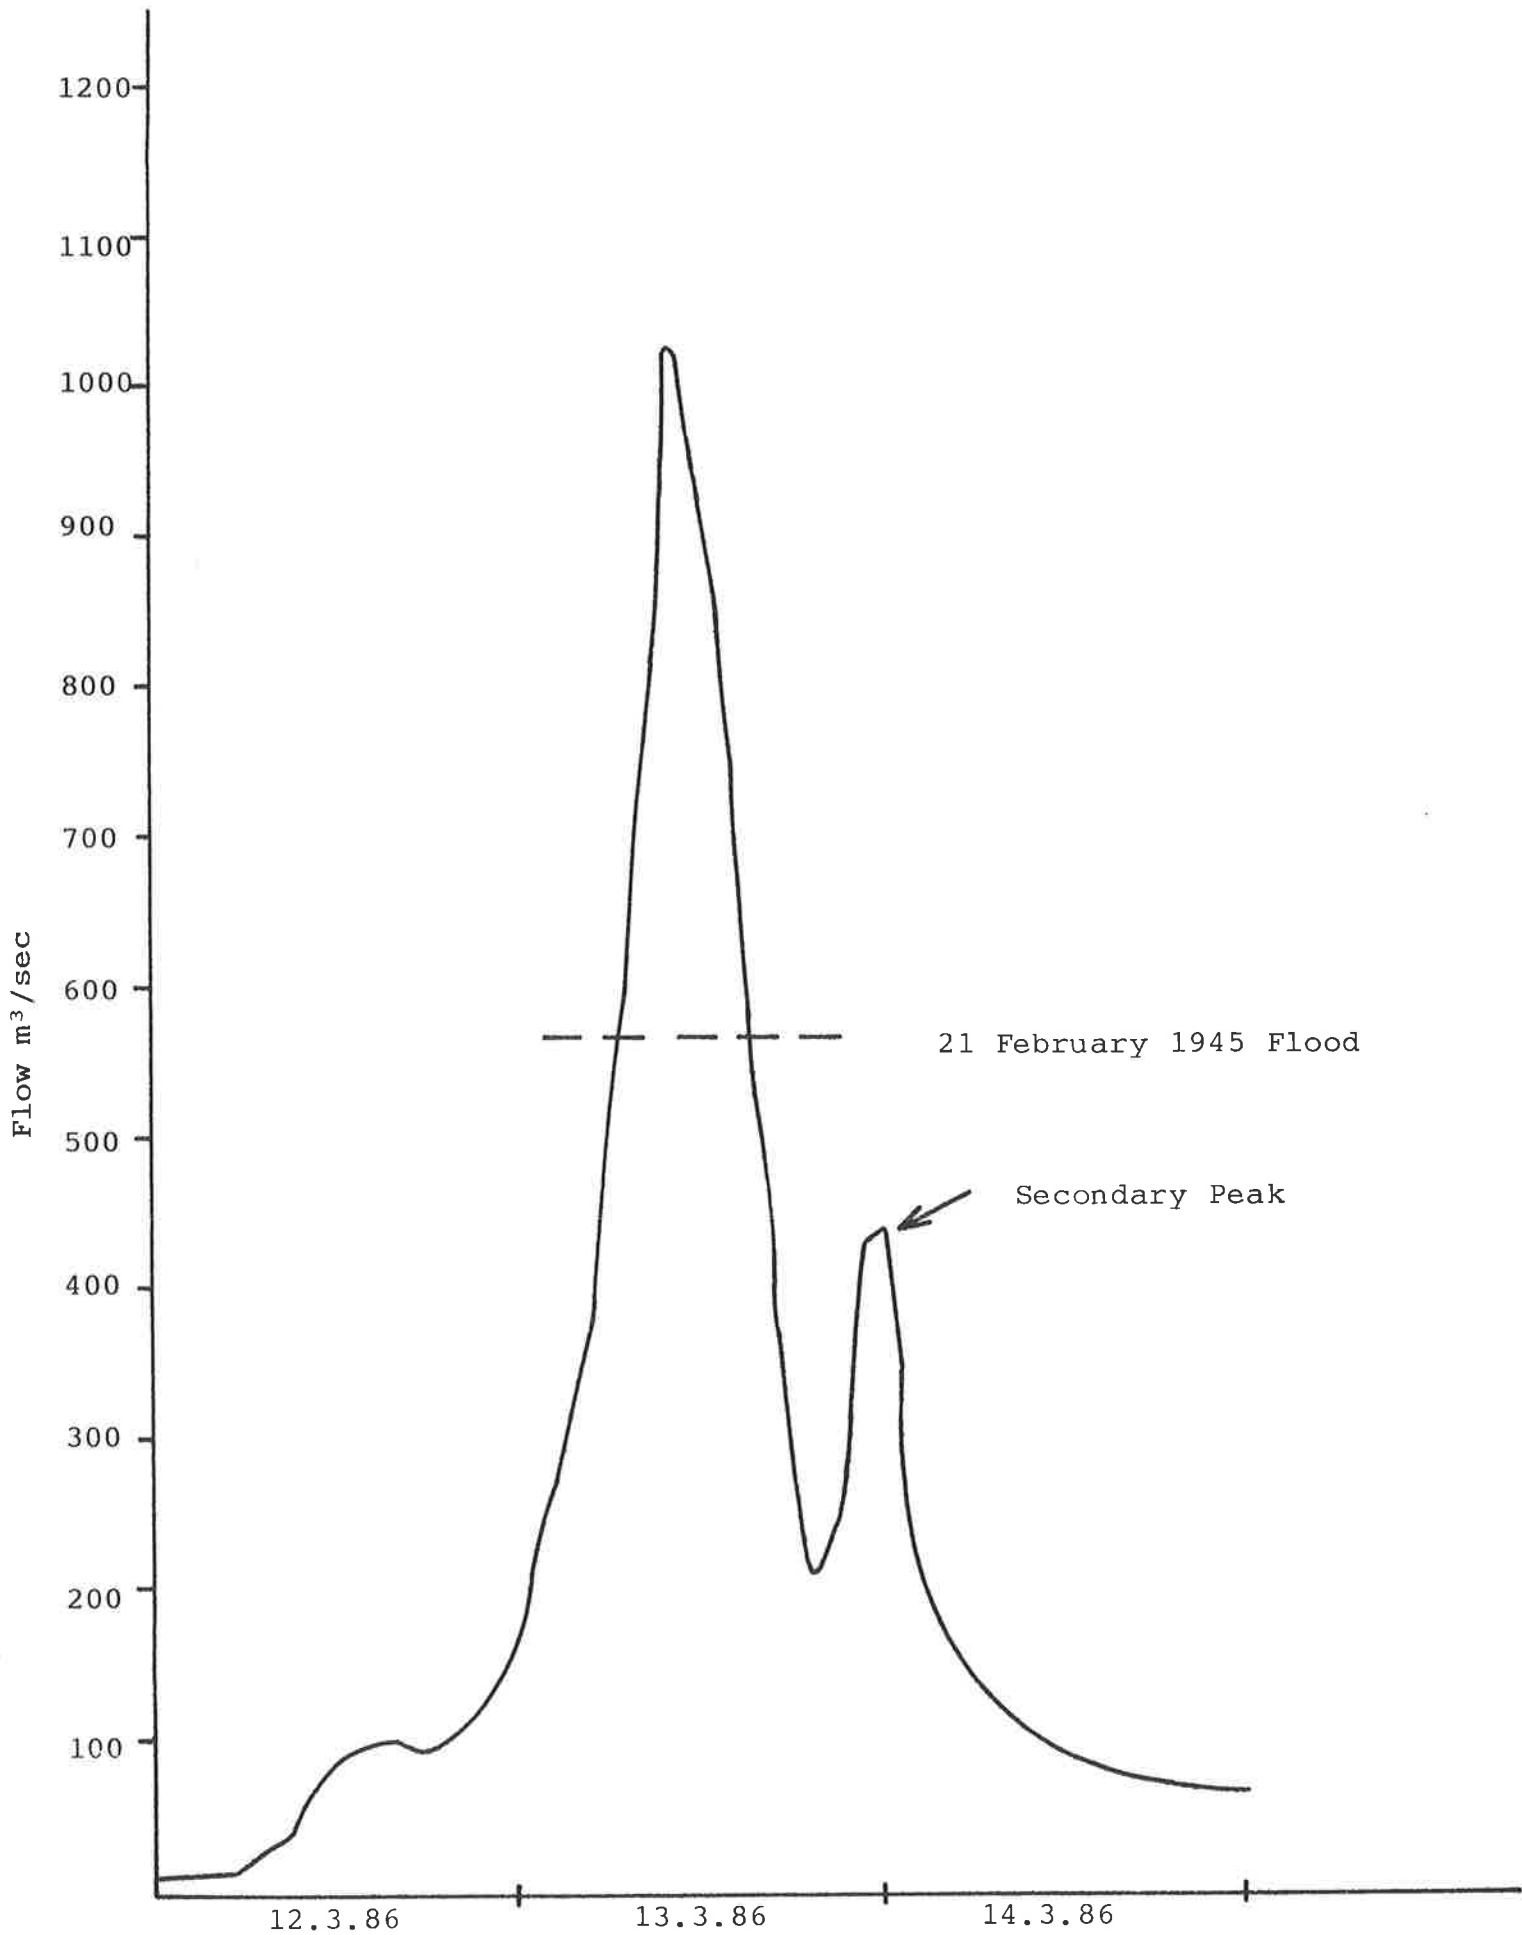
FIGURE 6 : DISCHARGE HYDROGRAPH FOR OPIHI RIVER AT ROCKWOOD.

Notable features of the hydrographs are the very rapid rate of rise to the flood peak, followed by a rapid fall in discharge for the first few hours after the peak (Fig. 6). The sharpness of the flood peaks, and the extremely high peak discharges are attributed to the intense rainfall at the end of the storm. The main part of the flood has a duration of about 20 hours and much of the hydrograph occurs within 12 hours.

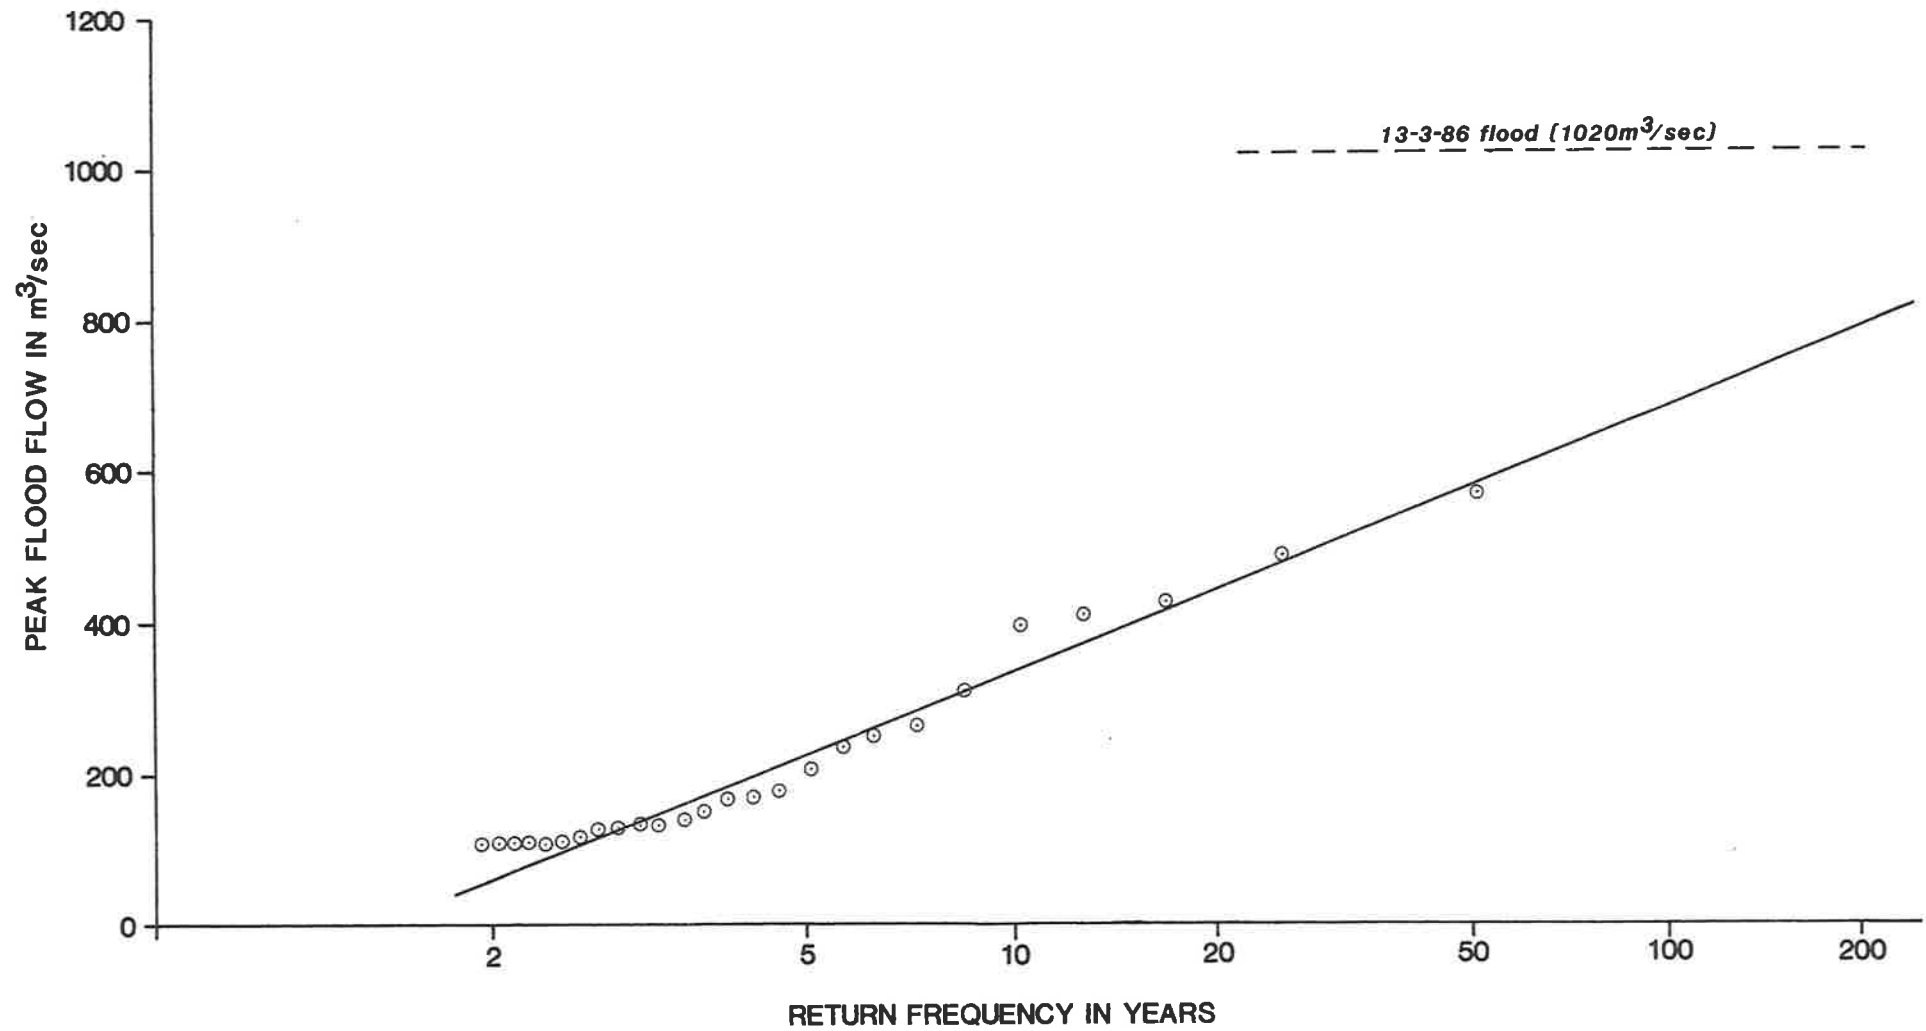
FIG 9: FLOOD FREQUENCY PLOT (GUMBELL)-OPIHI RIVER AT ROCKWOOD

Beable and McKerchar's regional flood study (1982) suggests that for South Canterbury the ratio of the 200 yr flood to the mean annual flood is approximately equal to 4.0.

This again suggests that the March 1986 flood is a very large event with a return period in excess of 200 years.

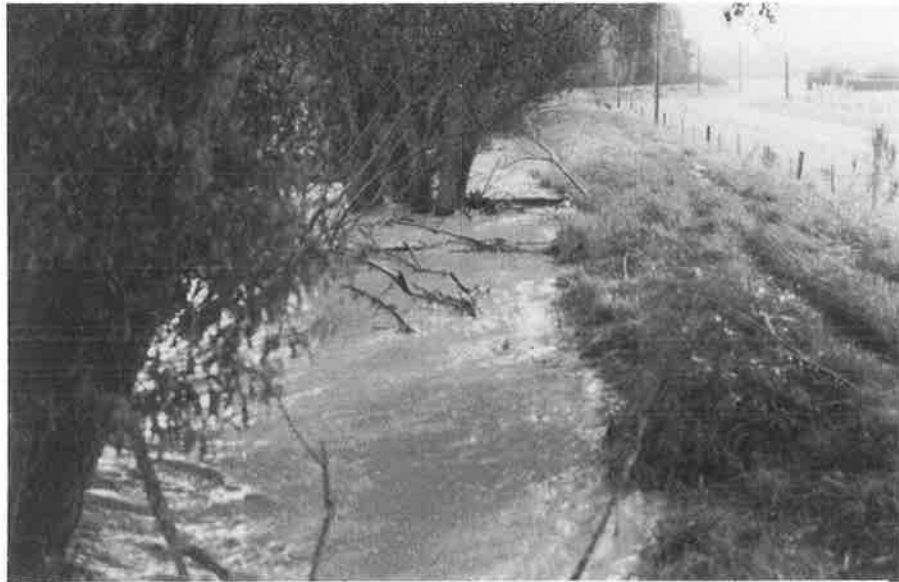
Hinds River within 300mm from top of stopbank between Poplar Road and Surveyors Road (Black Bridge).

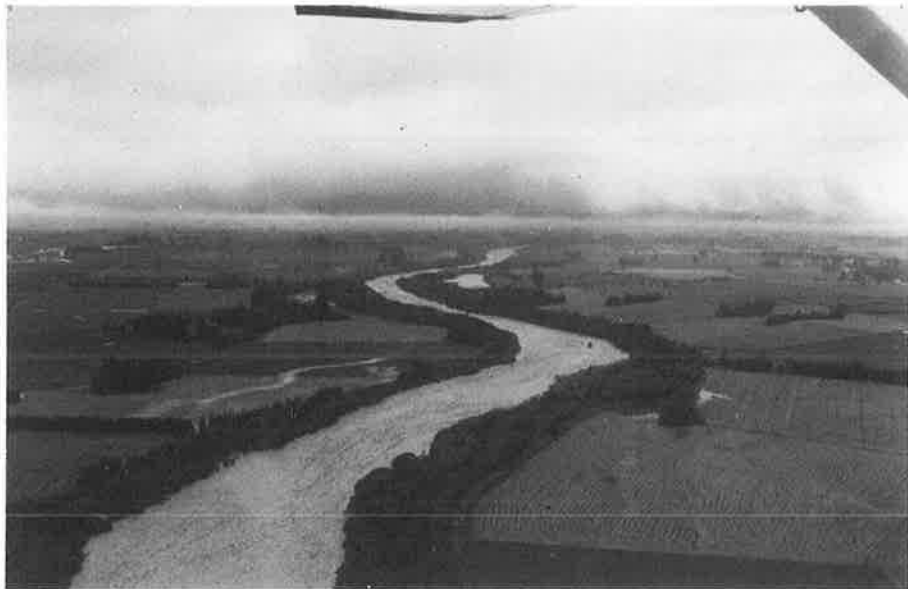
Orari River from near Coast looking inland. Photograph taken at peak of flood.

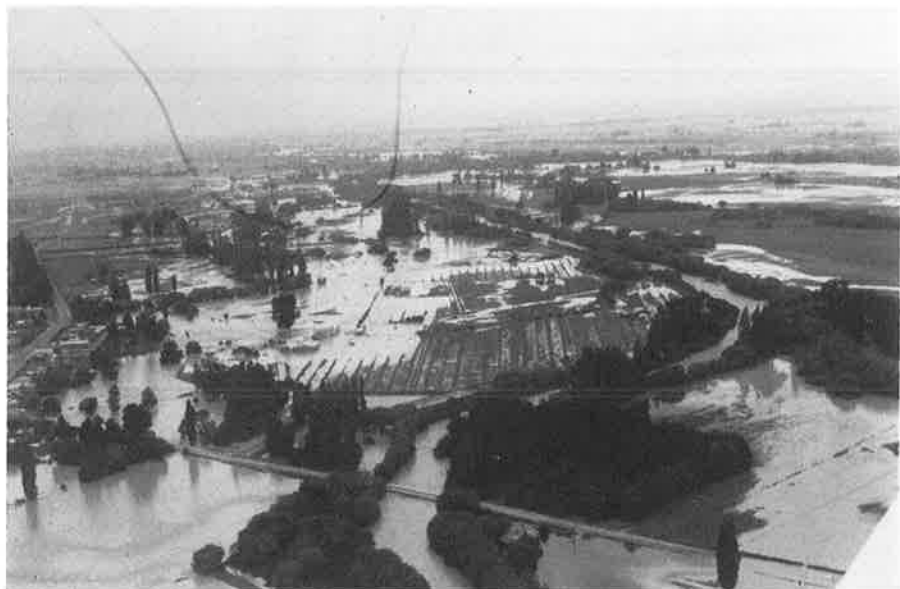
Waihi River. View south from SH72 towards Temuka in background. Winchester township in left foreground. Note the flooding along Dobies Creek to left of main river channel UEB (Waihi) Woollscour complex (centre of photo).

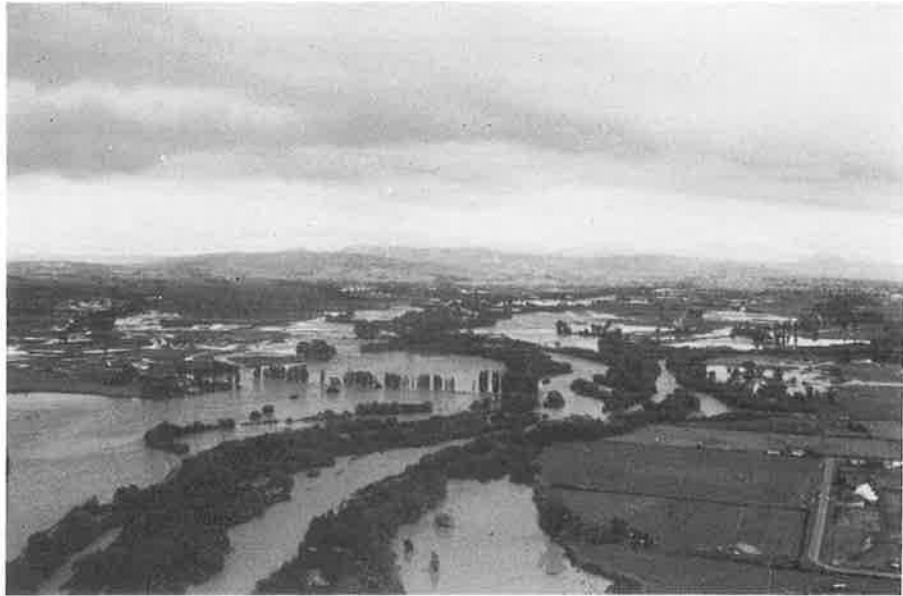
Te Moana River from Temuka (right foreground) looking upstream towards Geraldine.

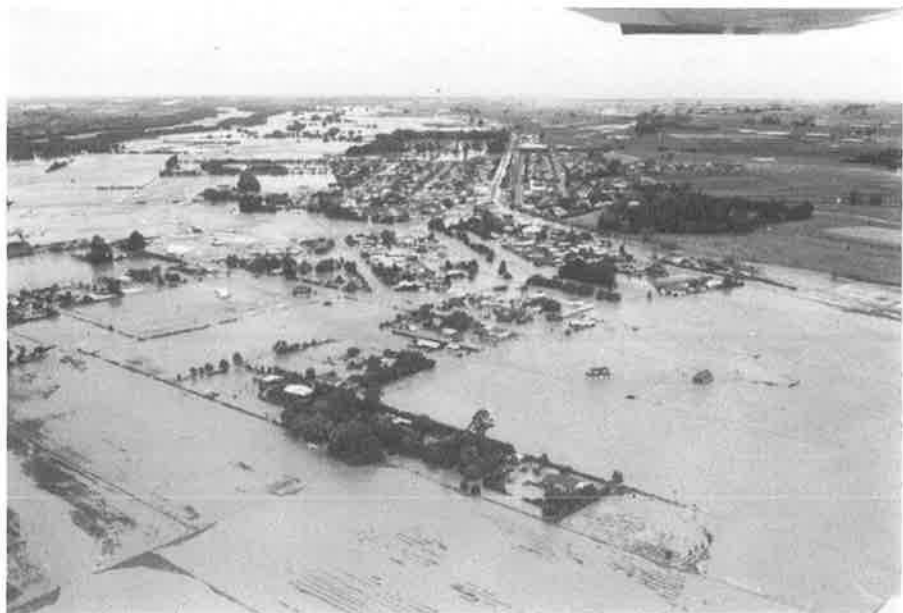
Flood protection along Tengawai River (to left of photo) overtopping and floodwaters inundated Pleasant Point township. Looking towards coast, lower Opihi River in top left.

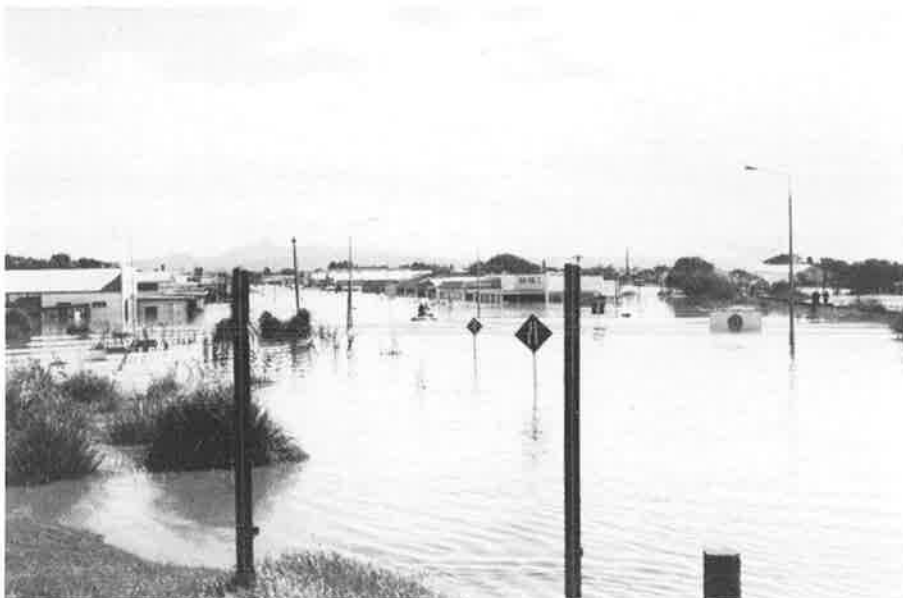
Washdyke looking north along State Highway 1.

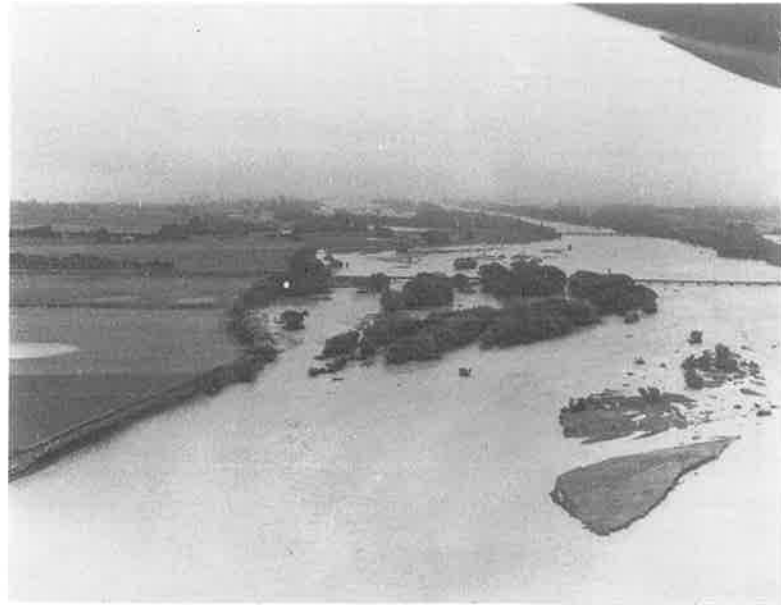
Pareora River from coast looking west. SIMT Railway Bridge right centre (Courtesy N.Z. Airforce).

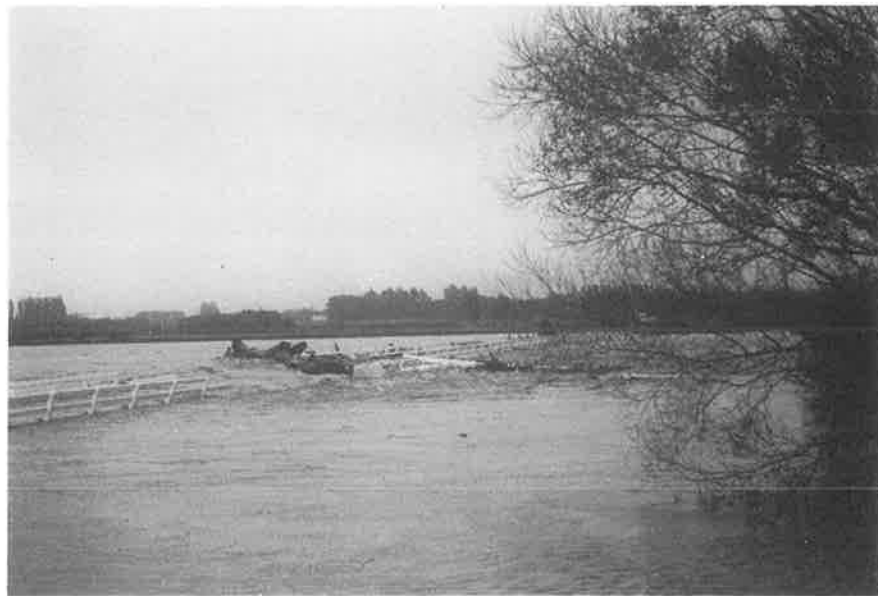
Bradshaws Bridge on Waihao River. Flood debris demolishing the handrails. (Courtesy M.E. Bruce).

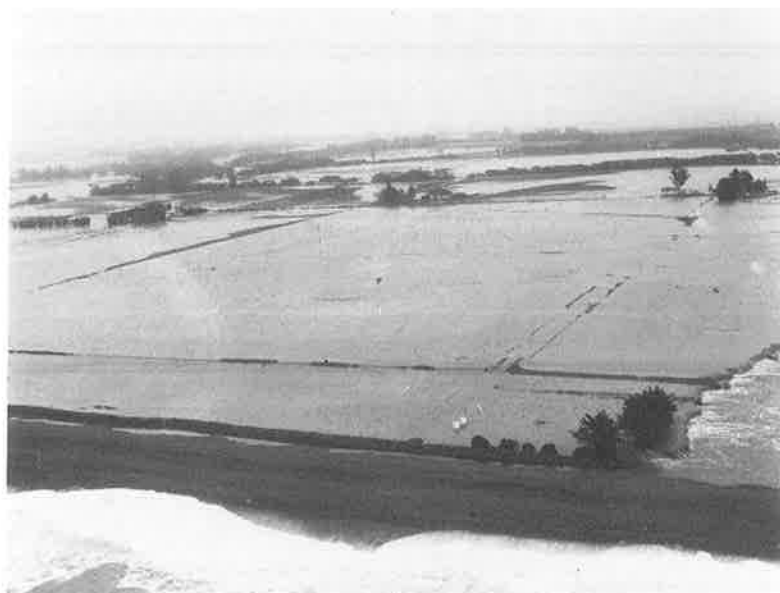
Waihao River at mouth (right foreground) looking west. River channel follows line of willow trees extending from upper left to right in photo. (Courtesy N.Z. Airforce).

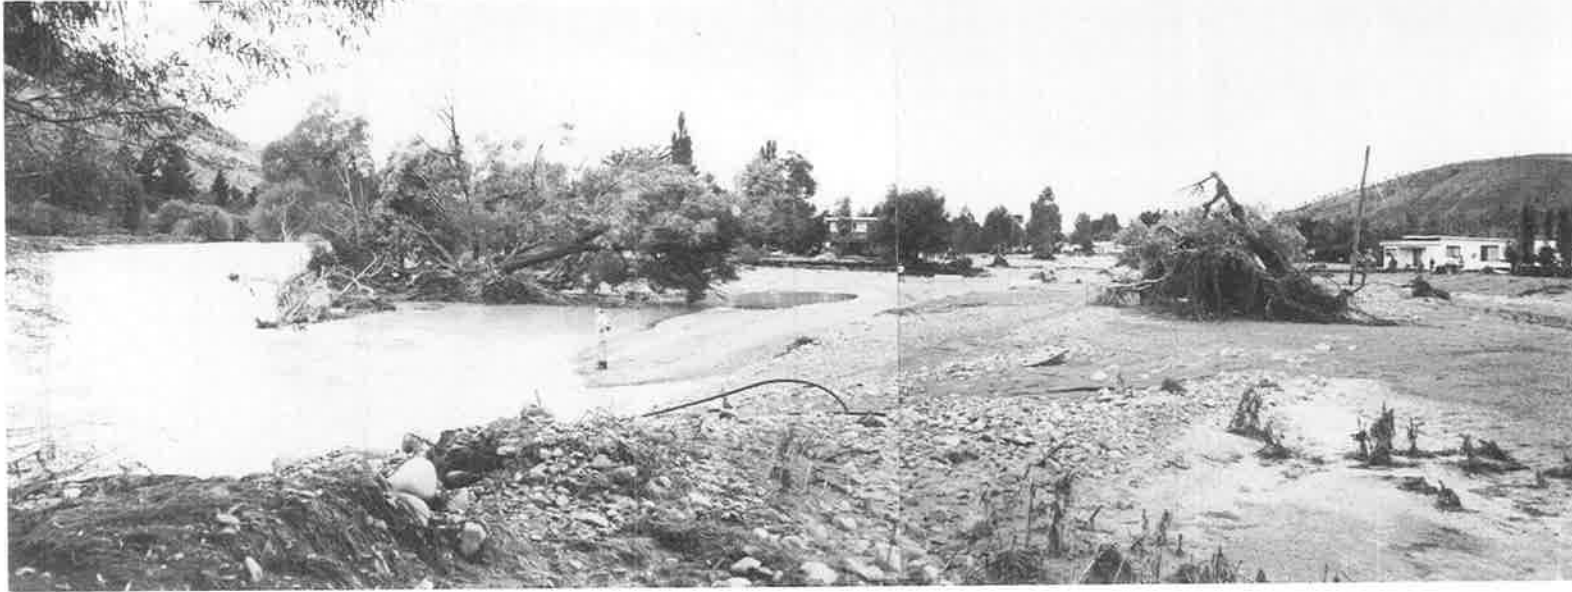
Overtopping and subsequent breaching of the stopbank at Pareora Huts caused major damage to buildings, roads and services in the area.

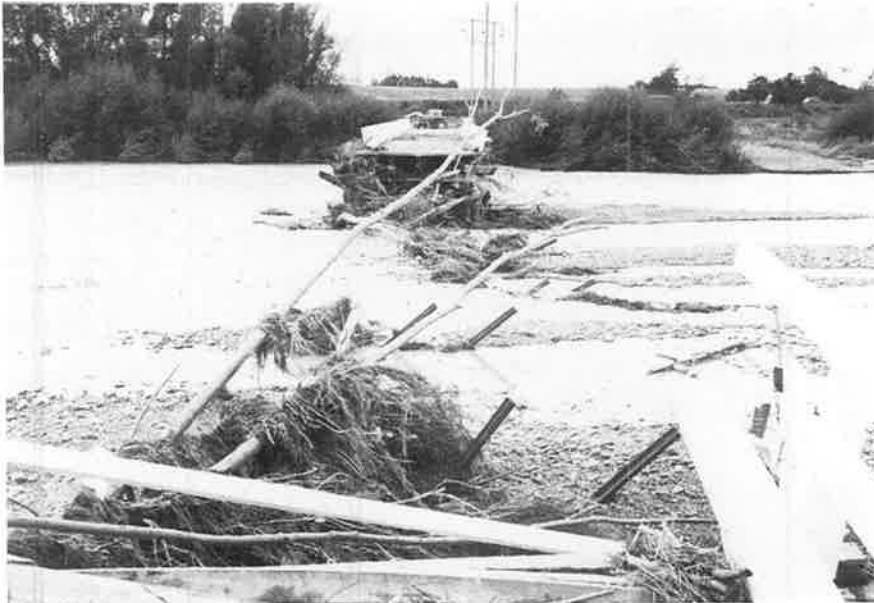
Many bridges throughout Strathallan and Waimate Counties sustained major damage. Brasells Bridge built in the early 1900s was extensively damaged.

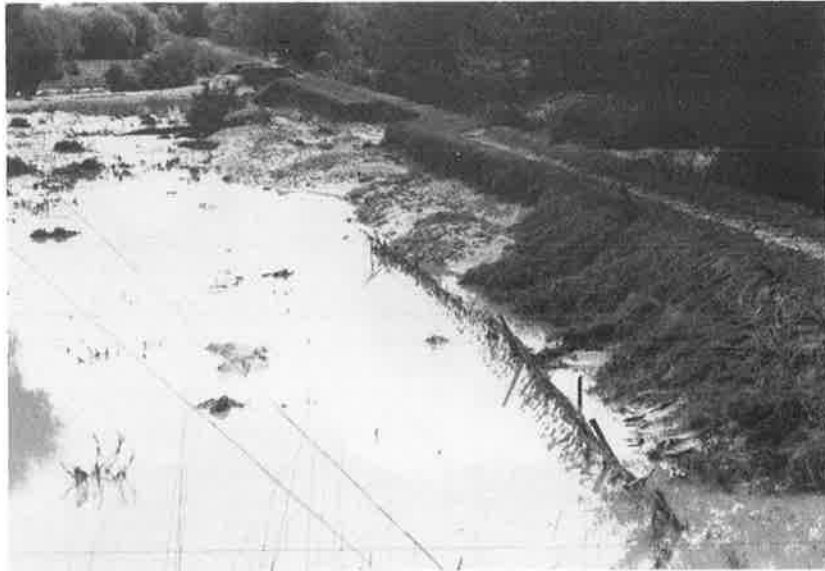
Stopbank (true right bank) immediately upstream from Saleyards Bridge (Opihi River) demonstrating process of stopbank failure. Flow overtopping the bank erode the stopbank from the top back towards the river side of the bank (mid photo) until eventually the bank is totally breached (top left photo).

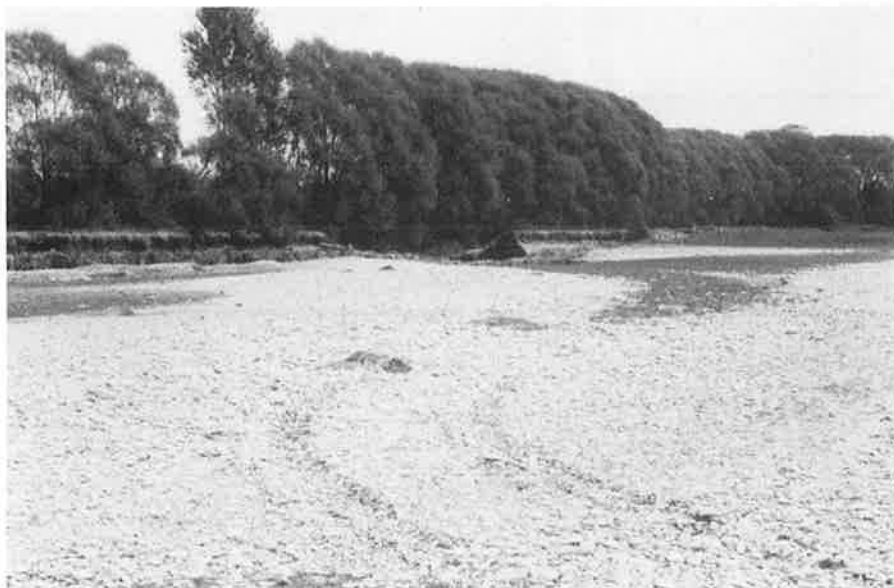
Shingle deposited onto farmland carried by flow through the breach in the stopbank (mid photo).

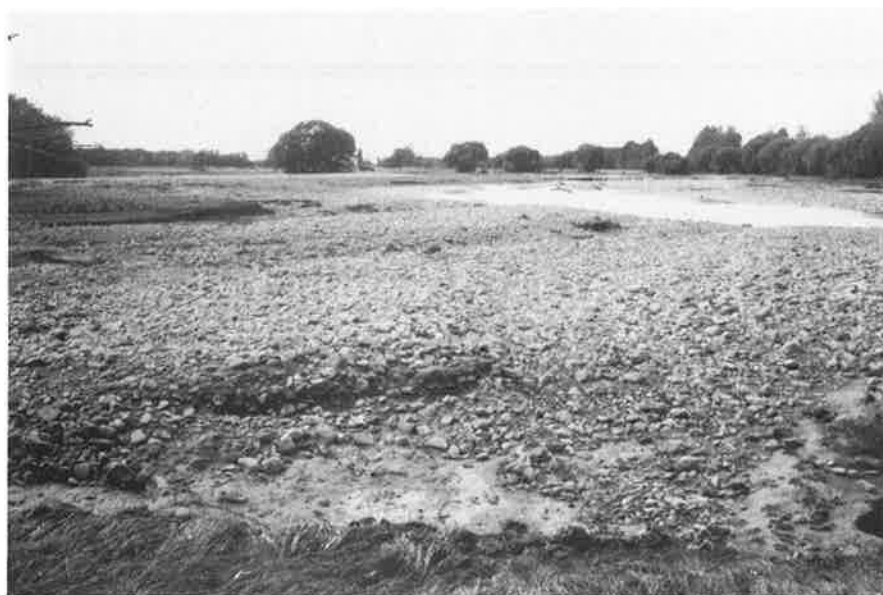
Out-of-channel flows caused major soil loss with some paddocks adjacent to the stopbanks being stripped completely bare down to the underlying shingle material.
