**SOUTH CANTERBURY CATCHMENT
and
REGIONAL WATER BOARD**

**REPORT ON FLOOD
13th MARCH 1986**

Prepared by: F. Scarf, R. S. Keys, R. J. Connell,
J. R. I. Cuff and J. R. Waugh

MAY 1987 – S.C.C.B. Publication No.47
ISSN. 0111 – 7335

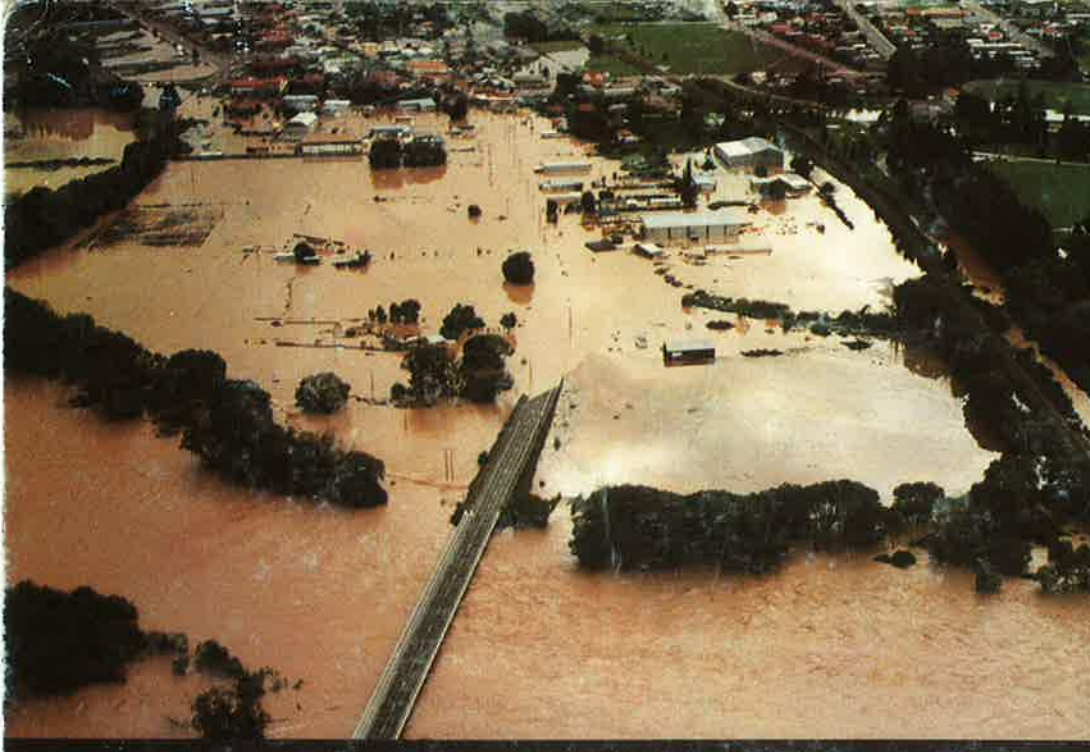
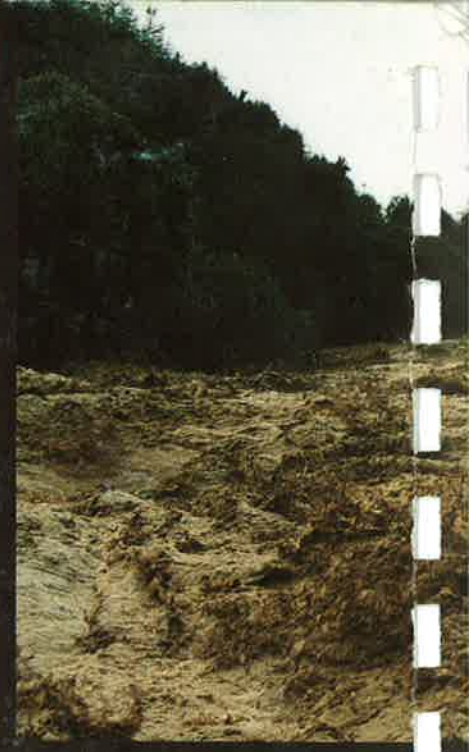
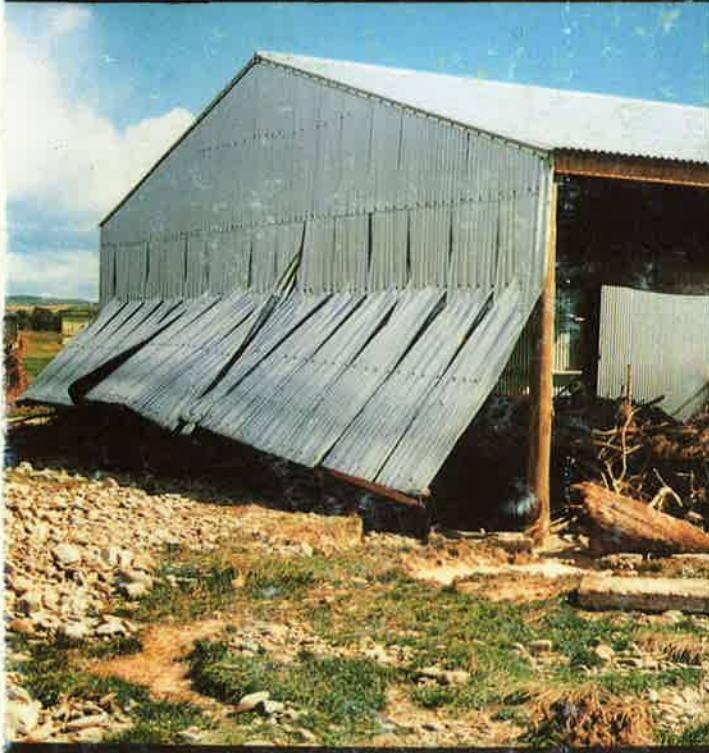
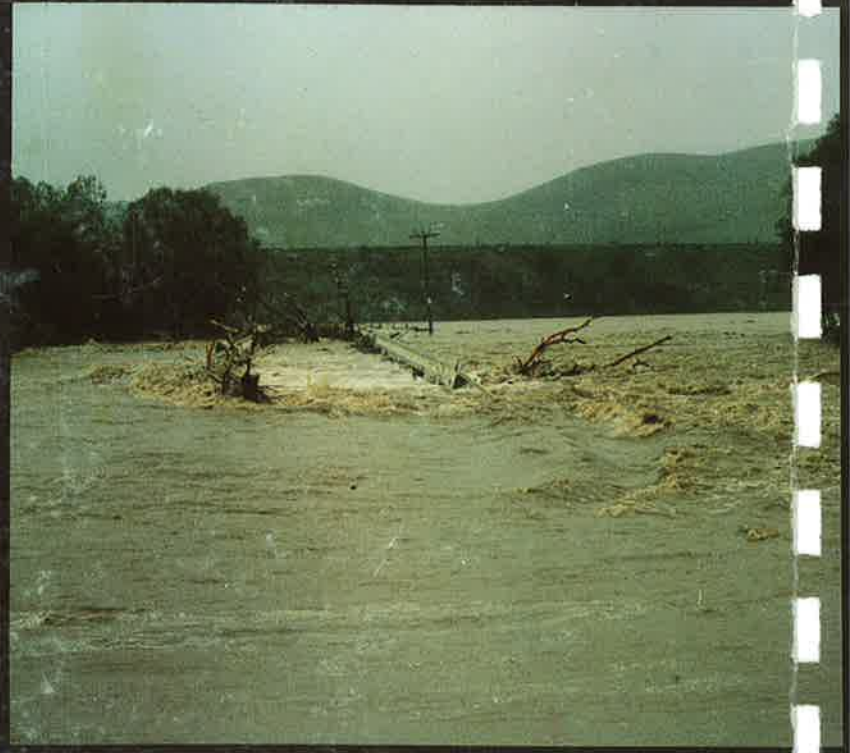
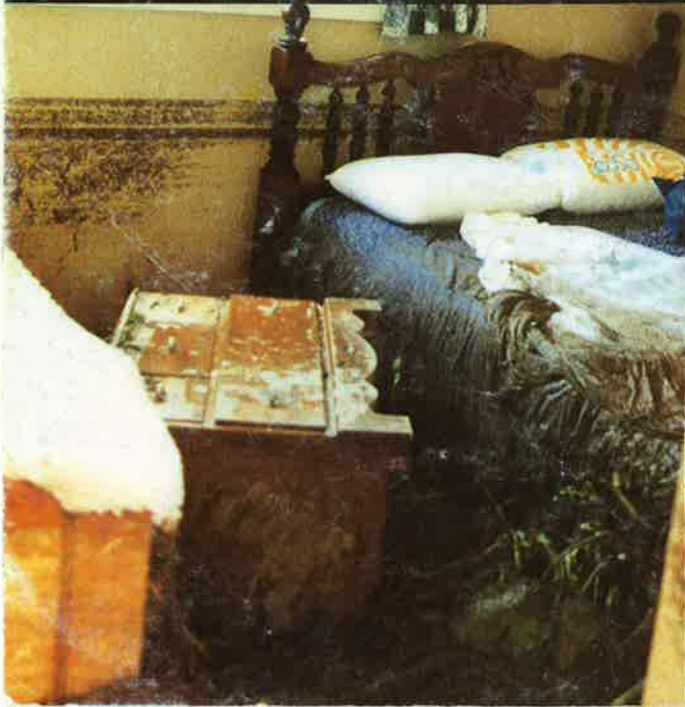
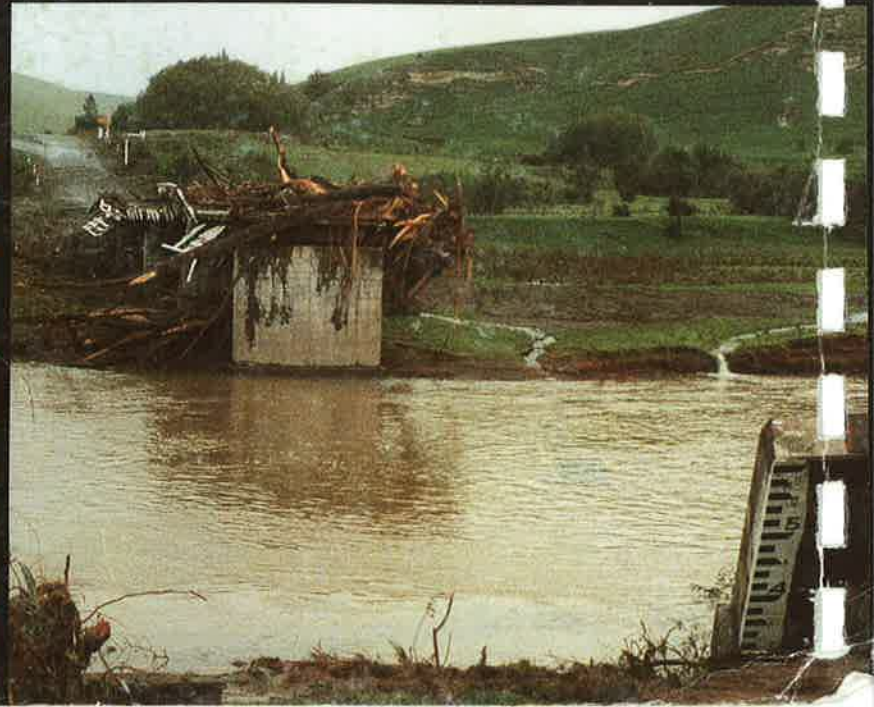
Back Cover

- Top left: Flooding in the vicinity of State Highway 1 Bridge at Temuka (top of photo).
- Top right: Tengawai River at Manahune.
- Centre left: Haybarn damaged by velocity of the floodwaters.
- Centre right: Debris demolishing handrails of McCulloughs Bridge over the Waihao River.
- Bottom left: Many houses were inundated, the floodwaters causing extensive damage.
- Bottom right: McCulloughs Bridge over the Waihao River was completely demolished by the flood. Note that the level of the bearers supporting the bridge was 6 m above the normal water level. Peak flood level at this site was about 7.5 m.
