Waikato region shallow lakes management plan: Volume 2

**Shallow lakes resource statement:
Current status and future
management recommendations**

Prepared by Tracie Dean-Speirs & Keri Neilson (Waikato Regional Council) with input from Paula Reeves (Wildland Consultants) and Johlene Kelly (Alchemists Ltd.)

10 October 2014

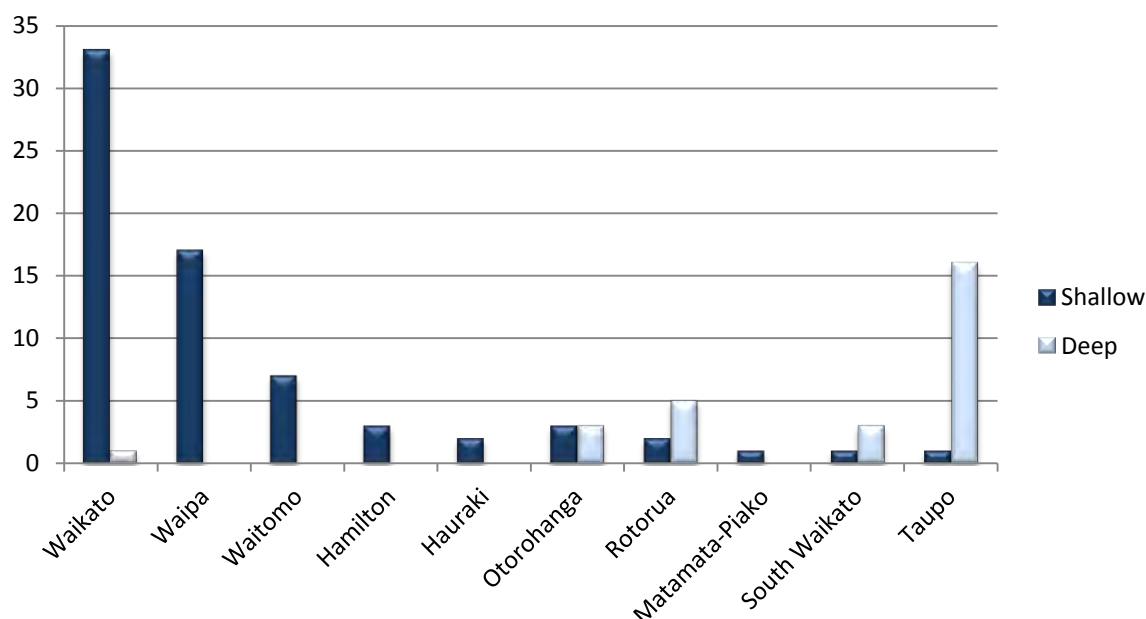
Figure 2 The number of shallow and deep lakes within districts in the Waikato region

Shallow lakes are found throughout the region, having formed in conjunction with the Waikato River system, the region's coast and cave systems, and the formerly extensive peat bogs of the region (Figure 1). Shallow lake 'hotspots' occur in the Waikato (peat, riverine, dune and karst lake types), Waipa (mostly peat lakes) and Waitomo Districts (mostly dune lakes) as shown in Figure 2.

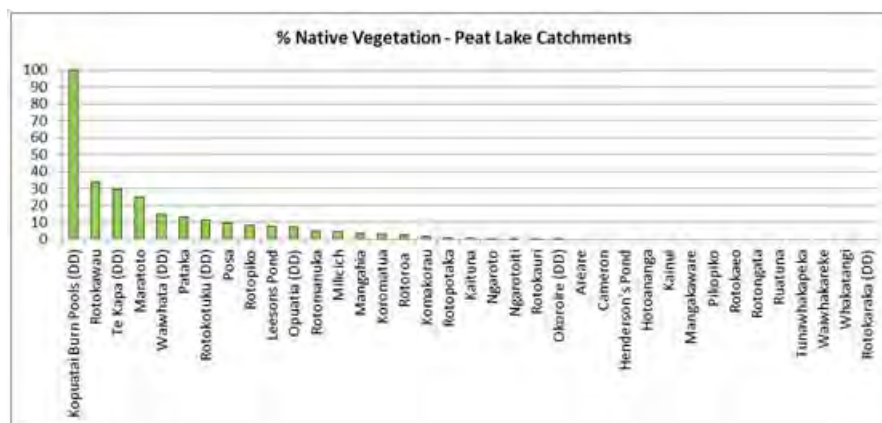
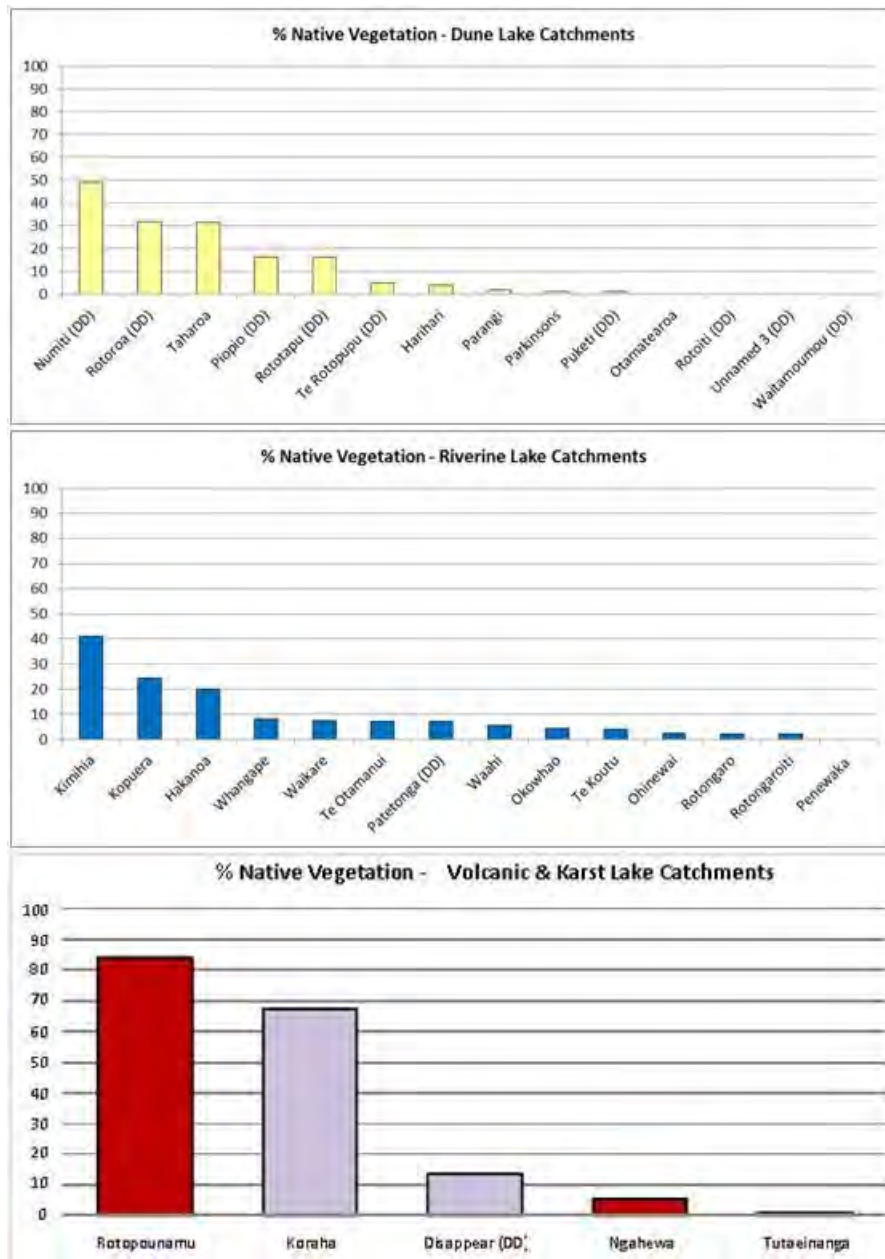
Figure 3 Estimated native vegetation cover in the catchments of shallow lakes (by type) in the Waikato region

Lake types are indicated by colour in the following way: volcanic, karst.

The only shallow lakes that still have largely forested catchments are Lake Rotopounamu which is situated within a conservation area, and the Kopuatai Burn Pools that are associated with the Kopuatai peat dome (Figure 3). Lake Koraha also has greater than 50% of its catchment in native forest, and is located within a conservation area. The Taharoa dune lakes (Lakes Numiti, Rotoroa, and Taharoa) have retained at least 30% native vegetation within their catchments, and WRC has made initial approaches to the Taharoa Lakes Trustees to assess the condition of the lakes and identify future management options to safeguard them.

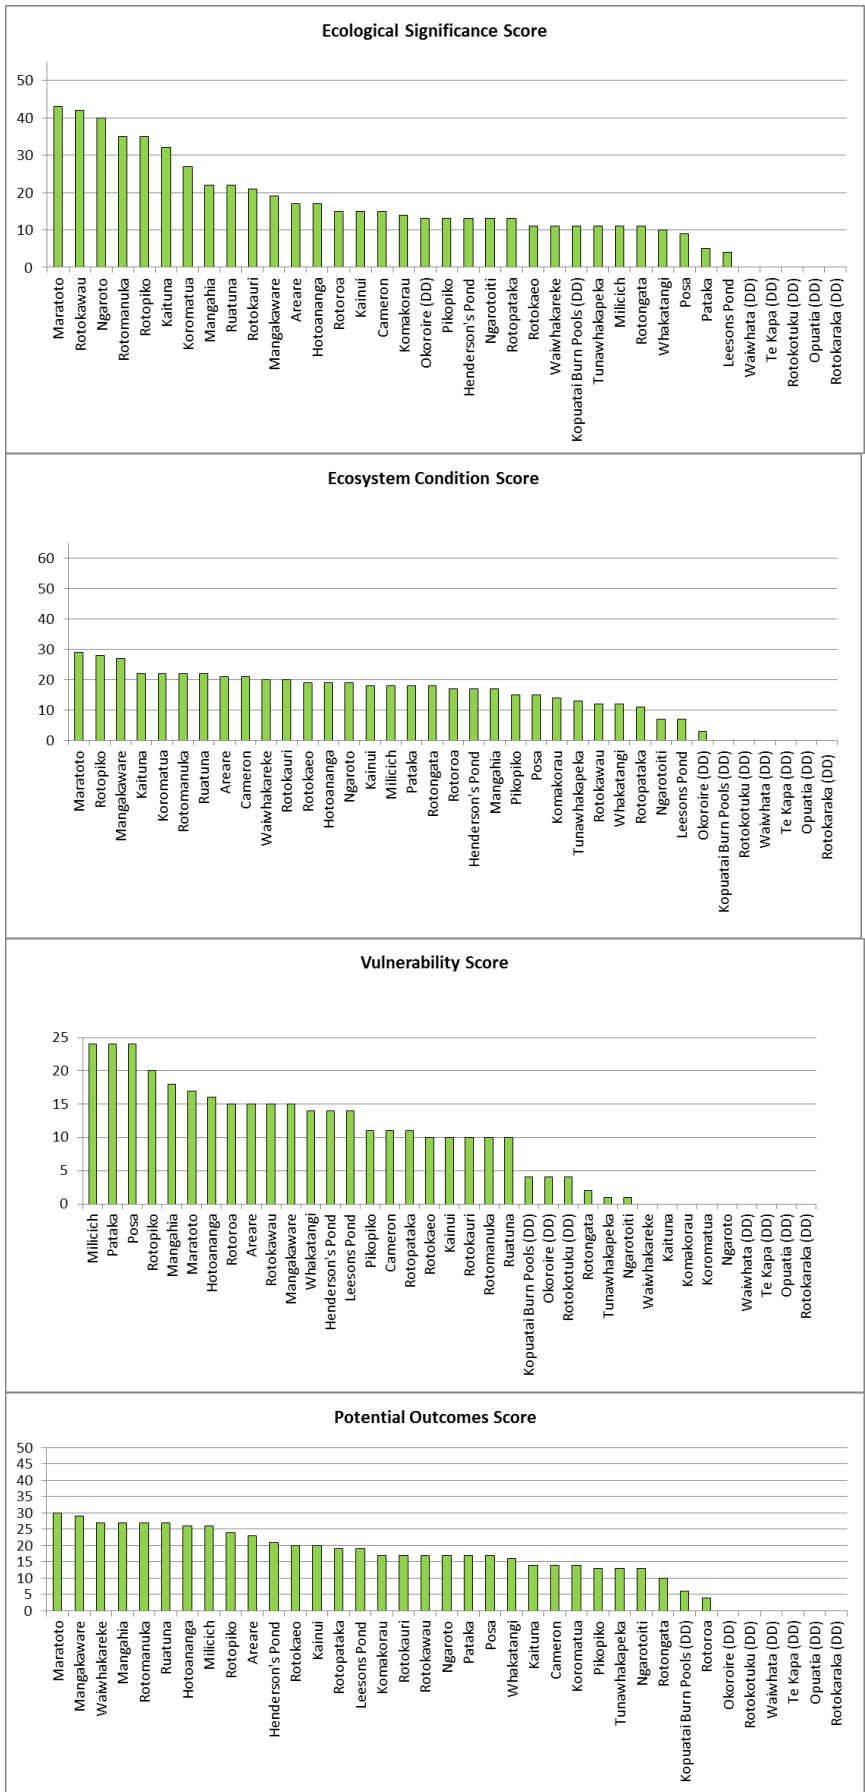
Figure 5 Peat lake scores (including best estimates) for different aspects of the lake prioritisation method used to rank lakes in the Waikato region

The majority of peat lakes have similar ecosystem condition scores (of 15-20) that reflect their poor water quality, the presence of pest fish, the small size of their wetland margins and the extent of hydrological modification that has arisen from changes to catchment land use (ie drainage).

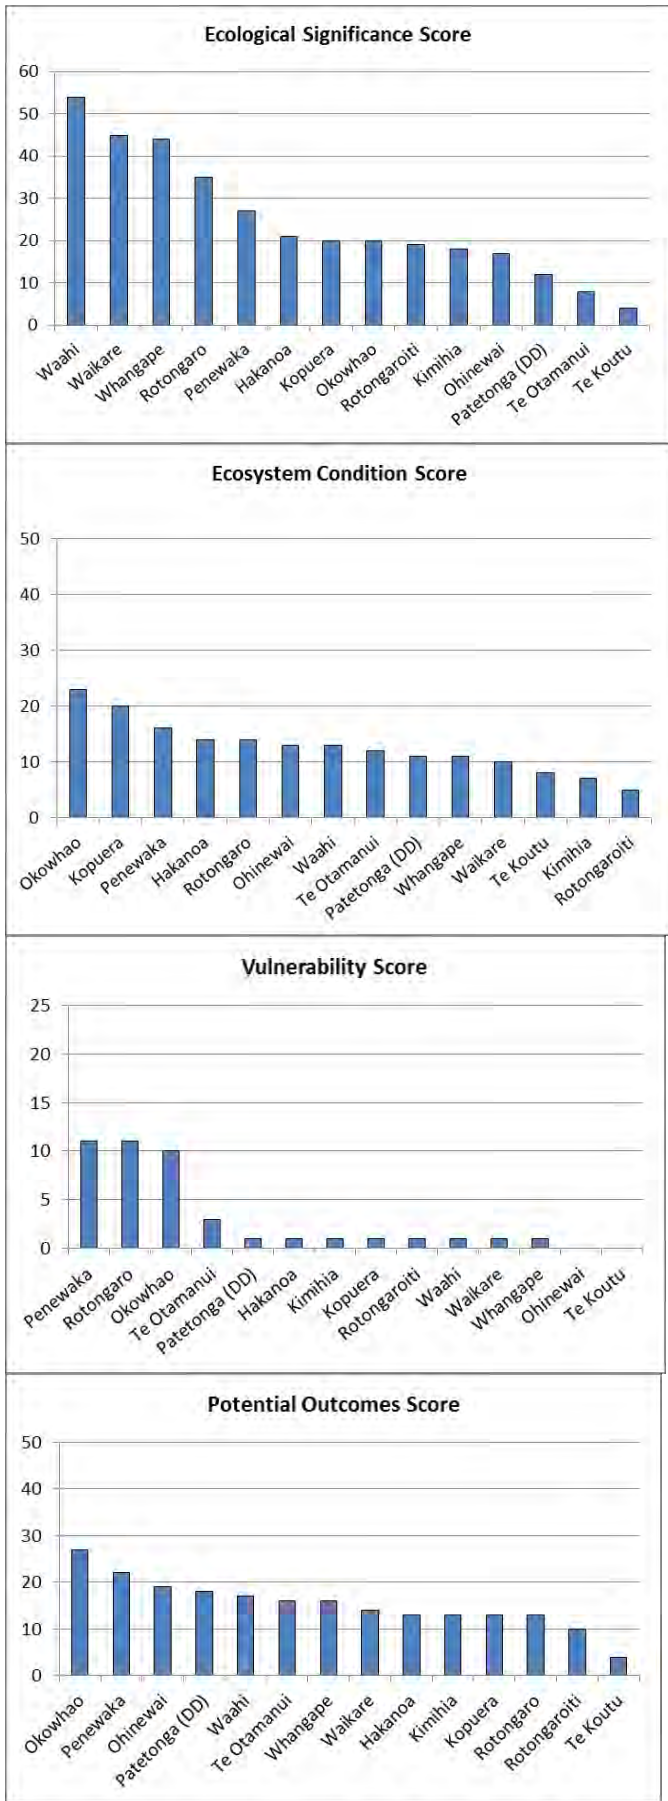
Figure 7 Riverine lake scores for different aspects of the lake prioritisation method used to score and rank the biodiversity values of lakes in the Waikato region (Wildland Consultants 2011a).

Ecosystem condition scores are low to moderate for all riverine lakes. All riverine lakes have poor water quality and most experience regular algal blooms. The interconnectedness of the riverine lakes facilitates the spread of pest fish and weeds so that almost all riverine lakes support pest fish and wetland weeds. Their poor condition translates to low vulnerability scores since many of the threats to these lakes have already occurred and are well entrenched.

Potential outcome scores are mostly low, as they recognise the practical difficulties and uncertainties associated with shallow lake restoration – particularly for the large riverine lakes that have highly modified hydrological regimes and extremely large catchment sizes.

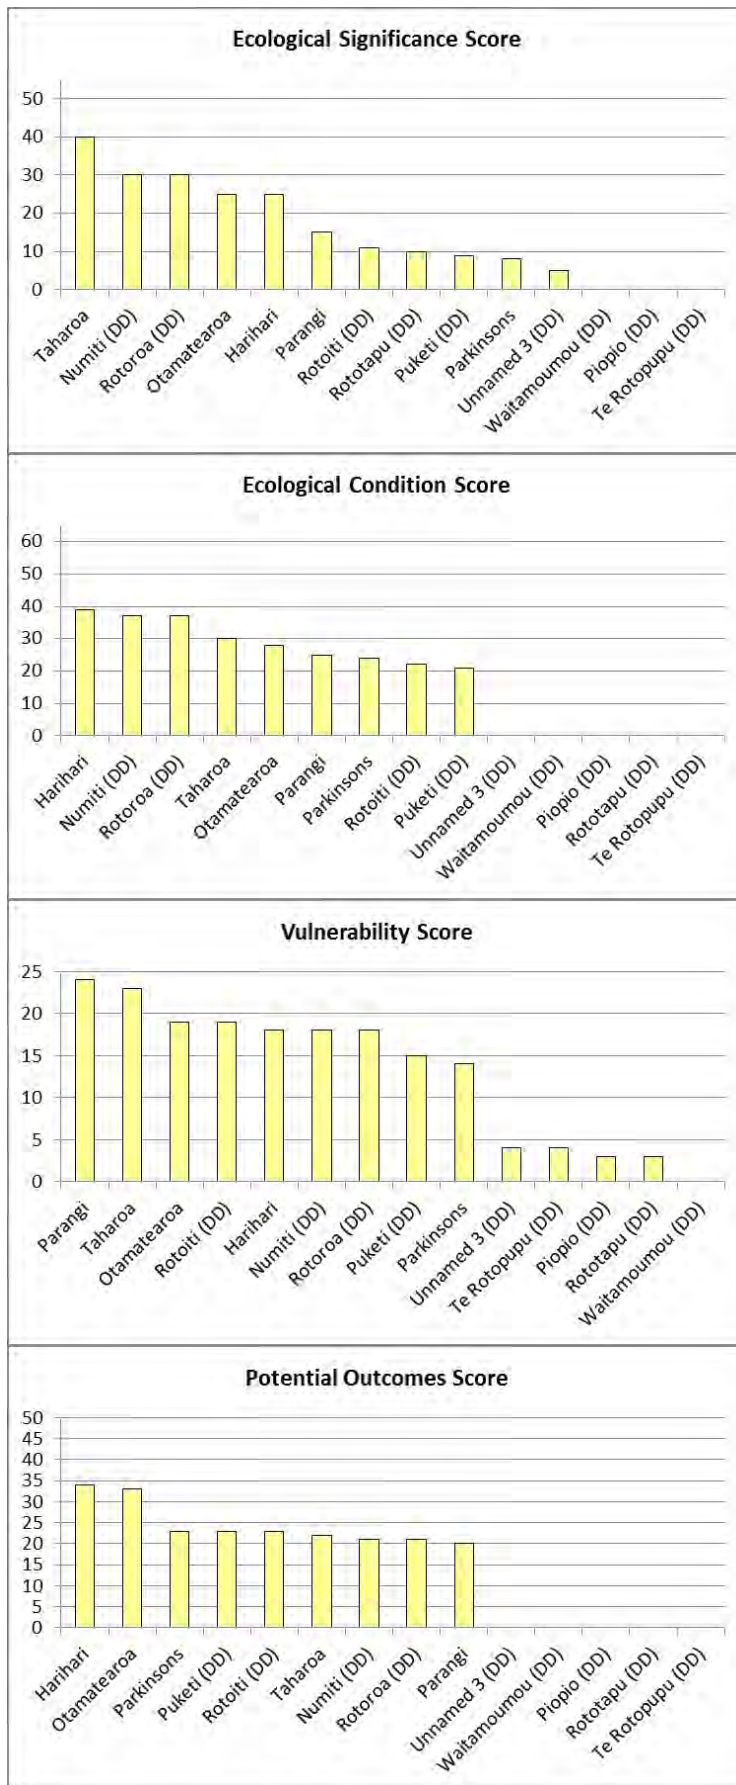
Figure 8 Dune lake scores (including best estimates) for different aspects of the lake prioritisation method used to rank lakes in the Waikato region (Wildland Consultants 2011a)

The Taharoa lakes, Lake Harihari and Lake Otamatearoa have the highest ecological significance and condition scores but also score highly for vulnerability.

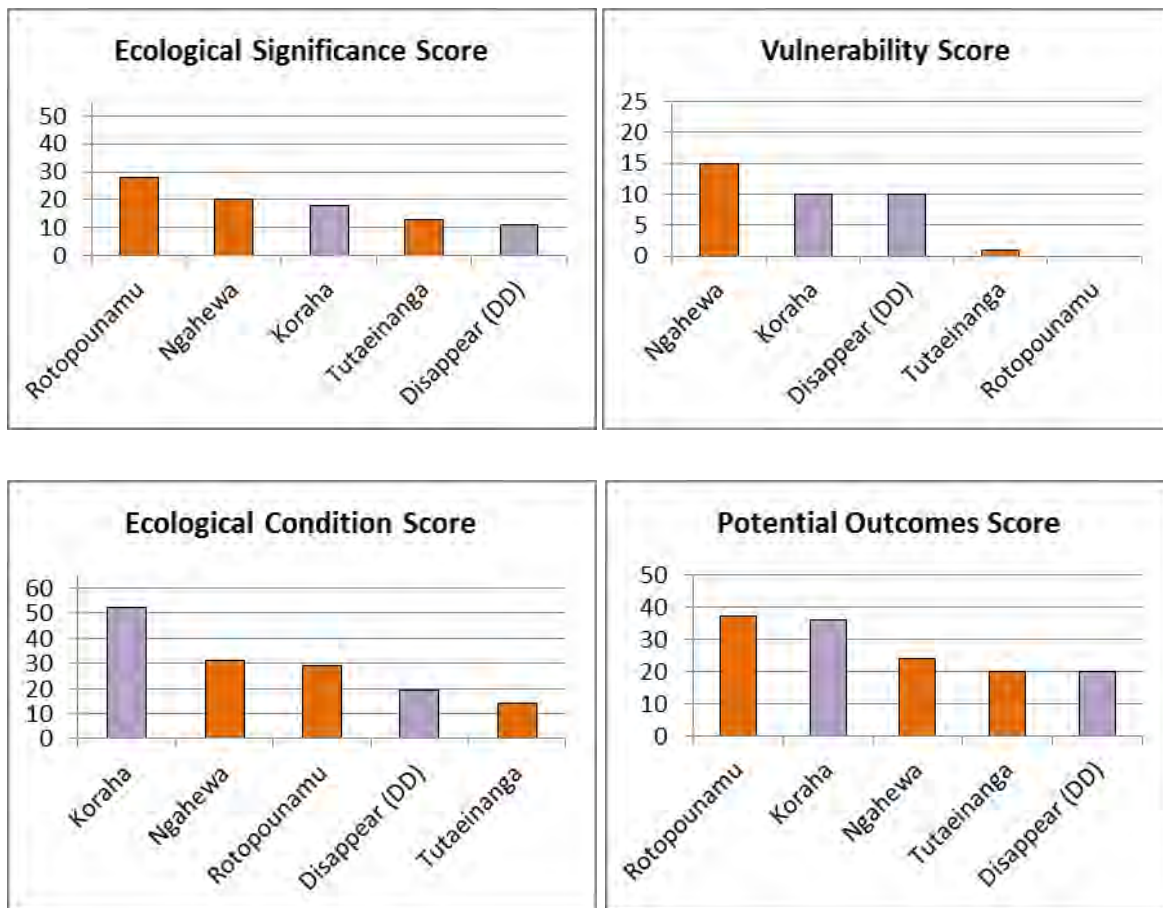
Figure 9 Volcanic and Karst lake scores for different aspects of the lake prioritisation method used to rank lakes in the Waikato region for their biodiversity values (Wildland Consultants 2011a).

Unfortunately, little is known about these lakes, and further information is required to assess their biodiversity values and overall condition. The following figures show their preliminary scores for different aspects of the lake prioritisation method that was used to rank karst and volcanic lakes in the Waikato region for their biodiversity values. Lake types are indicated by colour in the following way: volcanic, karst.
