# Catchment Environmental Monitoring Report 2013/14

For:  
Waikato Regional Council  
Private Bag 3038  
Waikato Mail Centre  
HAMILTON 3240

15 September 2014

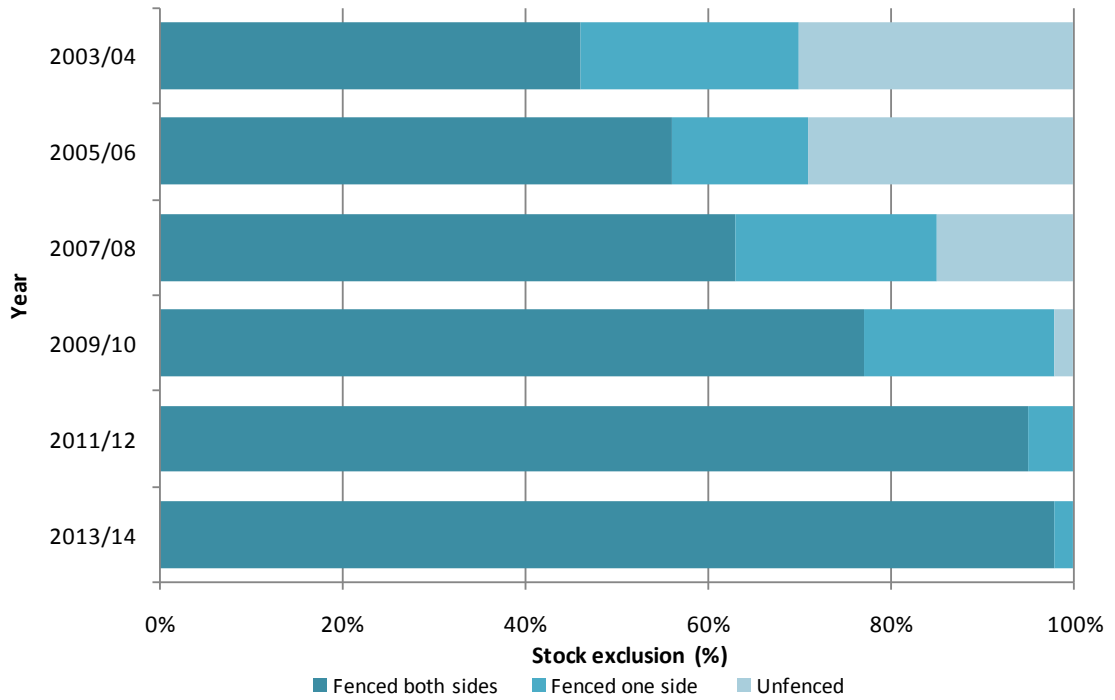
The 2013/14 riparian survey indicates that stock was excluded from both sides for 98% of the waterway and from one side for 2% of the waterway (Figure 3). There has been an increase from 46 to 98% in the length of stream fenced on both sides since the 2003/04 assessment (Figure 3).

**Figure 3: Matahuru Catchment stock exclusion by bank length (%).**

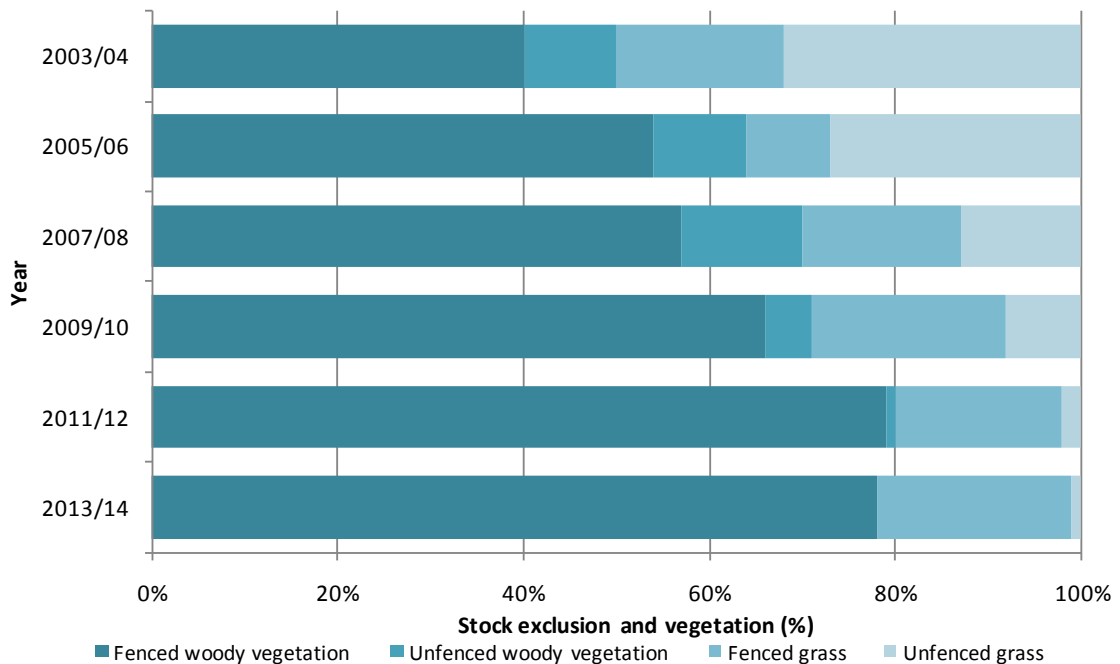
The proportion of stream bank that was fenced off and had woody vegetation increased from 40% to 79% of the total length of the Matahuru Stream between 2003/4 and 2013/14 (Figure 4). The 2013/14 assessment indicated that 79% and 20% of stream bank is fenced woody vegetation and grass respectively, leaving only 1% as unfenced grass (Figure 4).

**Figure 4: Matahuru Catchment bank length fencing and vegetation combinations (%).**

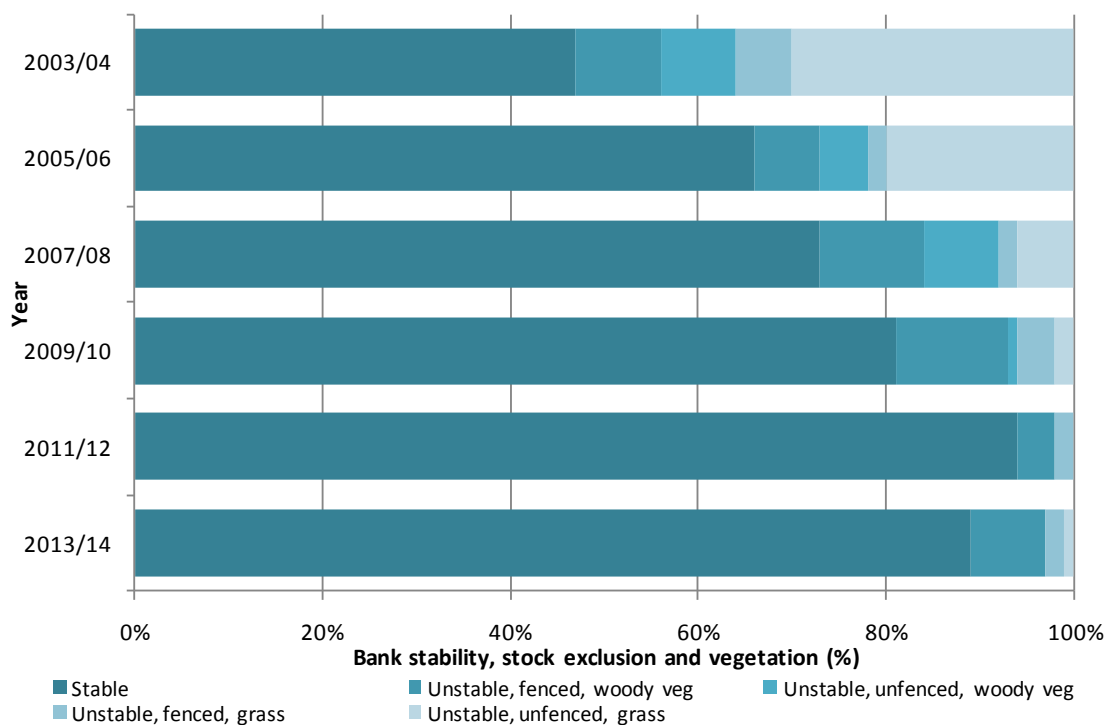
In 2013/14 an estimated 89% of the assessed riparian bank length was stable, up from 47% measured during the 2003/04 period. During 2013/14 11% of the total bank length was unstable this was represented by; fenced woody vegetation (8%), fenced grass (2%) and unfenced grass (1%). Unstable unfenced grass displayed the greatest decrease between 2003/04 and 2013/14, decreasing from 30% of total stream bank length to 1% (Figure 5).

**Figure 5: Matahuru Catchment stream bank stability (%).**

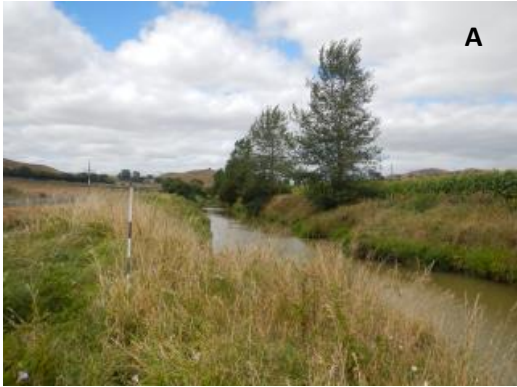
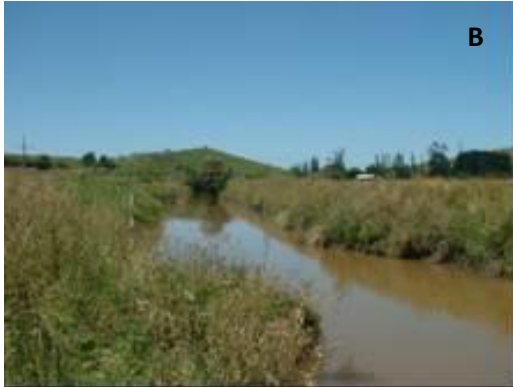
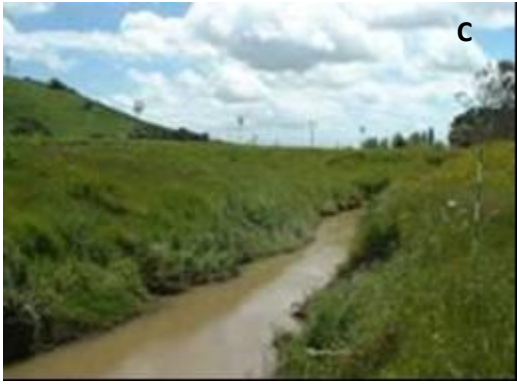
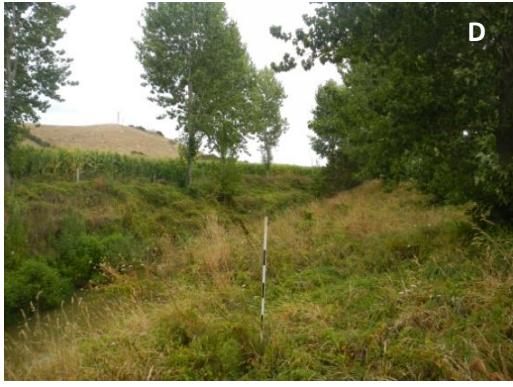
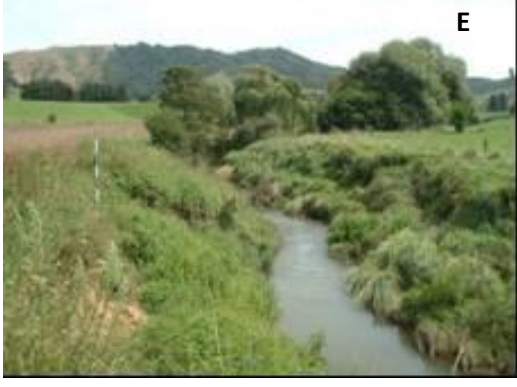
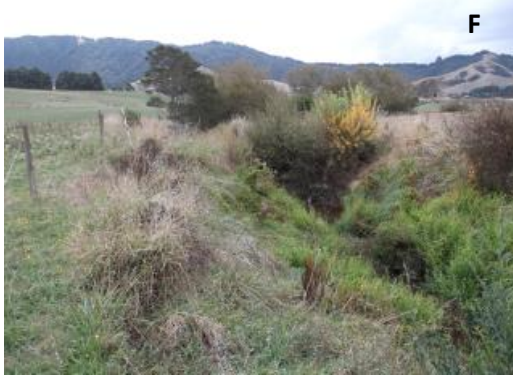
Figure 7: Matahuru Stream photo point examples of visual change between 2003/04 and 2013/14 for assessment 1 at 000 m (A and B), assessment 2 at 750 m (C and D) and assessment 11 at 750 m (E and F).

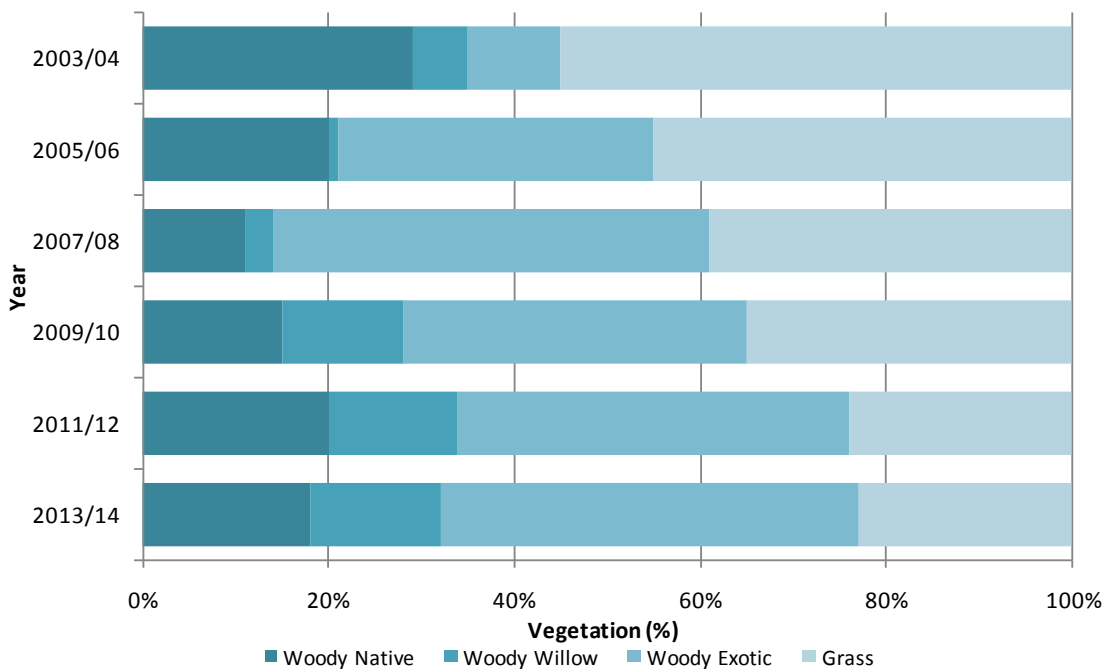
Riparian vegetation contributes to stream bank stability and can help regulate instream temperatures increases. Natural biodiversity along the riparian margin can be increased through the planting of native vegetation. Riparian vegetation is split into grass and woody vegetation (native + willow + exotic other). Figure 9 shows that during the most recent reporting period (2013/14) 23% of the total length of the riparian margin was grass. The remainder was woody vegetation, of which 18% was native, 14% was willow and 45% was other exotic species. The length of the riparian margin in grass has decreased from 55% to 23% between 2003/04 and 2013/14. During the same period both woody exotic and woody willow vegetation increased, however woody native vegetation decreased (Figure 9).

Figure 9: Pokaiwhenua Catchment riparian vegetation by bank length (%).

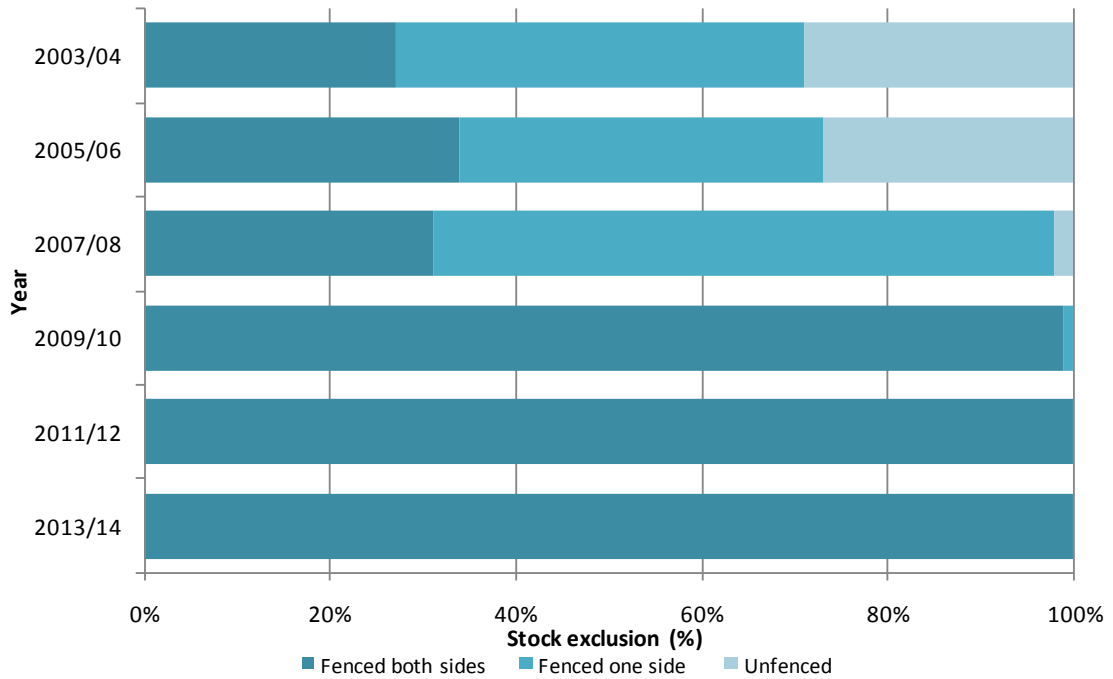
Since the 2011/12 reporting period, stock have been excluded from both sides of the entire assessed length of the Pokaiwhenua stream. This represents an increase from 27% to 100% in the length of stream fenced, on both sides, since reporting began in 2003/04 (Figure 10).

**Figure 10: Pokaiwhenua Catchment stock exclusion by bank length (%).**

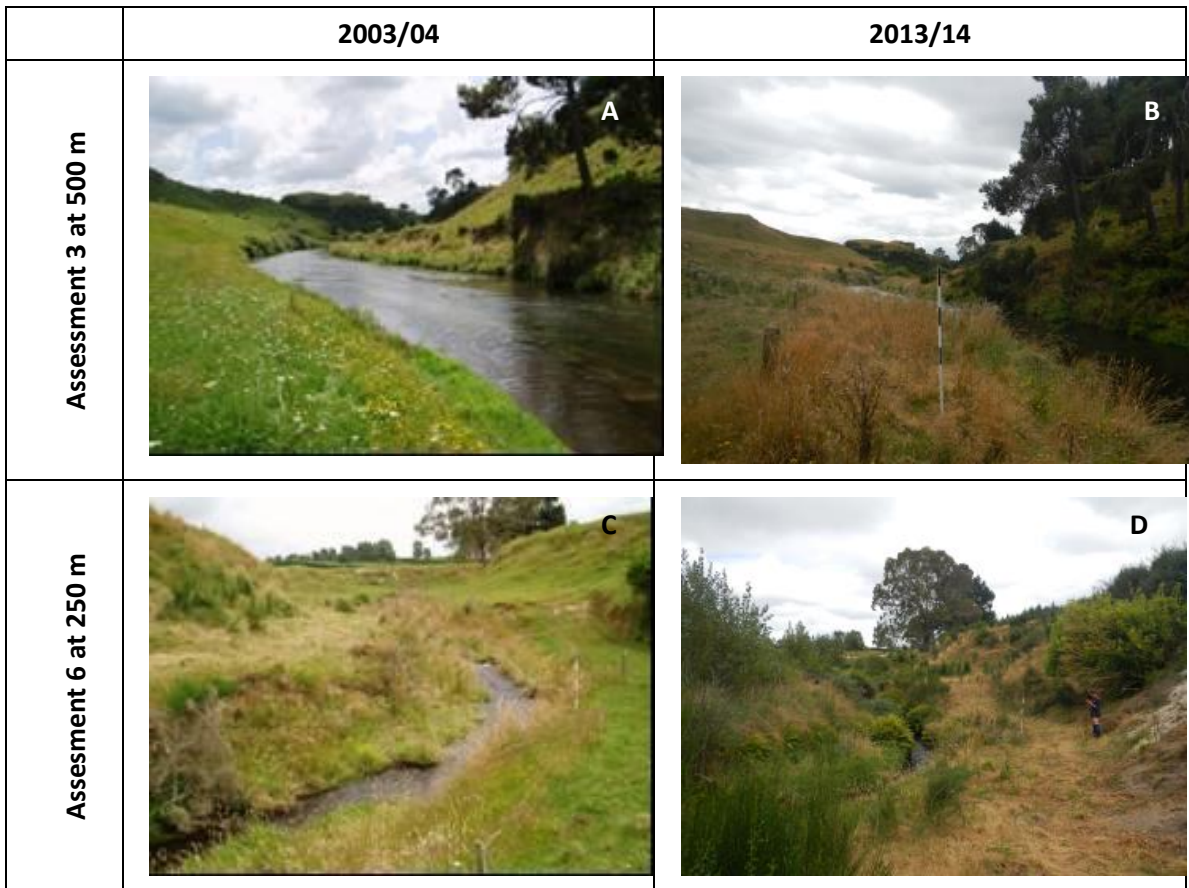
The initial photo point assessment in the Pokaiwhenua catchment was during the summer of 2003/04 with subsequent assessments completed in 2005/06, 2007/08, 2009/10, 2011/12 and 2013/14. Appendix 3 presents a comparison for each photo point for the 2003/04 and 2013/14 assessment years. In 2013/14 Six 1 km stretches of stream bank were assessed at 250 m intervals, giving a total of 30 images for the Pokaiwhenua catchment. Considerable sections of the stream have been fenced (Figure 10), preventing stock access and allowing rank grass to grow (Figure 14, A and B). The percentage of riparian grass cover has also decreased since the project began and this has been replaced by woody vegetation (Figure 9) which is evident at some photo point sites (Figure 14, C and D).

Figure 14: Pokaiwhenua Stream photo point examples of visual change, assessment 3 at 500 m (A and B) and assessment 6 at 250 m.

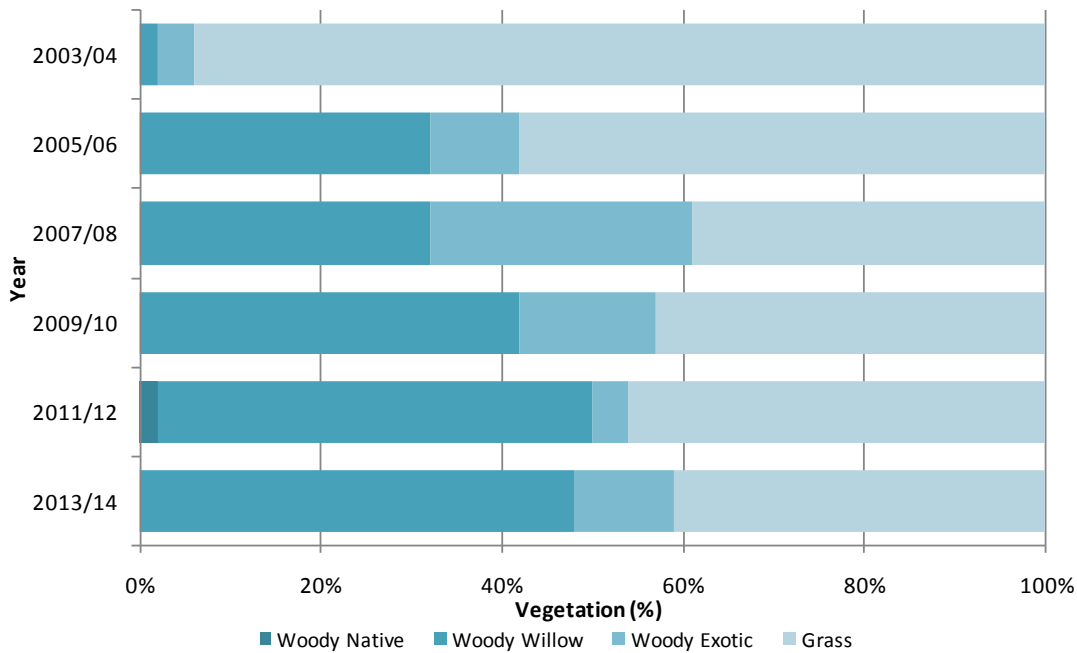
which 0% was native, 48% was willow and 11% was other exotic species. The length of riparian margin in grass has decreased from 94% to 41% between 2003/04 and 2013/14. Woody willow vegetation has displayed the greatest increase in riparian vegetation cover during the reporting period (Figure 16).

**Figure 16: Mangare Catchment riparian vegetation cover (%).**

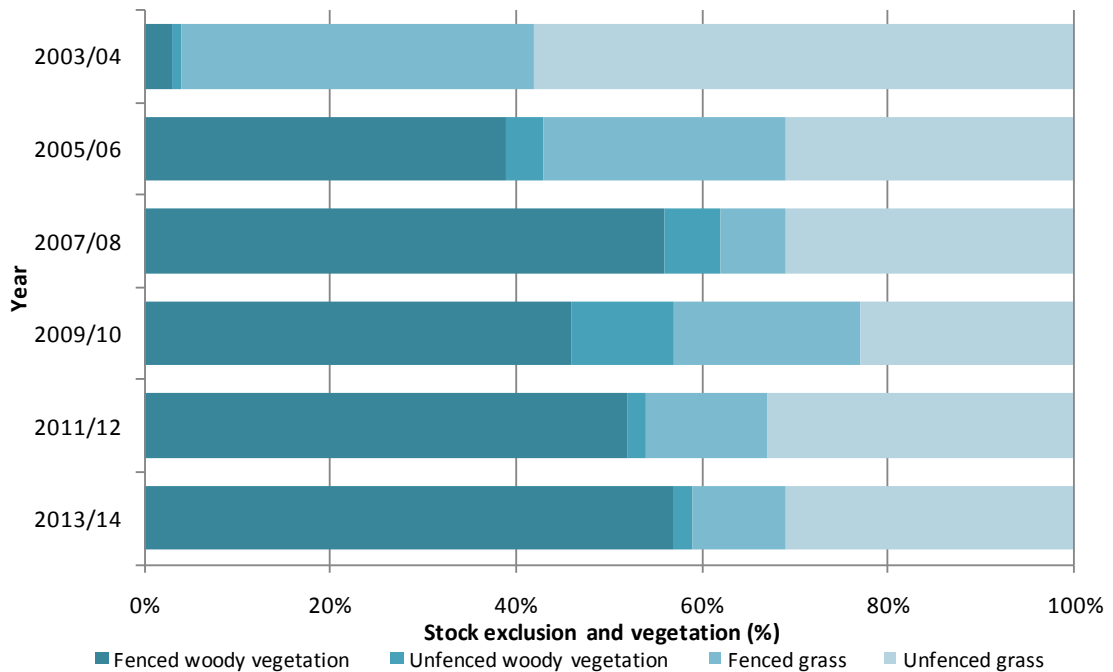
There has been an increase in fencing from 41% to 67% over the total stream bank length since the baseline assessment (Figure 18). The majority of the fenced banks (85% of the total fenced bank length) have woody vegetation. The proportion of stream bank that is fenced off and has woody vegetation has increased from 3% to 57% of the total length. During the 2013/14 reporting period of the stream bank that was in grass, 31% and 10% was unfenced and fenced respectively (Figure 18).

**Figure 18: Mangare Catchment bank length fencing and vegetation combinations (%).**

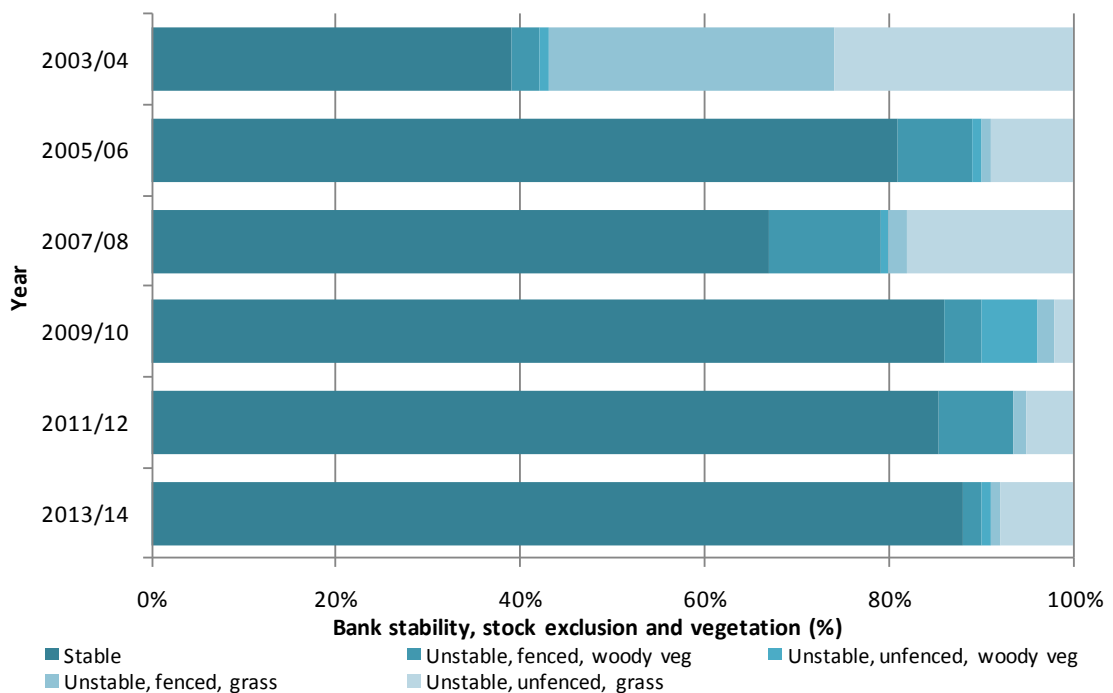
Stream bank stability can be improved through planting riparian vegetation, and fencing out stock. Unstable stream banks are one of the main sources of sediment in waterways. An estimated 88% of the assessed riparian bank length is considered stable (Figure 19), up from the 39% measured in the 2003/04 assessment. The remaining 12% is unstable. Grass is present on 9% of the total unstable bank length.

**Figure 19: Mangare Catchment stream bank stability (%).**

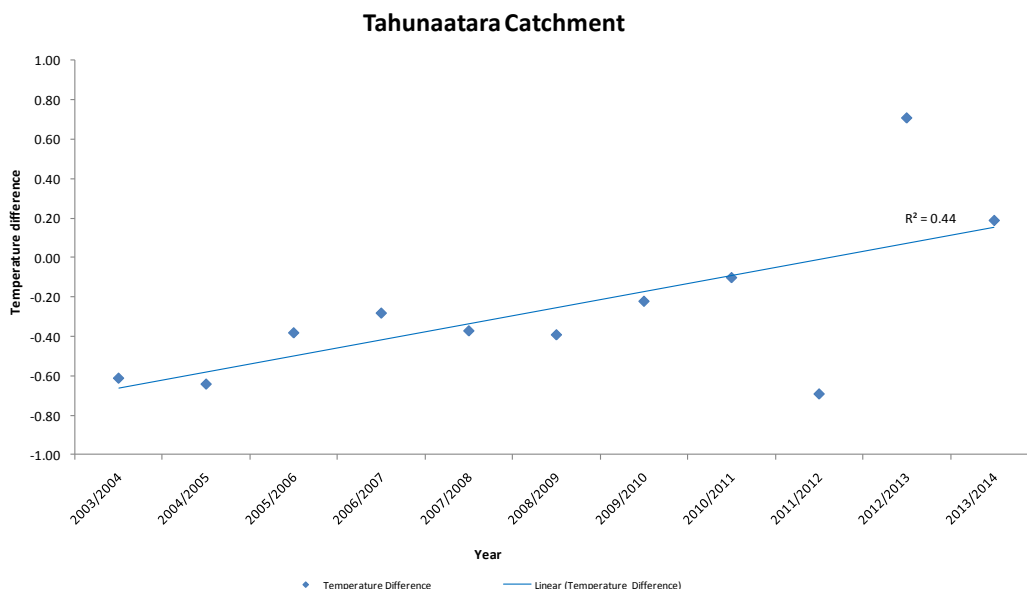
**Figure 23: Temperature difference (downstream-upstream temperature) observed in the Tahunaatara Catchment (2003-2014).**

Figure 23 indicates that initially the downstream temperature was cooler than upstream however this difference was decreasing overtime. The temperature difference then departed from the observed trend for the 2011/12 and 2012/13 assessment years, returning to the observed trend for the 2013/14 assessment period. Although by 2013/14 the upstream temperature was cooler than the downstream temperature. Historically shading of the stream has been sparse and sporadic.

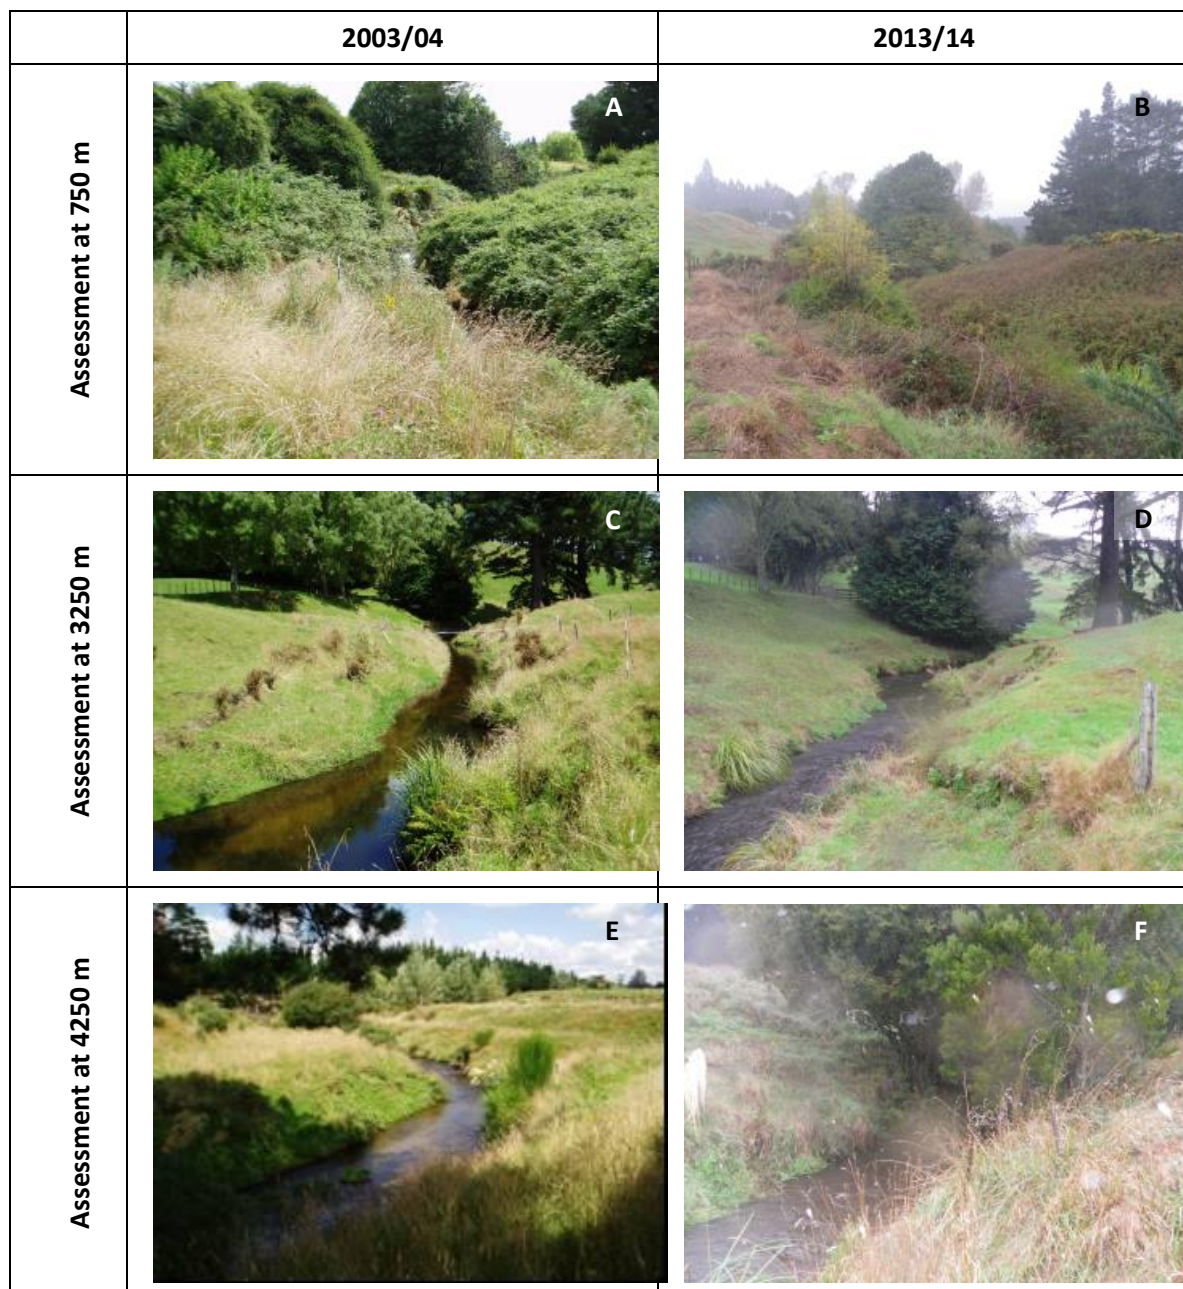
Photo surveys have been undertaken along the Pokaitu Stream in 2003/04, 2008/09 and 2013/14. Appendix 3 presents a comparison for each photo point for the 2003/04 and 2013/14 assessment years. Photos are taken along the stream every 250 m for a distance of nearly five kilometres resulting in 20 images. During the initial assessment in 2003/04 about half of the photo points indicated that considerable stretches of the stream were fenced or difficult to access, this observation remained unchanged during the most recent assessment (Figure 24, A and B). Other sections displayed little change between 2003/04 and 2013/14 due to a lack of riparian enhancement during the reporting period (Figure 24, C and D). Those sections that were fenced displayed an improvement in riparian vegetation and shading (Figure 24, E and F). Although not shown, some areas of tree removal were observed during the riparian survey.

Figure 24: Pokaitu Stream photo point examples of visual change at 750 m (A and B), 3250 m (C and D) and 4250 m (E and F) in 2003/04 and 2013/14.
