Motu River

*A description of its catchment, channel,
waters and sediments*

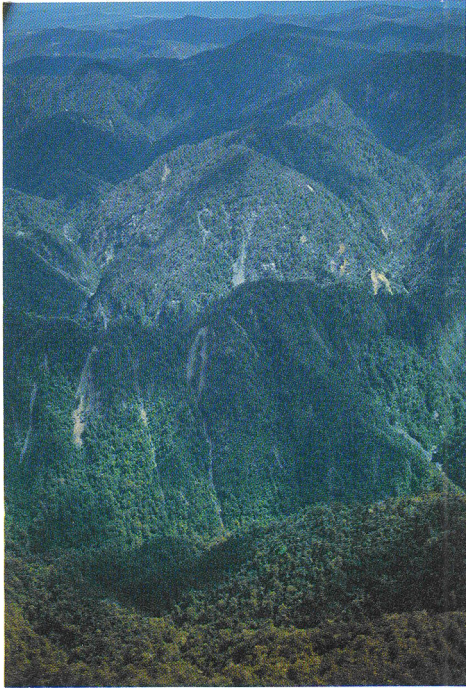
1a. Very steep slopes at over 1000 m altitude in the eastern part of the Motu River catchment showing debris slide scars and some recent wind damage.

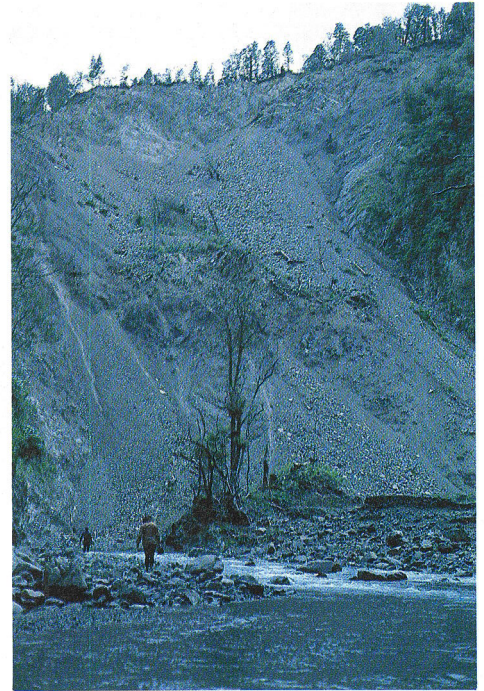
1b. A large deep-seated rock slide in a crush zone on the Te Kahika Stream (Plate 2). This rock slide probably occurred during a storm in late 1978.

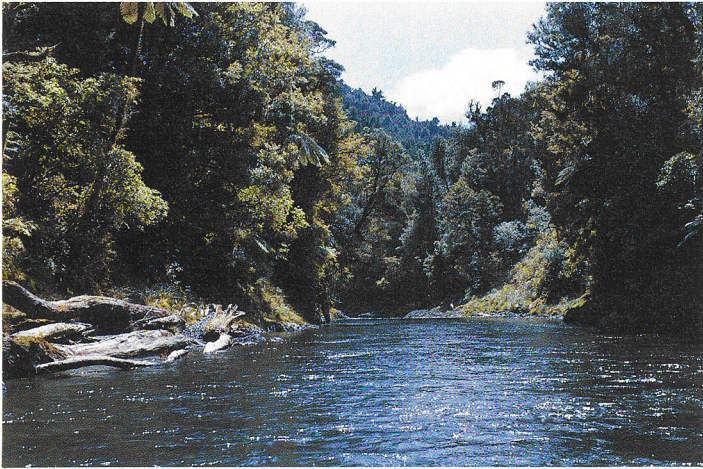
3a. A typical view of the Motu River between Kirk's Clearing and the Upper Gorge. The vegetation is in good condition.

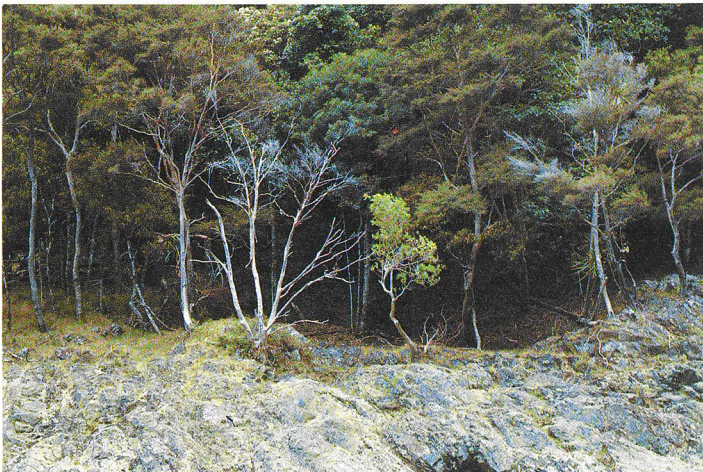
3b. The understorey vegetation is adversely affected where there is a high population of goats on the west bank of the river.

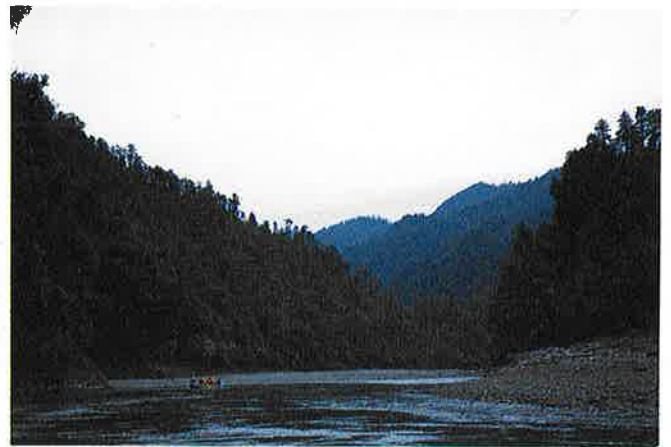
5d. Lower Motu River.

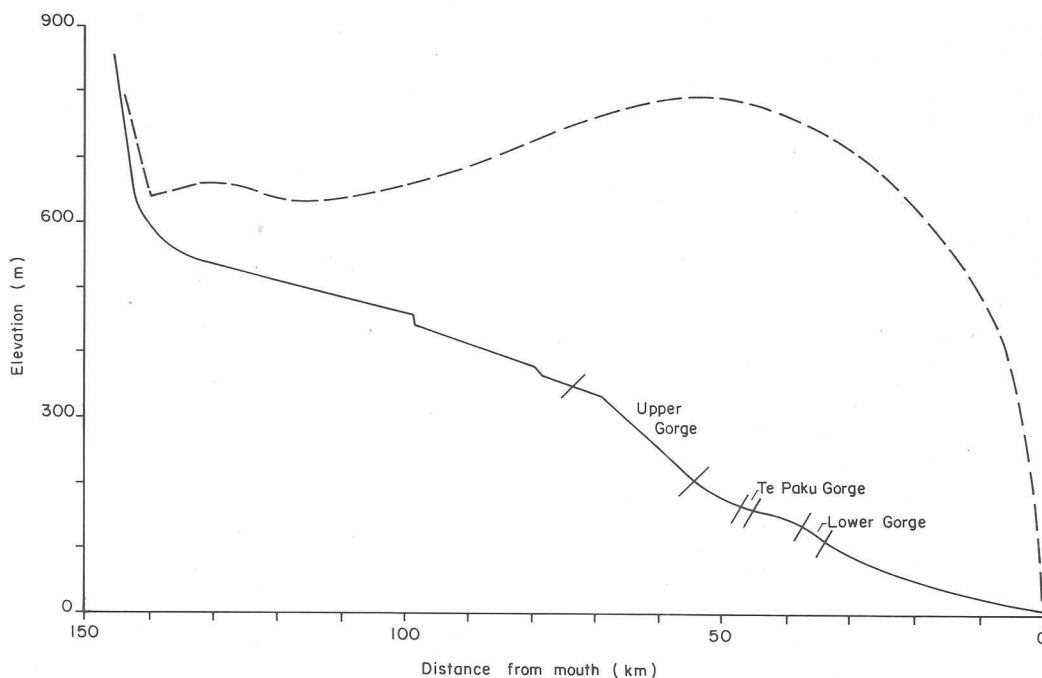
Fig 3.1 Longitudinal profile (solid line) of the Motu River (after Riddell 1980). The generalised contour of the surrounding hilltops is also included (broken line).
