Coastal hazard mapping as a planning technique for Waiapu County

Coastal hazard mapping as a planning technique for Waiapu County, East Coast, North Island, New Zealand

Water and Soil Division, Ministry of Works and Development, Wellington

**National Water and Soil Conservation Organisation
Wellington 1981**

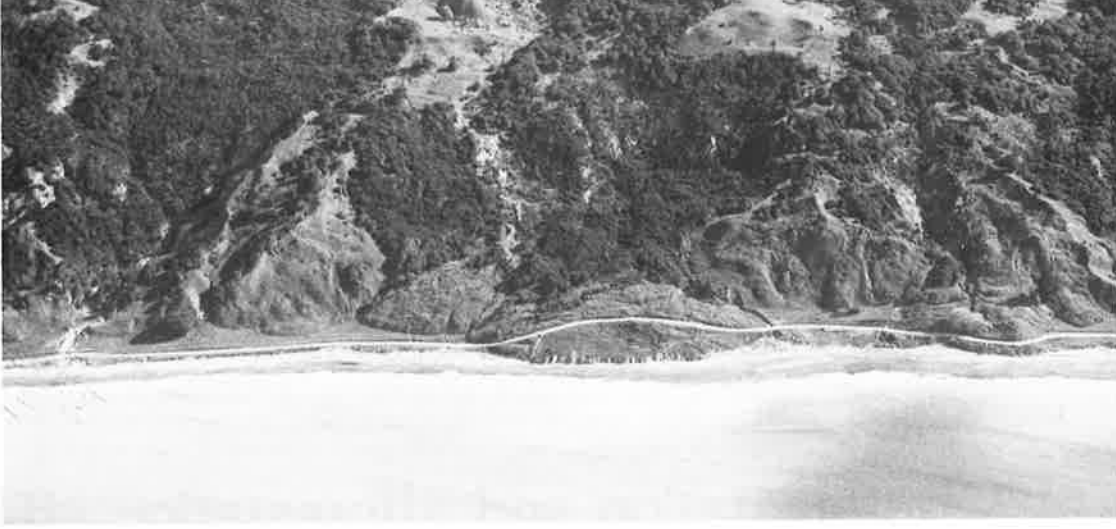
a Active earth flows at the toe of a gravity slide at the south end of Waipiro Bay about 45 km south of East Cape.

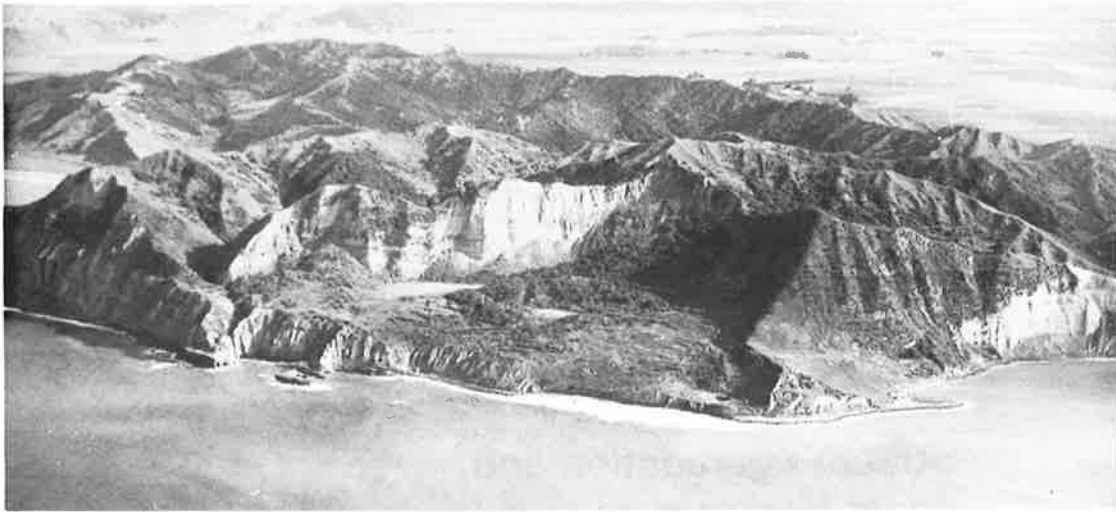
b Fault plane failure at the south end of Kaiaua Beach about 80 km south of East Cape.

An example of a possible fault-plane failure is shown in Figure 6b. The landslide was investigated in January 1980 and a fault was observed in the same position and parallel to the main landslide scarp. The strata were observed to dip gently landwards. From field and aerial photographic investigations, it was estimated that the slide had moved about 8.4 million m³ of material.

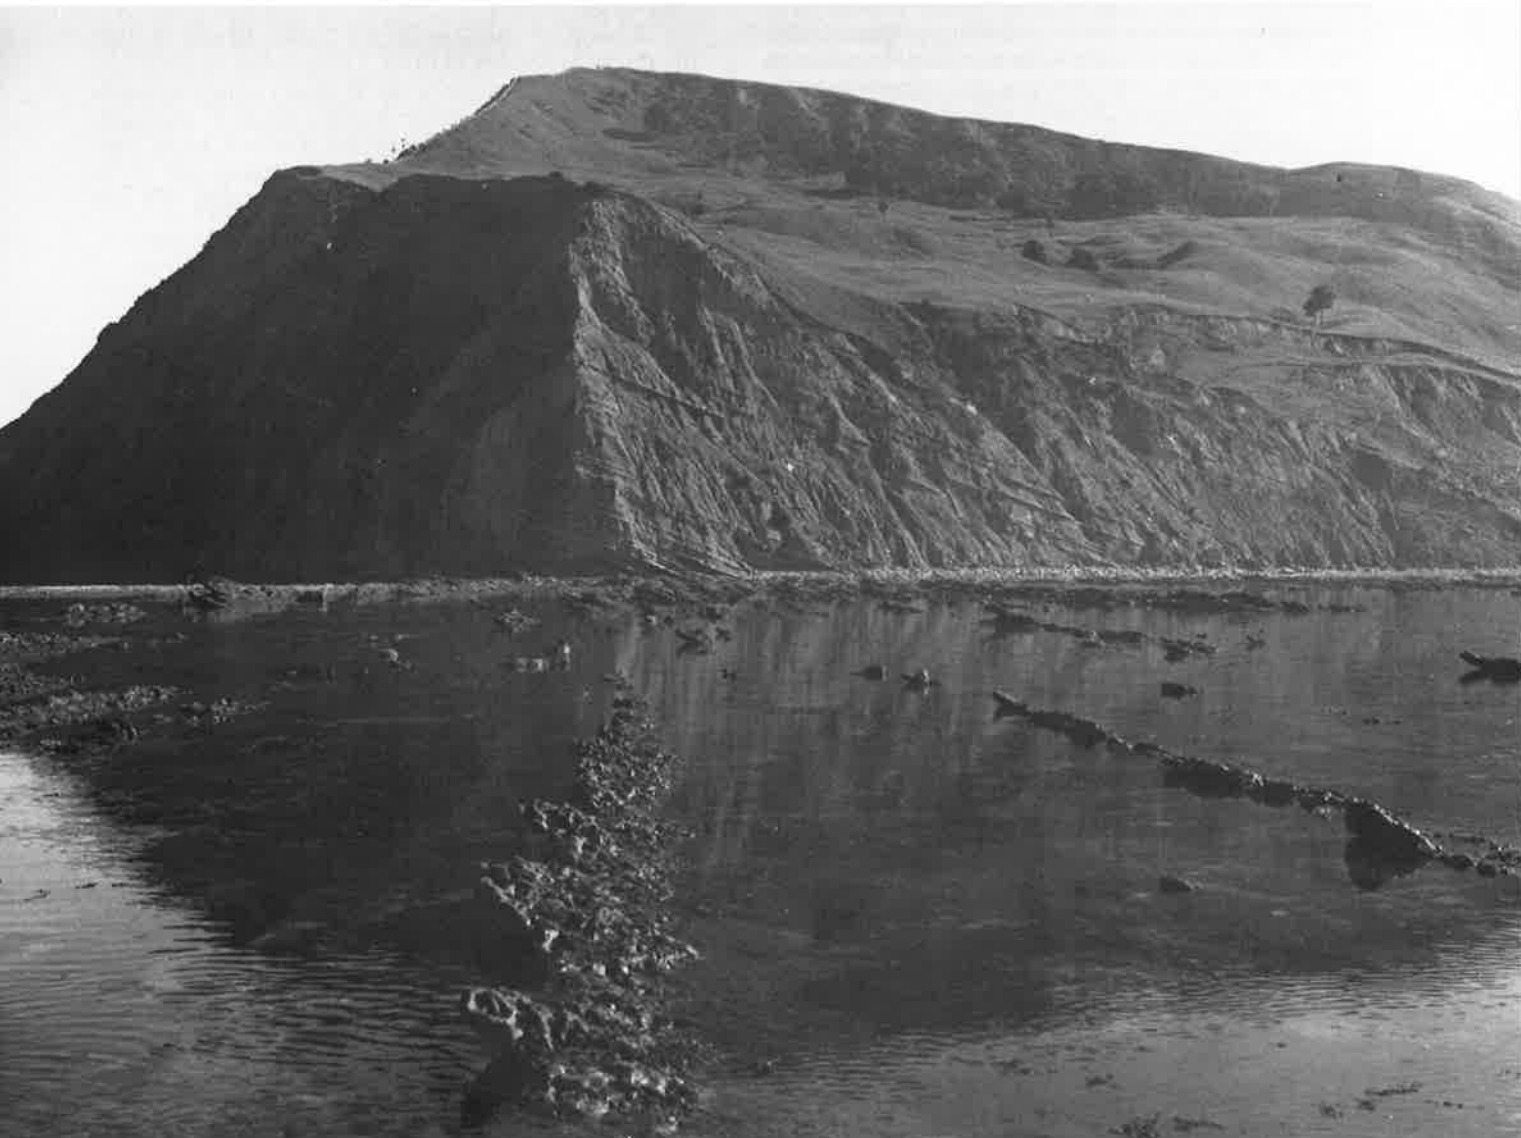
c Bedding plane failure at Tatapouri headland about 110 km south of East Cape. The intertidal shore platform has formed over the last 6500 years and is up to 430 m wide.

had moved about 1.2 million m³ of material. A similar, very large bedding-plane failure is shown in Figure 6c.

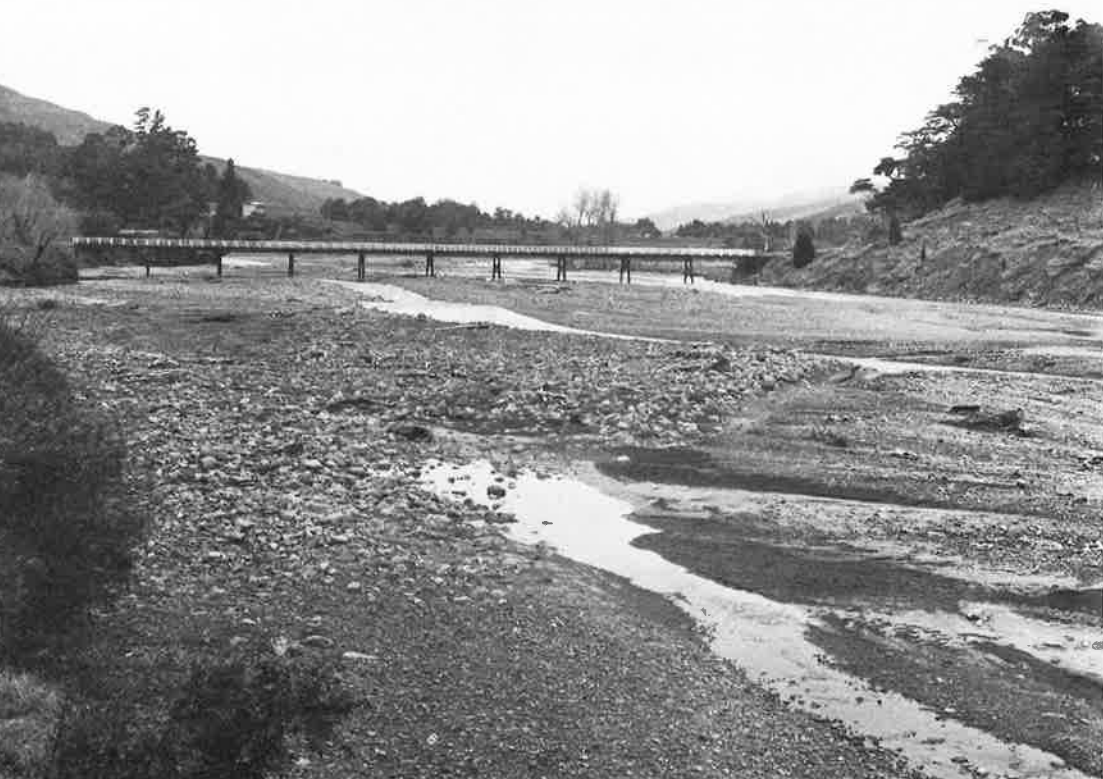
Figure 7 The bridge over Tapuaeroa River bed, looking downstream. Pahikiroa Station is on the right. From 1912 to 1979 the river bed has aggraded 13.72 m under the bridge. [25 June 1980]

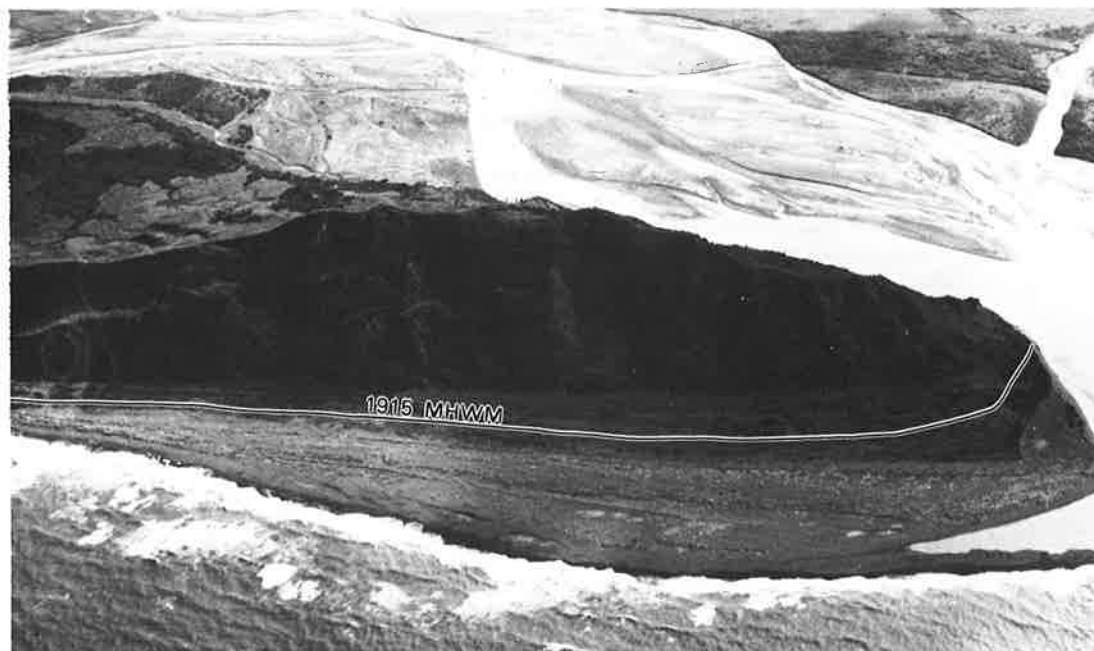
Figure 8 Oblique aerial view of Te Wharau Beach south of the Waiapu River mouth. The 1915 shore line is shown and indicates over 200 m of accretion from Waiapu-derived bedload. Note the extensive aggradation in the lower river bed. [21 May 1979]

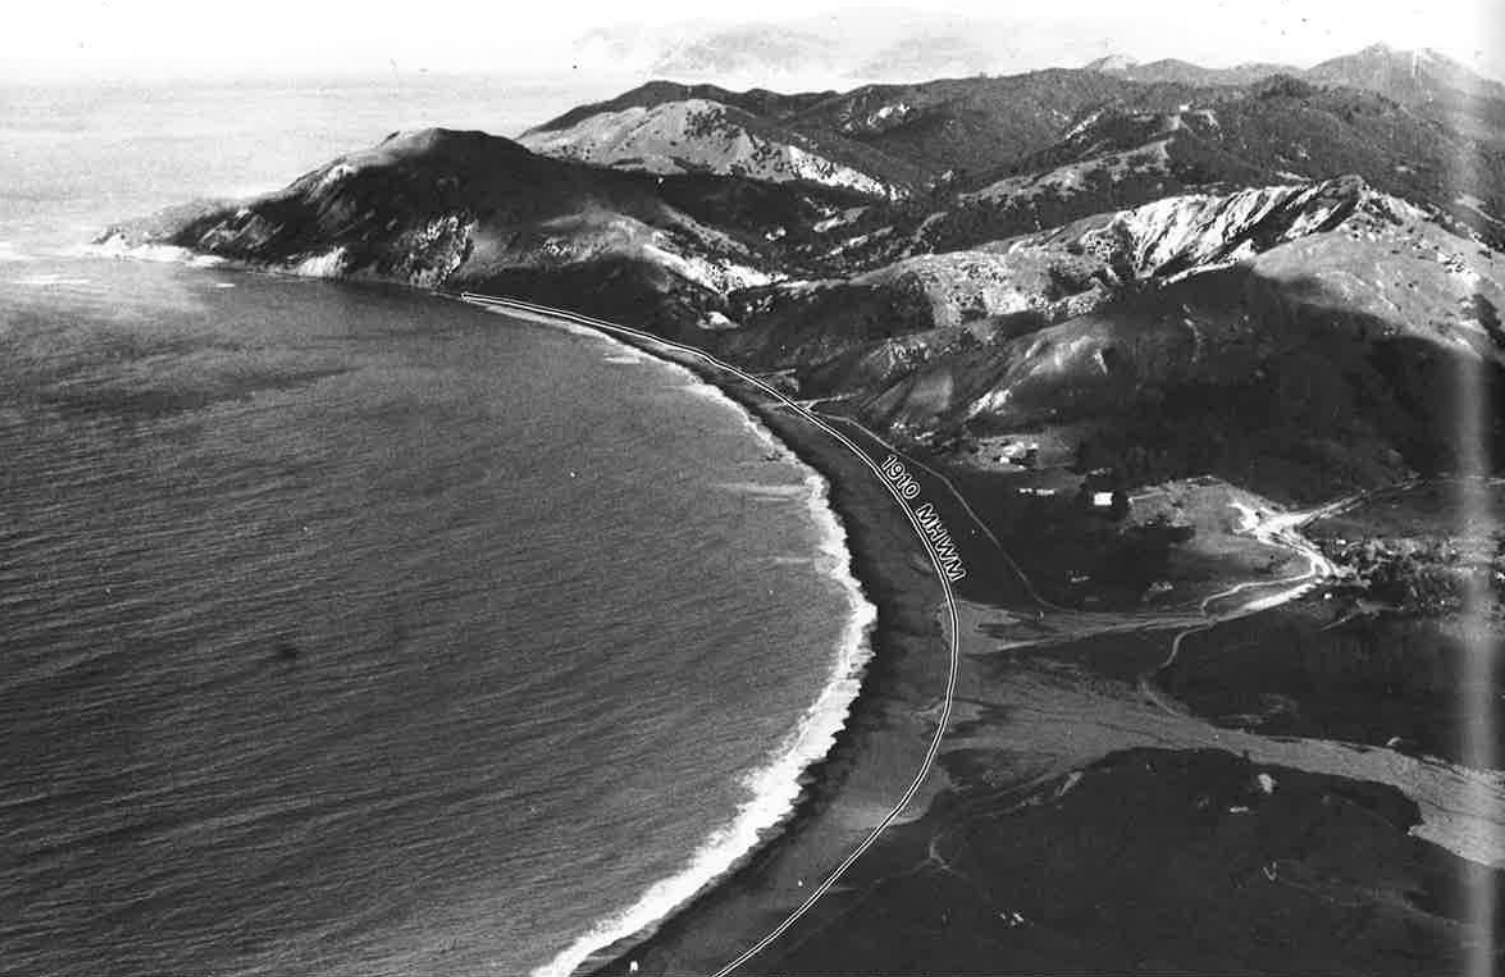
Figure 9 Oblique aerial view of Tuparoa looking south. The 1910 shore line position is shown and indicates about 50 m of accretion from bedload supplied by the Tohoratea River, Waitekaha Stream, and two unnamed streams about 1 km south. Note the extensive aggradation in the Waitekaha Stream bed, foreground. [21 May 1979]

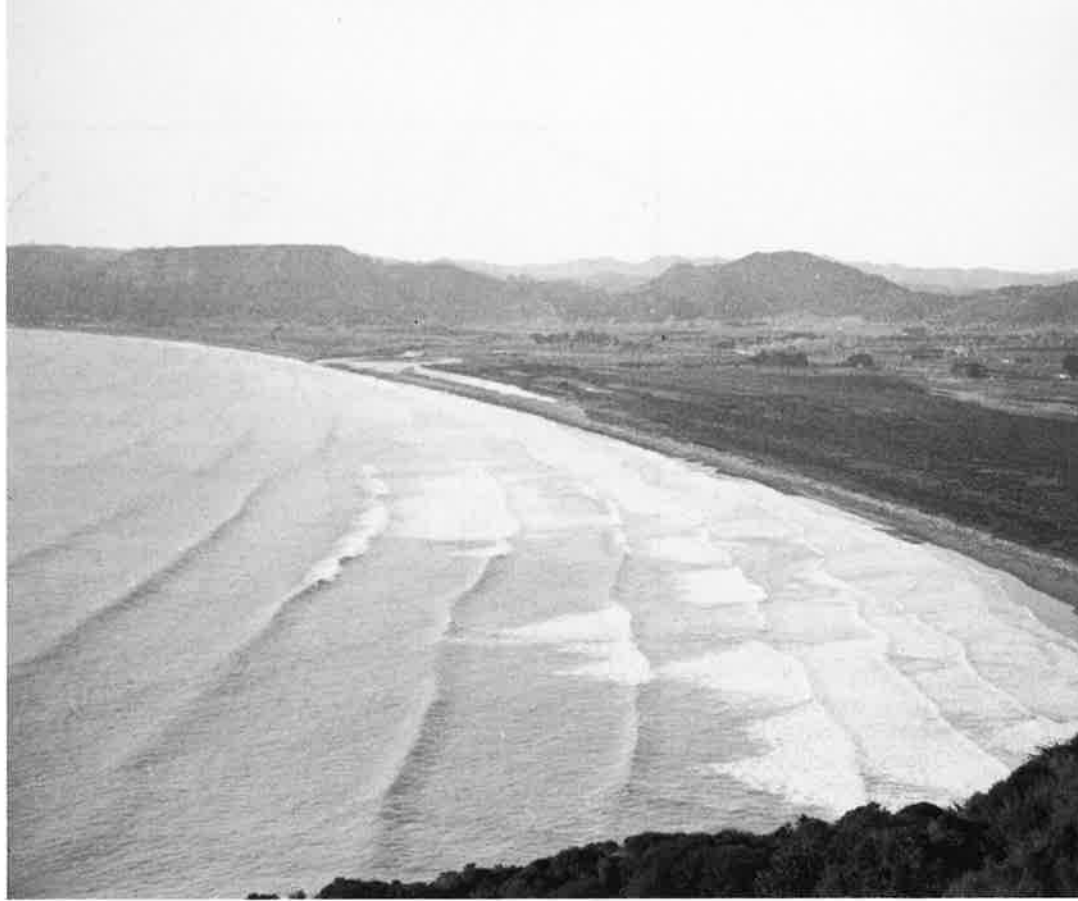
Figure 10 Kawakawa Bay looking east, showing refracted southerly swells approaching from the northeast generating a north-westerly longshore drift towards the observer. [11 September 1977]

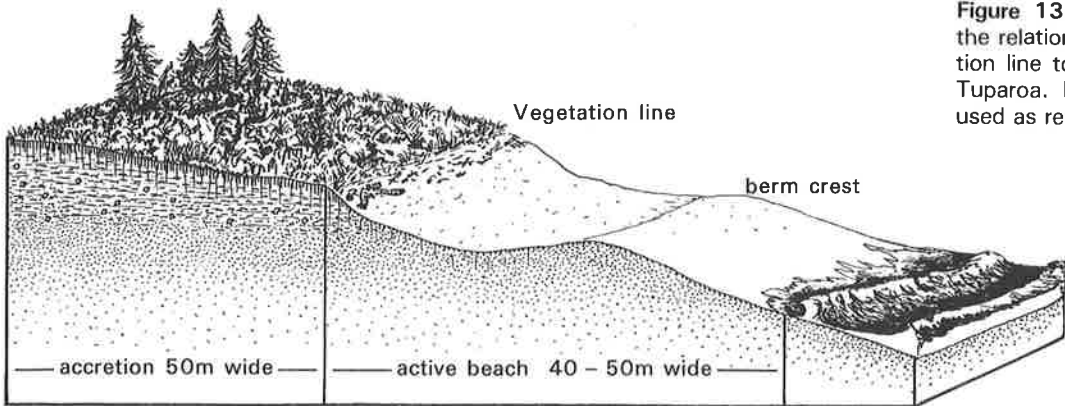
Figure 13 Diagram showing the relationship of the vegetation line to the berm crest at Tuparoa. Both features were used as reference shore lines.

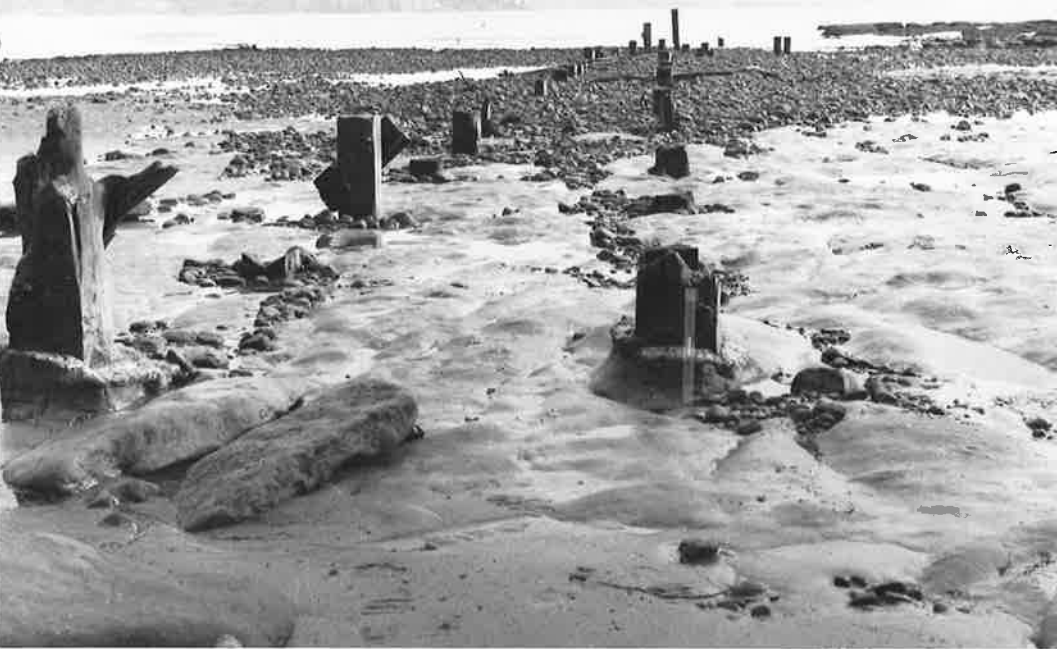
Figure 15 Looking west across Kawakawa Bay towards Matakaoa Point, showing decapitated wooden wharf piles exposed at low tide on the shore platform plane cut in Late Tertiary rocks 400 m east of Te Araroa. In 1914 the platform plane was level with the concrete around the piles in the foreground. Gravels on the lower plane are from the Awatere River. Plastic rule against the righthand pile is 0.4 m long. [23 May 1979]

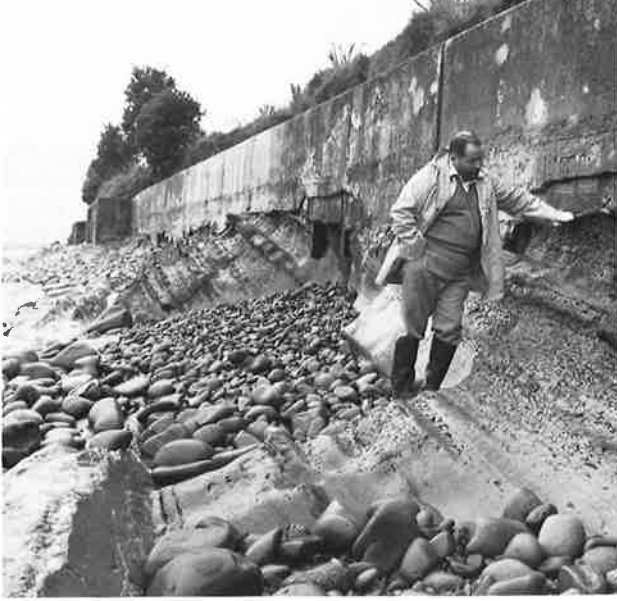
Figure 16 Central Tokomaru Bay looking south, showing Mr B. Edgar, Waiapu County Engineer, alongside an endangered section of concrete sea wall constructed in 1965. The wall rests on a shore platform ramp cut in Late Tertiary alternating sandstone-siltstone beds dipping about 40° landward. In the boulder-filled hollow the platform ramp has been downcut 1.2 ± 0.1 m since 1965. Both increased wave turbulence at the sea wall base and the corrosive action of locally derived boulders have accelerated downcutting rates. [25 June 1980]

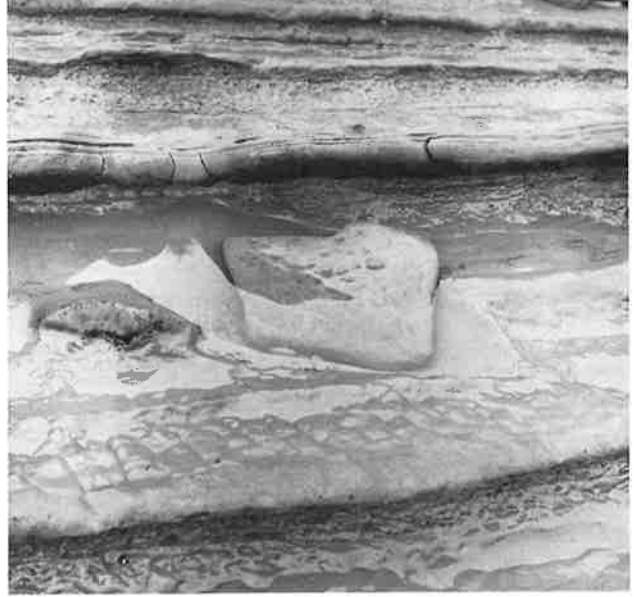
Figure 17 A locally derived sandstone boulder resting in a pothole cut by the boulder in a siltstone bed on the shore platform ramp, central Tokomaru Bay. [25 June 1980]

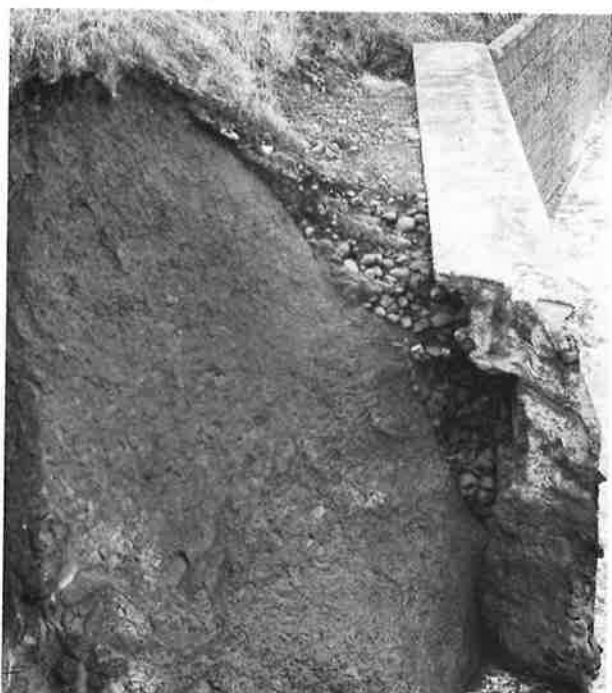
Figure 18 Northern Tokomaru Bay looking north, showing an outflanked sea wall. The rocks are Late Tertiary sandstone-siltstones that have retreated about 7 m since 1945. Note the polygonal cracking breaking up the cliff face. [24 May 1979]

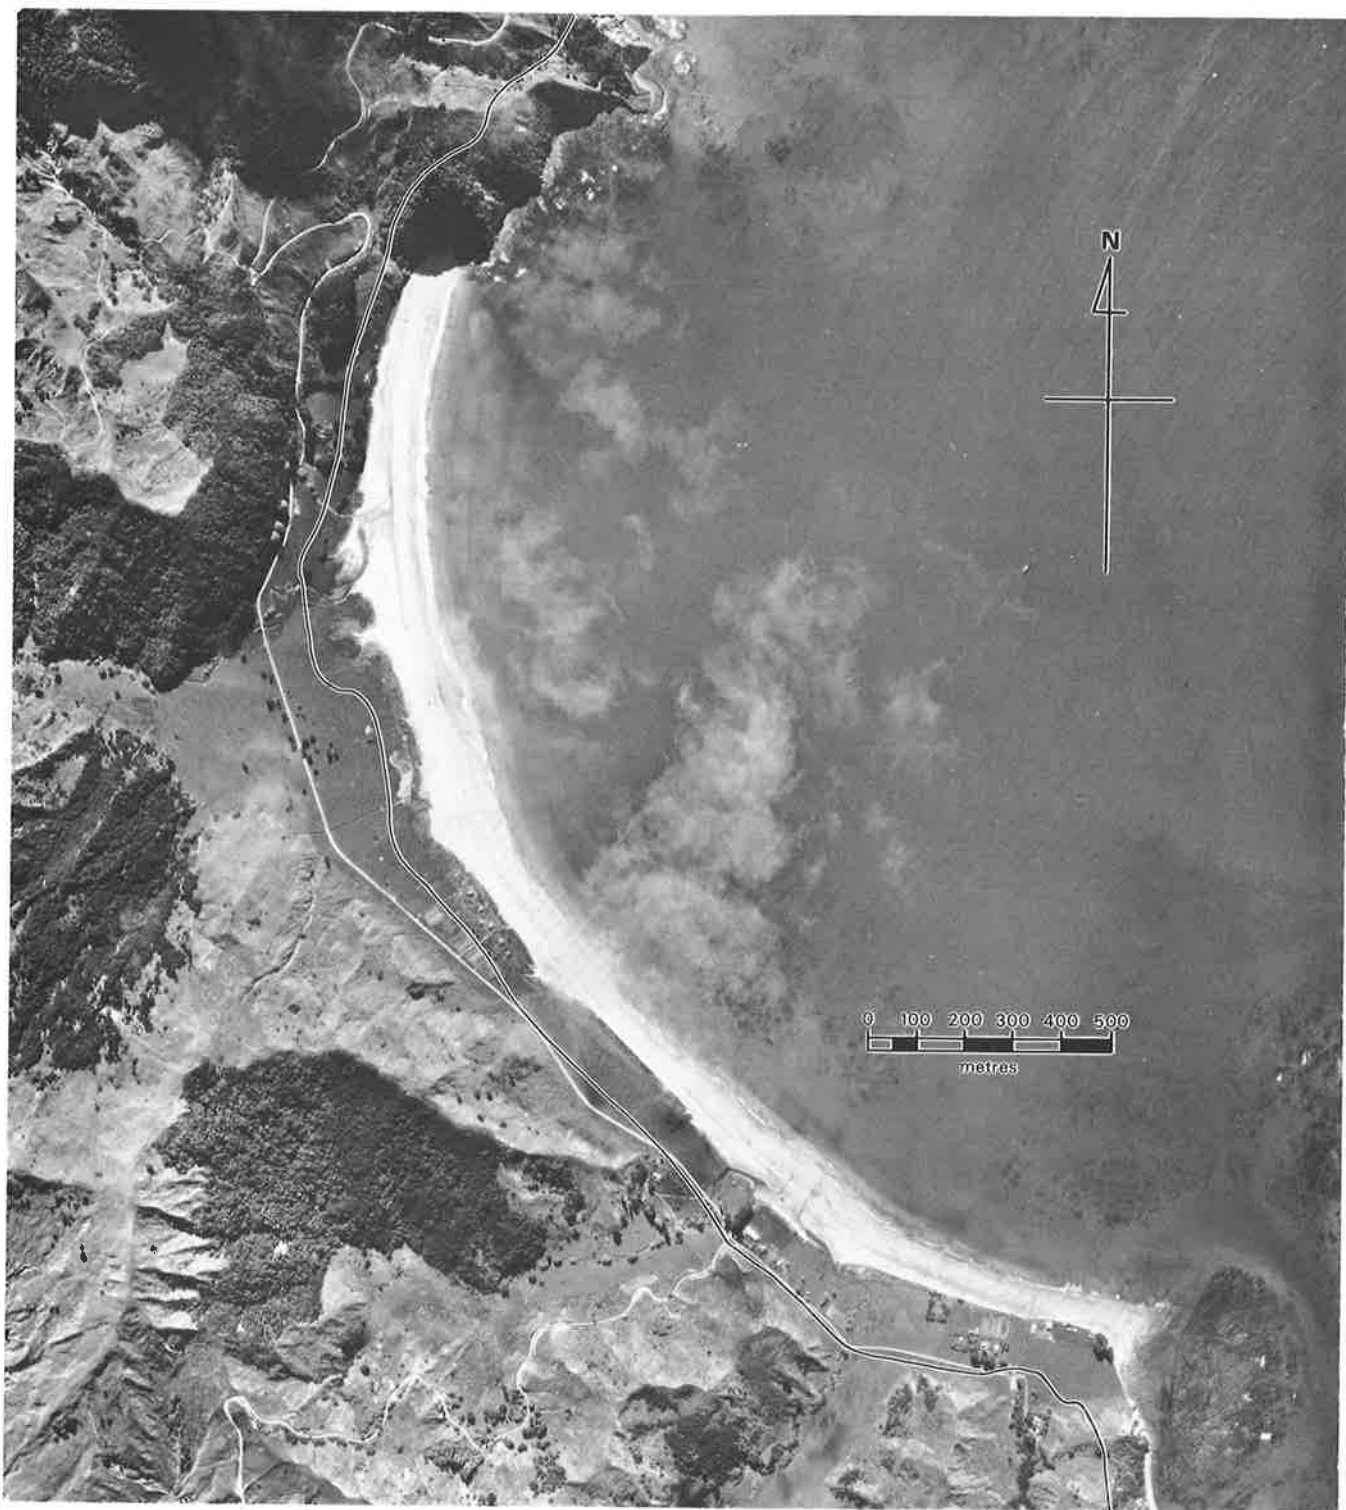
Figure 21 Coastal Hazard Photomap of Anaura Bay, based on aerial photograph: Survey 3566, photo A/7, 30 April 1972.

For the eroding section the hazard zone width increases to a **maximum of 174 m** ($1.24 \text{ m/yr} \times 100 + 50 \text{ m}$) by the southern stream mouth, based on maximum erosion at 1.24 m/yr (item 03, Appendix 2). As most of the coastal plain is less than 174 m wide and is backed by steep hills, the hazard zone extends only to the toe of the hills.

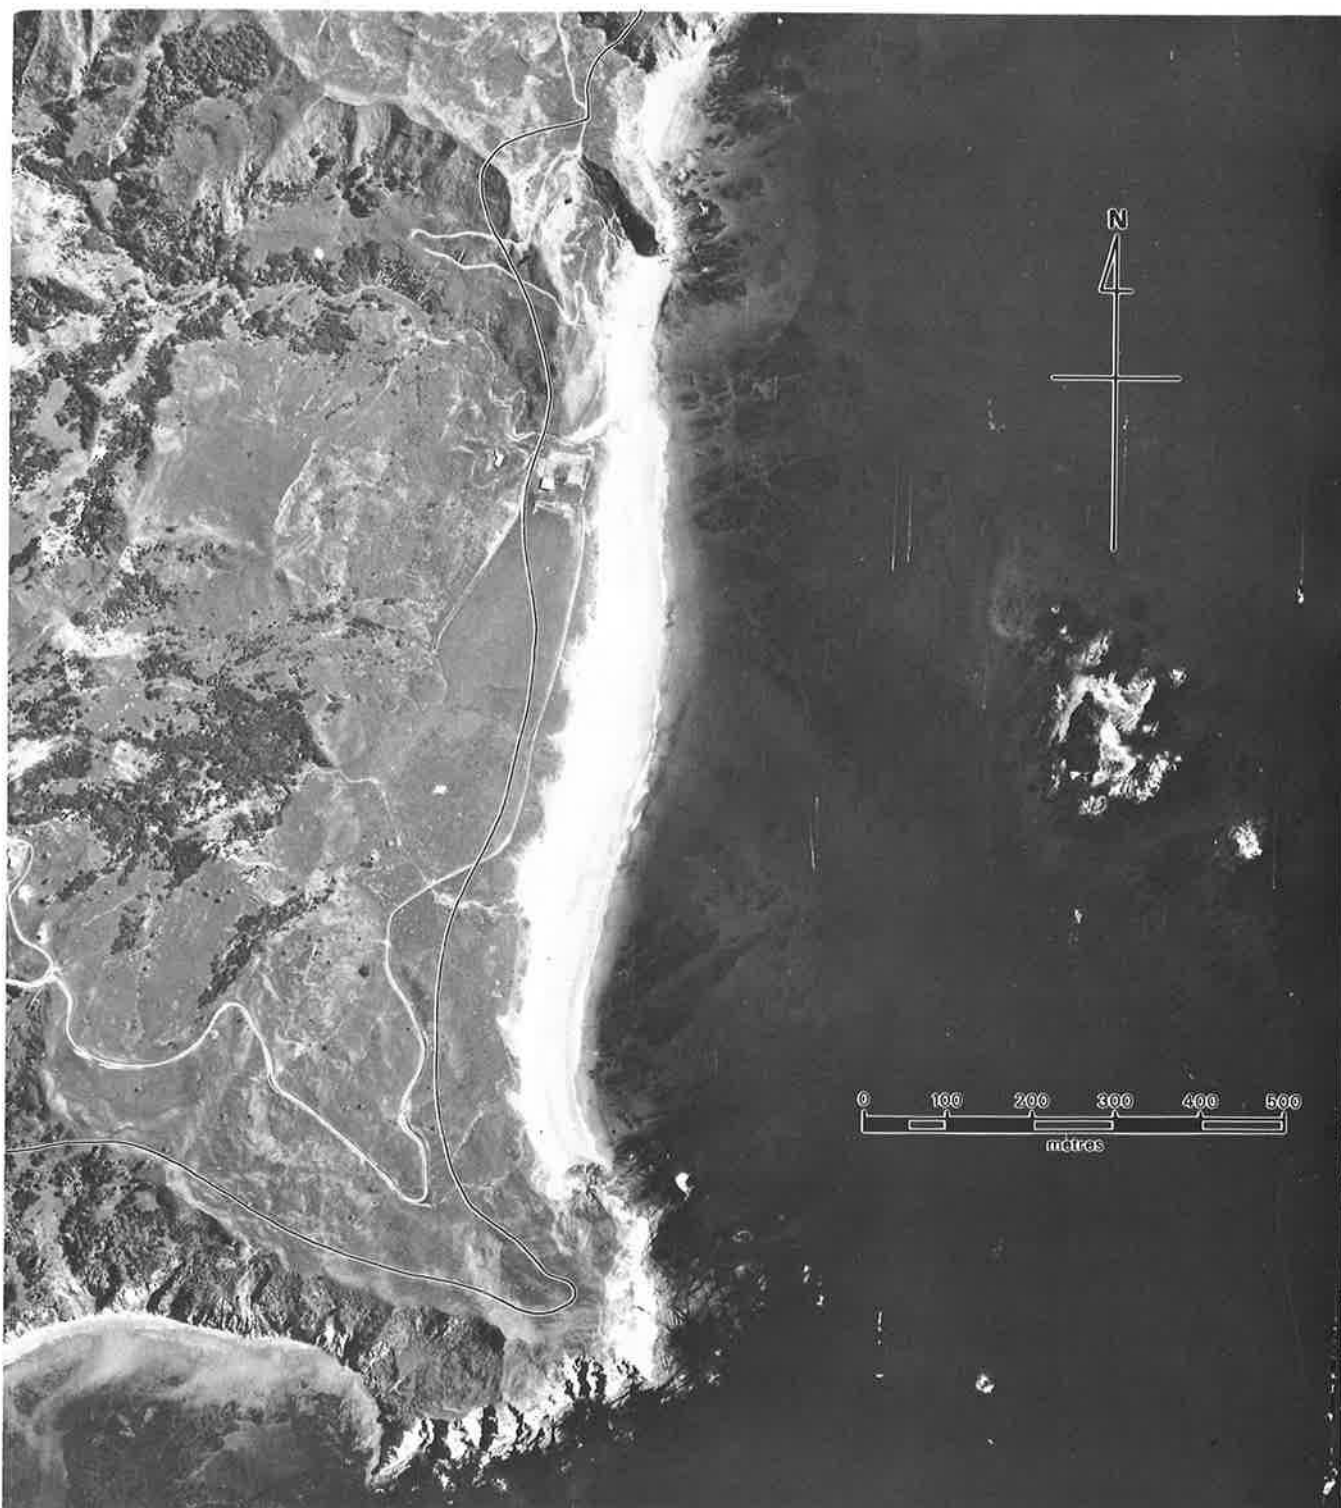
Figure 22 Coastal Hazard Photomap of Nuhiti Road Beach, based on aerial photograph: Survey 3298, photo 4460/57, 22 October 1972.

dunes, a **minimum width of 100 m** is adopted, based on an estimated erosion rate of 0.5 m/yr ($0.5 \text{ m/yr} \times 100 + 50 \text{ m}$). For the eroding Late Tertiary mudstone headlands, a hazard zone **width of 35 m** is calculated ($0.21 \text{ m/yr} \times 100 + 14 \text{ m}$), based on maximum erosion at 0.21 m/yr (item 14, Appendix 2), extending inland from the top edge of the recent or relict landslide scarps.

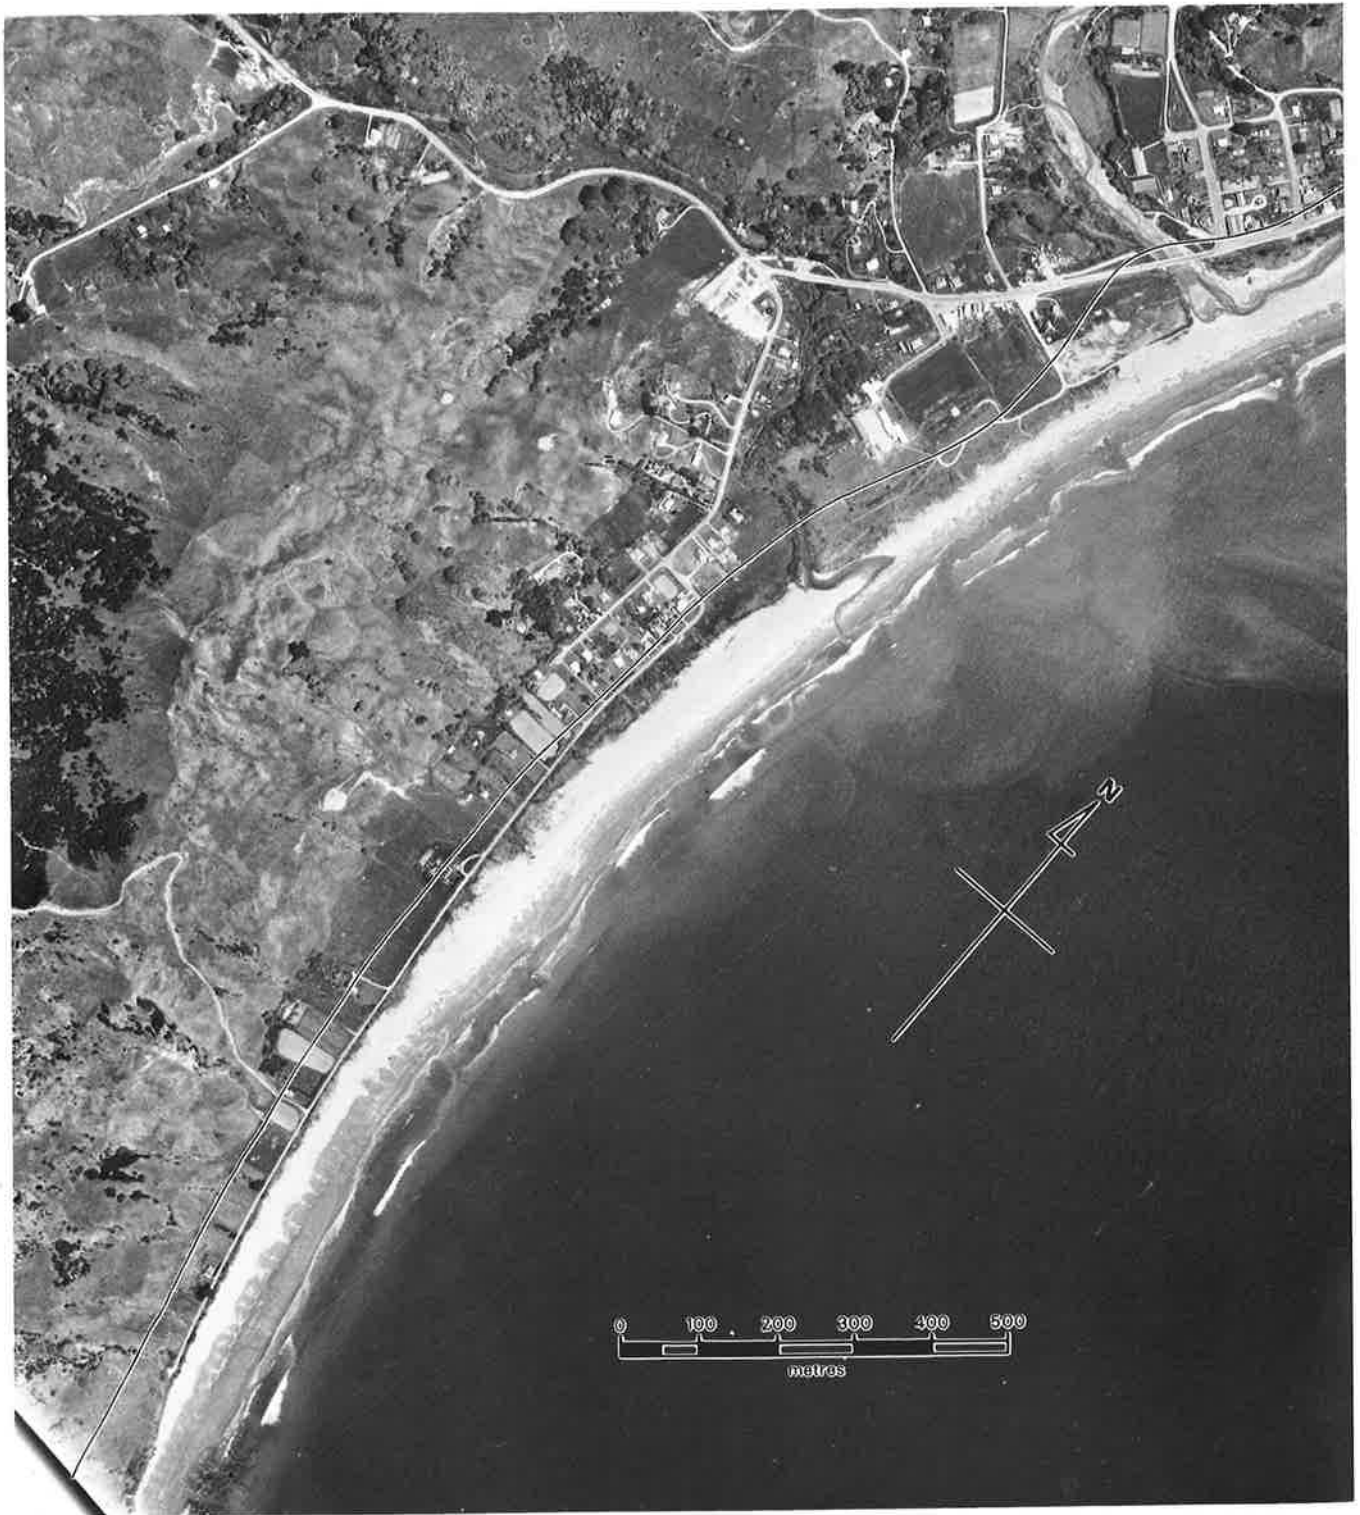
Figure 23 Coastal Hazard Photomap of Tokomaru Bay south, based on aerial photograph: Survey 3298, photo 4457/56, 22 October 1972.

With the exception of the eroding coastline south of the terminus of the southern coastal road, the entire coastline shown on the map is accreting (items 08–10, Appendix 2). According to criteria given previously, the hazard zone width is 50 m along the accreting section of coast, increasing in width around the mouths of the Mangahauini River (northernmost in Figure 23) and the Waiotu Stream (about 600 m further south). Both mouths migrate along the coast causing localised erosion.

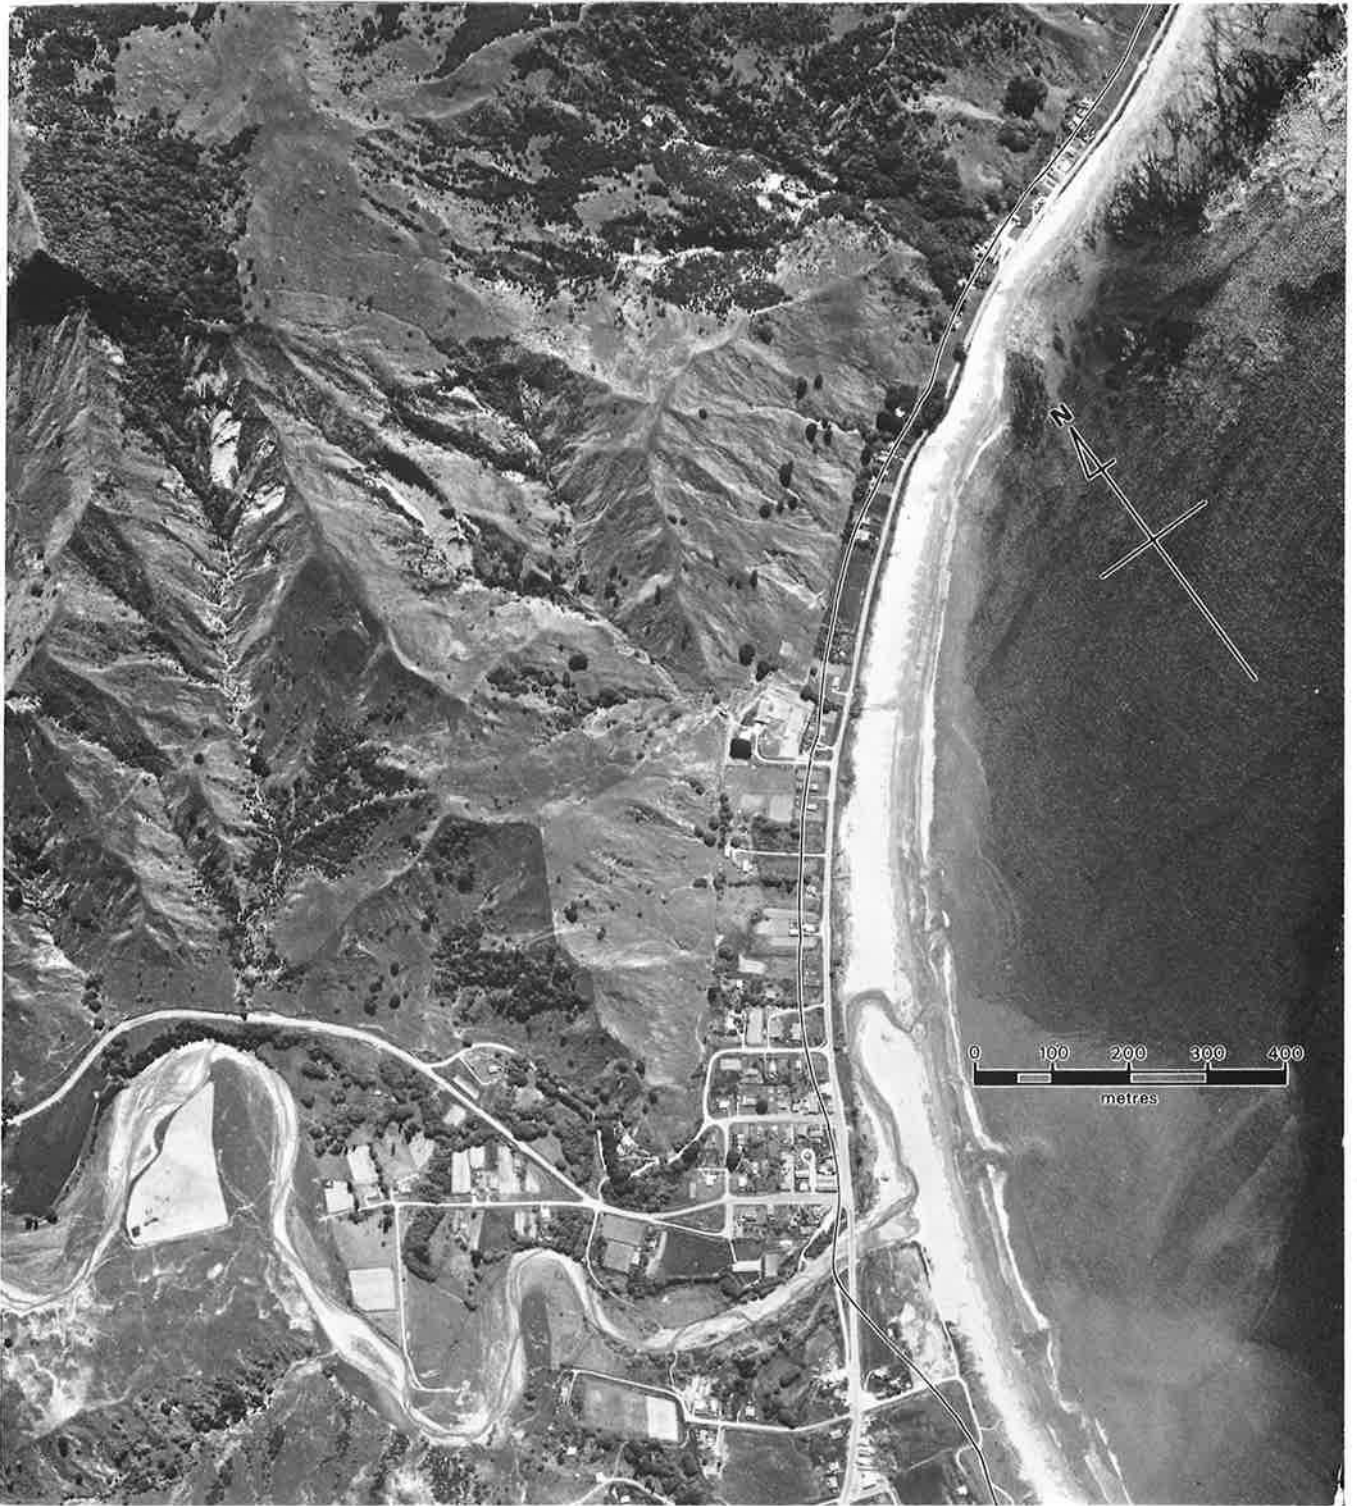
Figure 24 Coastal Hazard Photomap of Tokomaru Bay centre, based on aerial photograph: Survey 3298, photo 4457/56, 22 October 1972.

Here, a hazard zone **width of 35 m** is calculated ($0.21 \text{ m/yr} \times 100 + 14 \text{ m}$), based on maximum backcutting at 0.21 m/yr (item 14, Appendix 2), extending inland from the toe of the sea wall. For the southern accreting section of coast a hazard zone **extending 50 m** inland from the vegetation line is adopted.

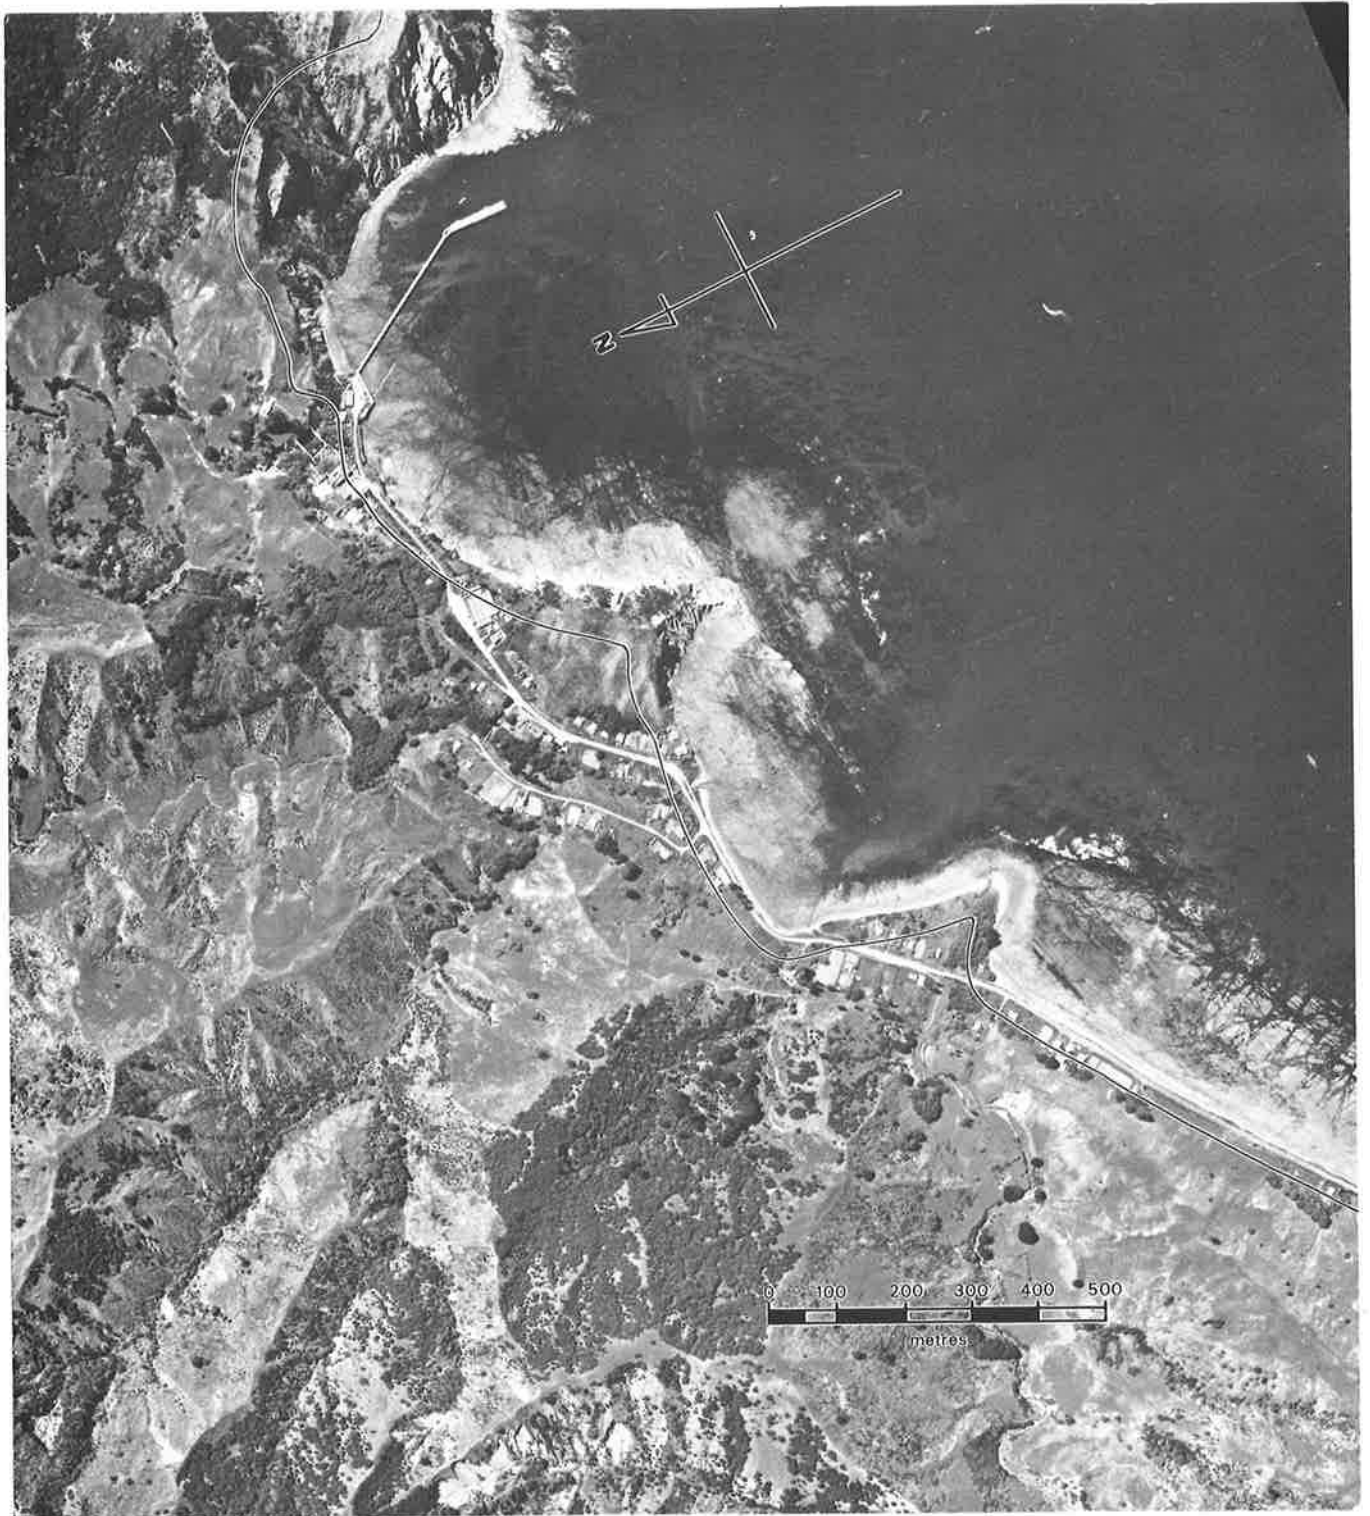
Figure 25 Coastal Hazard Photomap of Tokomaru Bay north, based on aerial photograph: Survey 3298, photo 4456/57, 22 October 1972.

hazard zone **width of 35 m** is calculated ($0.21 \text{ m/yr} \times 100 + 14 \text{ m}$), based on the maximum erosion rate. For the northern bay containing the wharf, a hazard zone **width of 35 m** is calculated ($0.21 \text{ m/yr} \times 100 + 14 \text{ m}$), based on maximum backcutting at 0.21 m/yr , extending inland either from the toe of the Late Tertiary mudstone bank, or the top edge of the landslide scarps.
