Coastal hazard mapping as a planning technique for Waiapu County

Coastal hazard mapping as a planning technique for Waiapu County, East Coast, North Island, New Zealand

Water and Soil Division, Ministry of Works and Development, Wellington

**National Water and Soil Conservation Organisation
Wellington 1981**

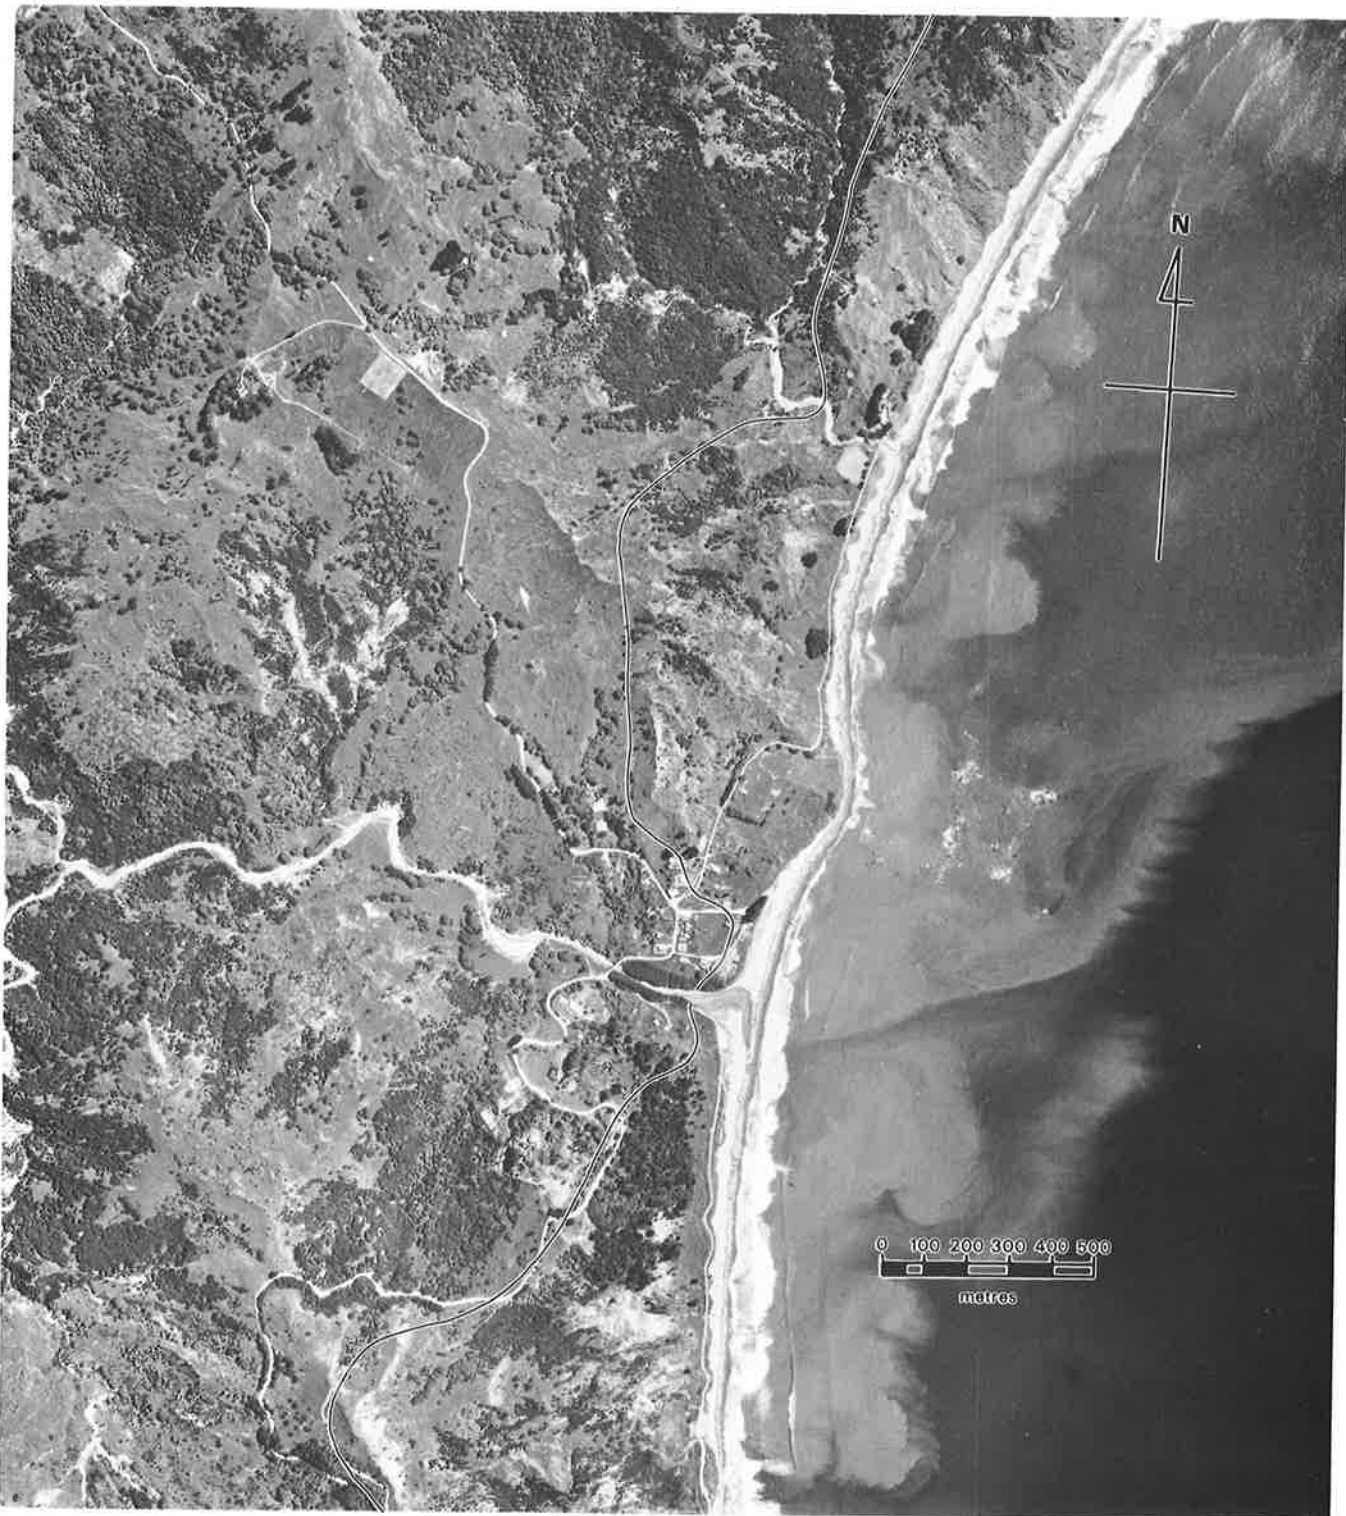
Figure 26 Coastal Hazard Photomap of Waipiro Bay, based on aerial photograph: Survey 3298, photo 4434/60 30 October 1972.

mum erosion in Waipiro Bay of 0.27 m/yr (item 20, Appendix 2). The zone extends inland up to 780 m from the vegetation line to accommodate landsliding. At the mouth of the Waipiro Stream next to the township, the zone narrows to 50 m from the vegetation line because the land is an uplifted river terrace with a low susceptibility to landsliding. About 1.9 km further north at the Taurapu Stream mouth the seaward ridge crests converge close to the coast, hence the zone extends about 170 m inland from the beach to accommodate landsliding.

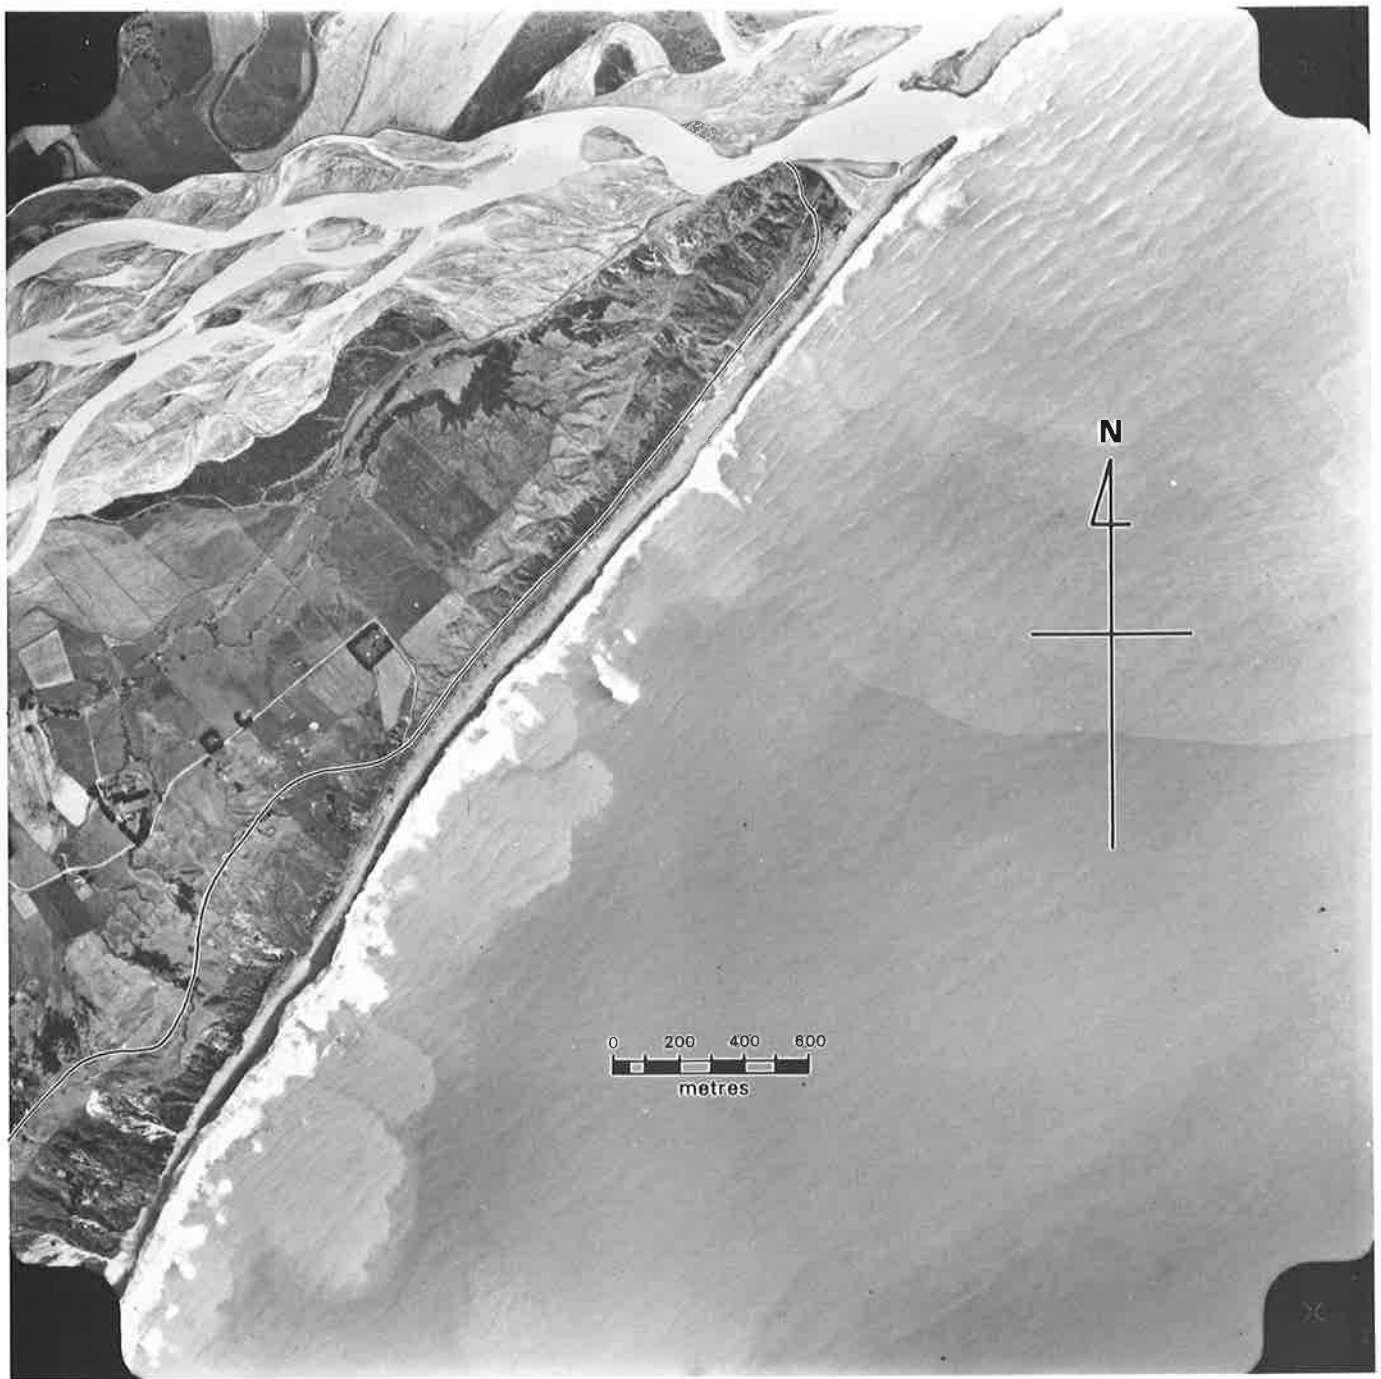
Figure 29 Coastal Hazard Photomap of Te Wharau Beach, based on aerial photograph: Survey 3298, photo 4426/46, 10 September 1971.

The entire coastline shown on the map is accreting (items 33–36, Appendix 2), but the seacliffs of Early Tertiary rocks south of the Te Wharau Beach road have a number of active landslides. For this reason the hazard zone **extends 100 m** landward of the crown of the landslides along this coastal section. North of the beach access road the line is **approximately 50 m** inland from the vegetation line. Because of the massive volume of sediment stored in the lower Waiapu River channel (top of Figure 29), the trend of accretion is likely to continue in the future.

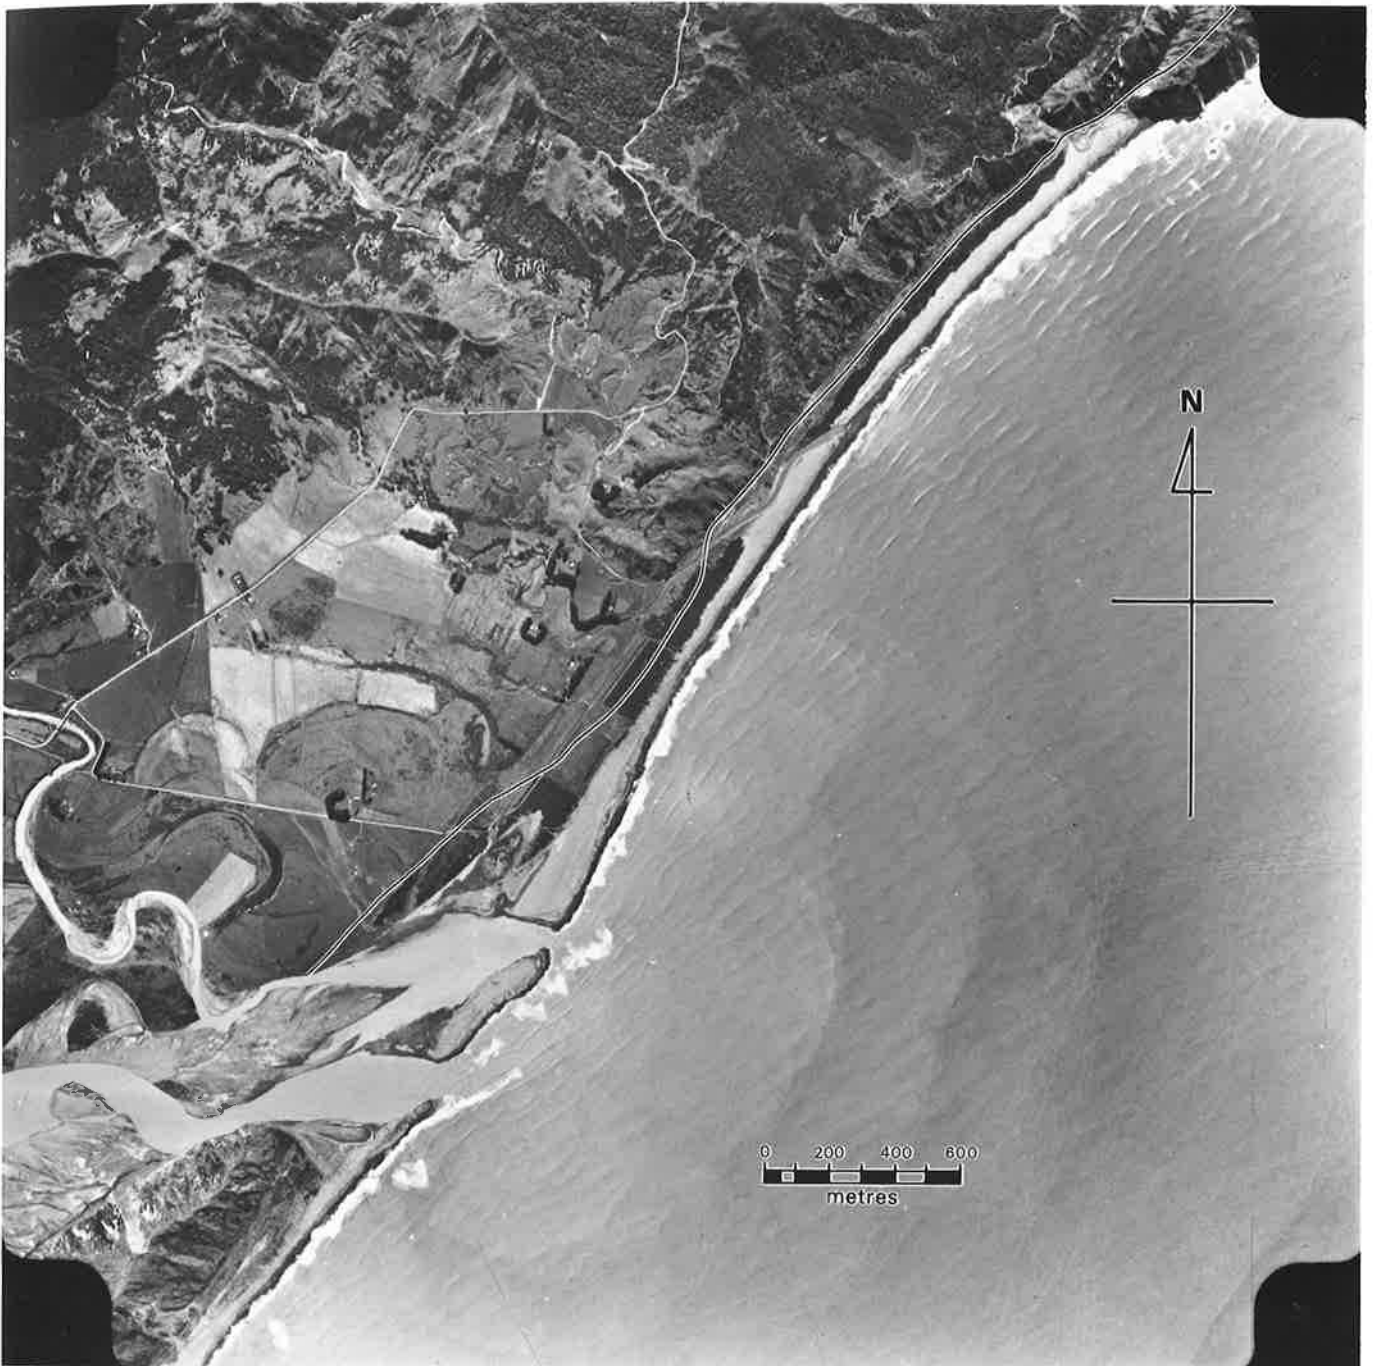
Figure 30 Coastal Hazard Photomap of Rangitukia Beach, based on aerial photograph: Survey 3298, photo 4425/43, 10 September 1971.

The entire coastline shown on the map is accreting (items 37-39, Appendix 2). The mouths of the Waiapu River (bottom of Figure 30) and Waikaka Stream (about 1.5 km further north) are very unstable and tend to migrate northwards. Because of the lower channel storage in the Waiapu River and the strong net northerly drift, accretion is likely to continue in the future along Rangitukia Beach. Near the river and stream mouths the hazard zone **extends 100 m** inland from the vegetation line to accommodate mouth migration. For the rest of the coast the zone **extends 50 m** inland from the vegetation line to accommodate short-term movements.

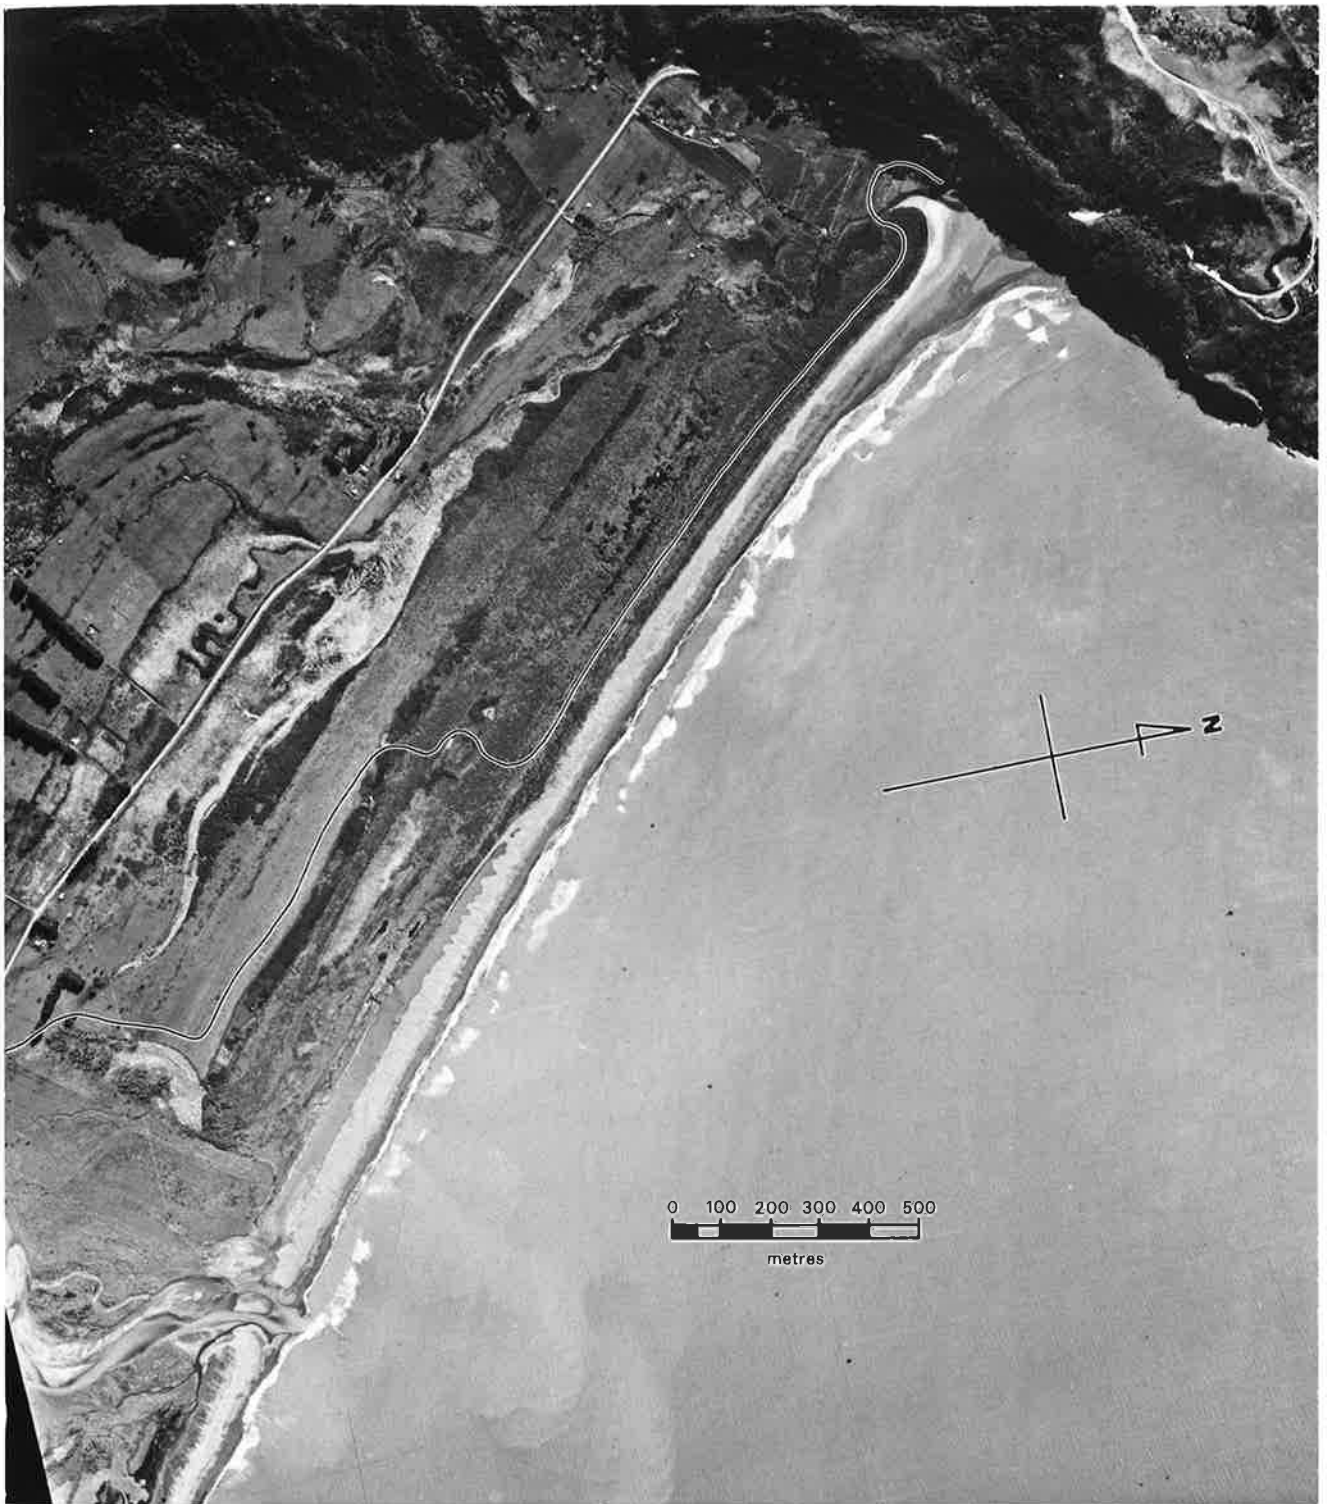
Figure 32 Coastal Hazard Photomap of Kawakawa Bay, based on aerial photograph: Survey 3298, photo 4419/25, 10 September 1971.

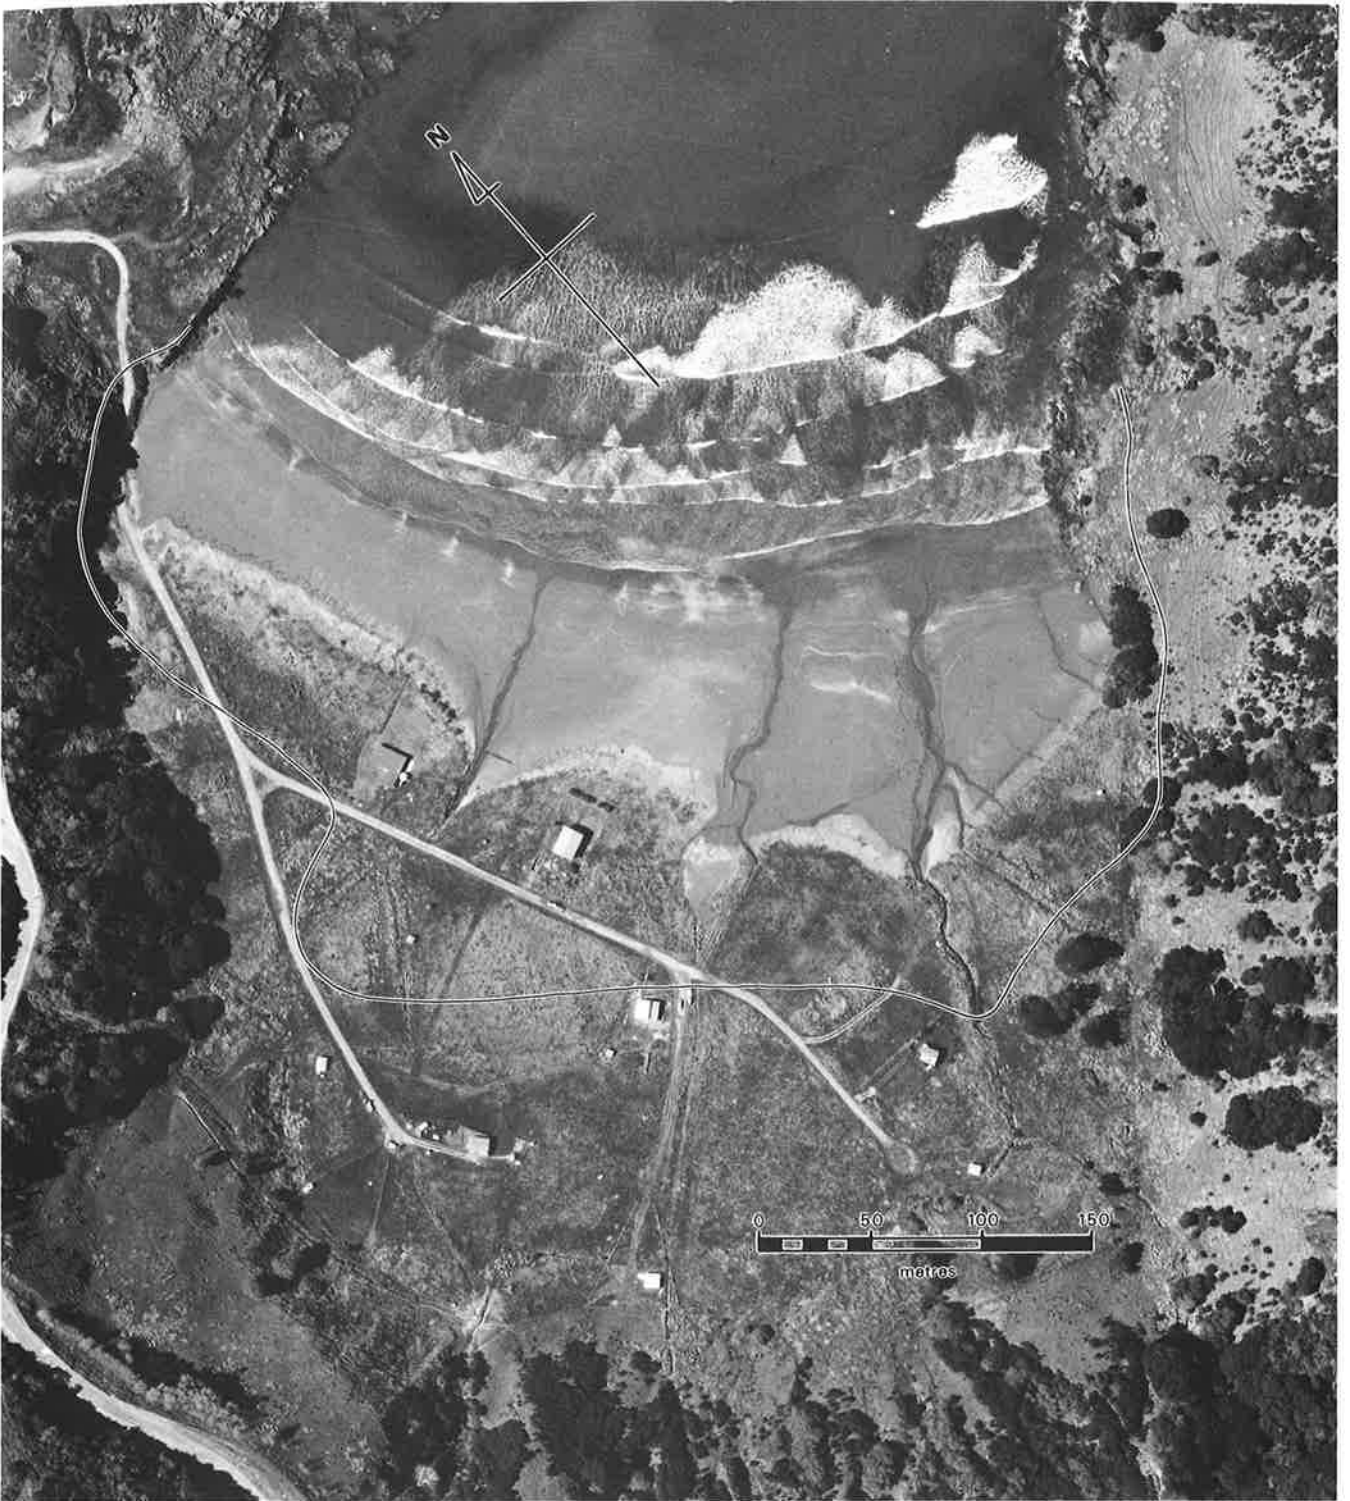
Figure 33 Coastal Hazard Photomap of Onepoto Bay, based on aerial photograph: Survey 5134, photo C1/6, 4 October 1977.

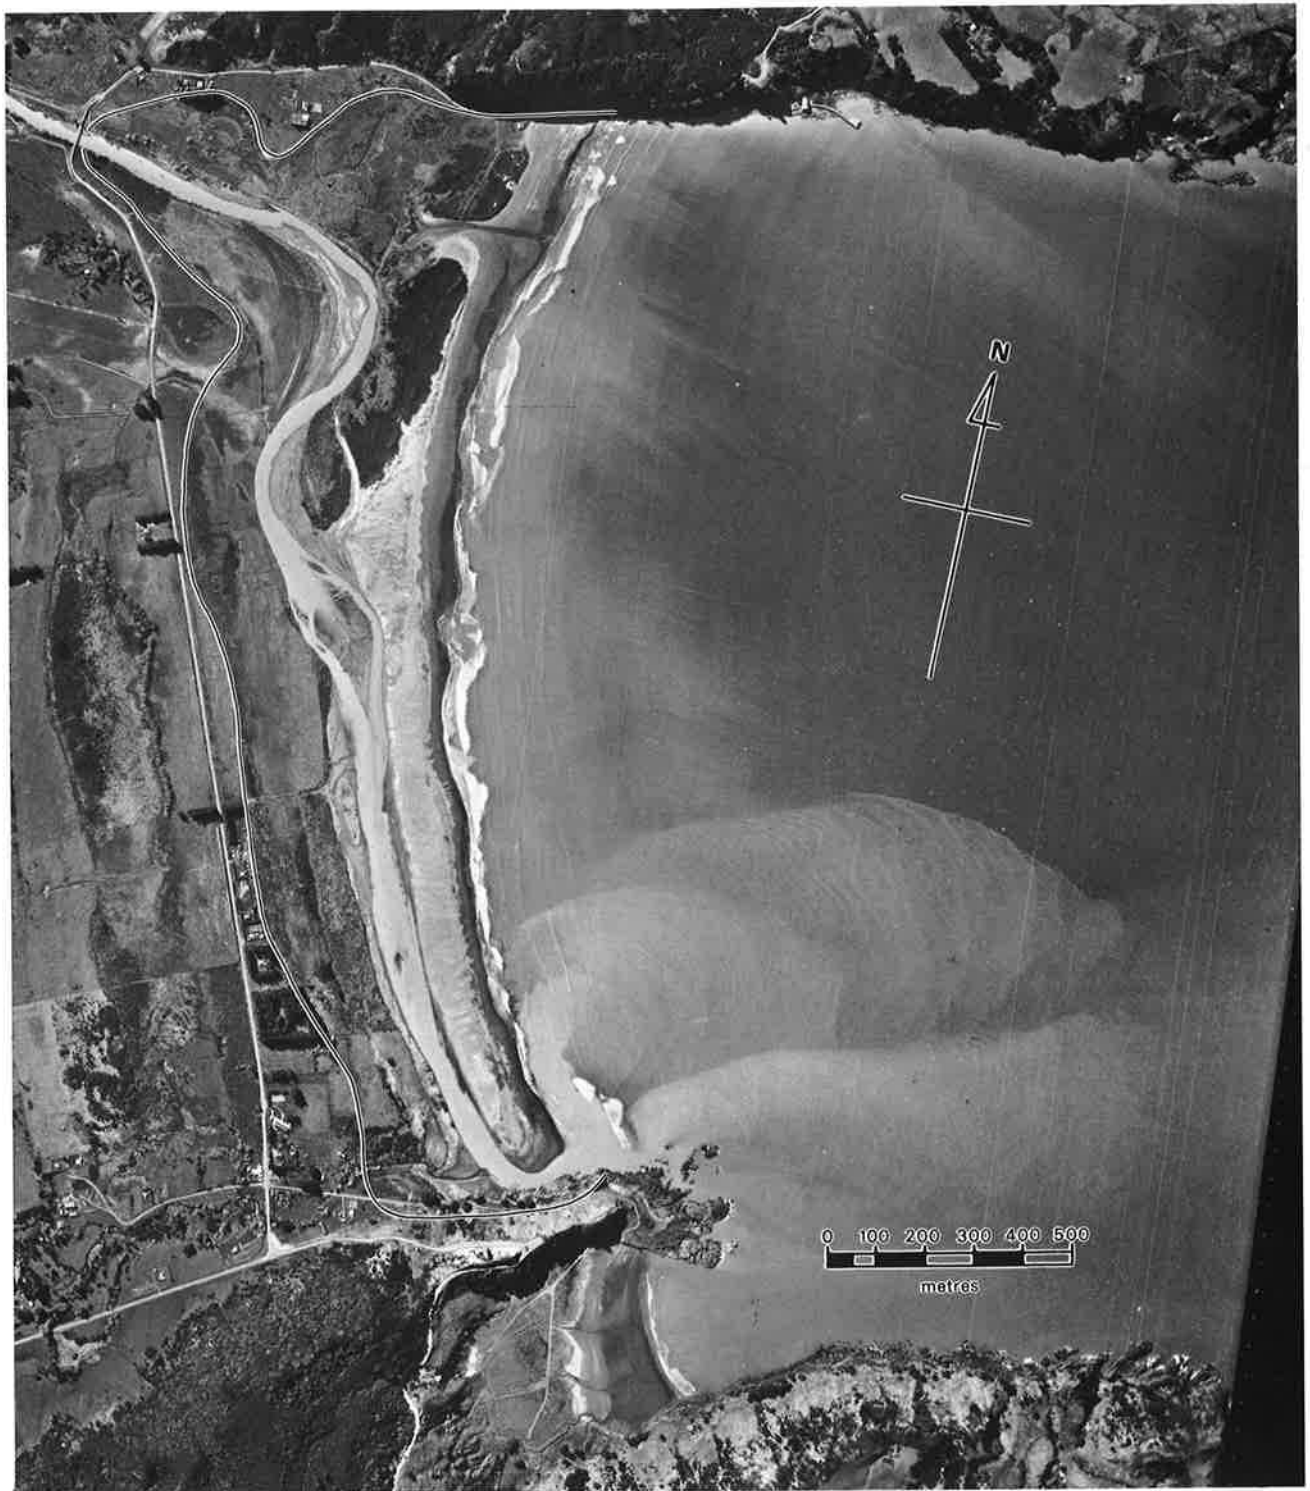
Figure 34 Coastal Hazard Photomap of Hicks Bay, based on aerial photograph: Survey 3298, photo 4418/20, 10 September 1971.

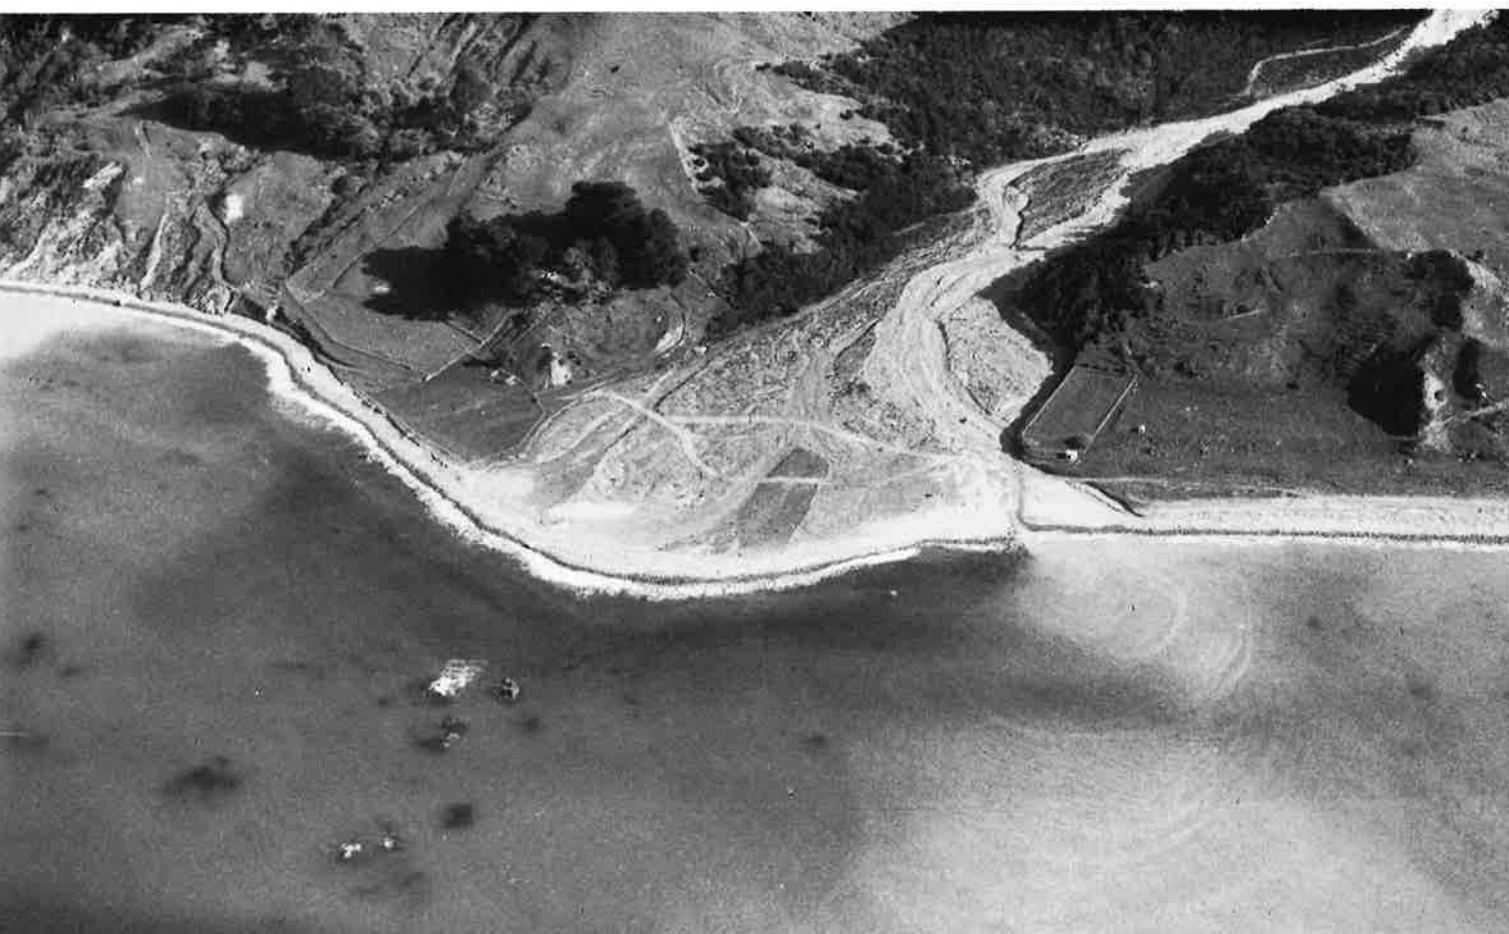
Figure 35 Oblique aerial view of a delta constructed from boulders at the mouth of the Waikawa Stream, southern Waipiro Bay. The stream supplies the beach with gravel and sand. [21 May 1979]

The beach grades north to south from gravel to fine, well-sorted sand (Table 1), to gravel. In the north, the gravel is supplied by the Te Maire Stream and in the south by the Waikawa Stream (Figure 35). Both streams have gravel deltas at their mouths and must supply large quantities of material during peak flows. The net northerly drift has transported the Waikawa-derived gravels as far as Waipiro township, and the Te Maire-derived gravels northwards out of Waipiro Bay. For much of its length the beach is fine, well-sorted sand, dominated by shell fragments, mudstone fragments, and quartz (Table 2). The predominant source for both the gravel and the sand appears to be the two streams, followed by a significant contribution from the nearshore seabed and a lesser amount from the eroding sea-cliffs to the south. Negligible amounts are contributed by longshore drift from Tokomaru Bay to the south.

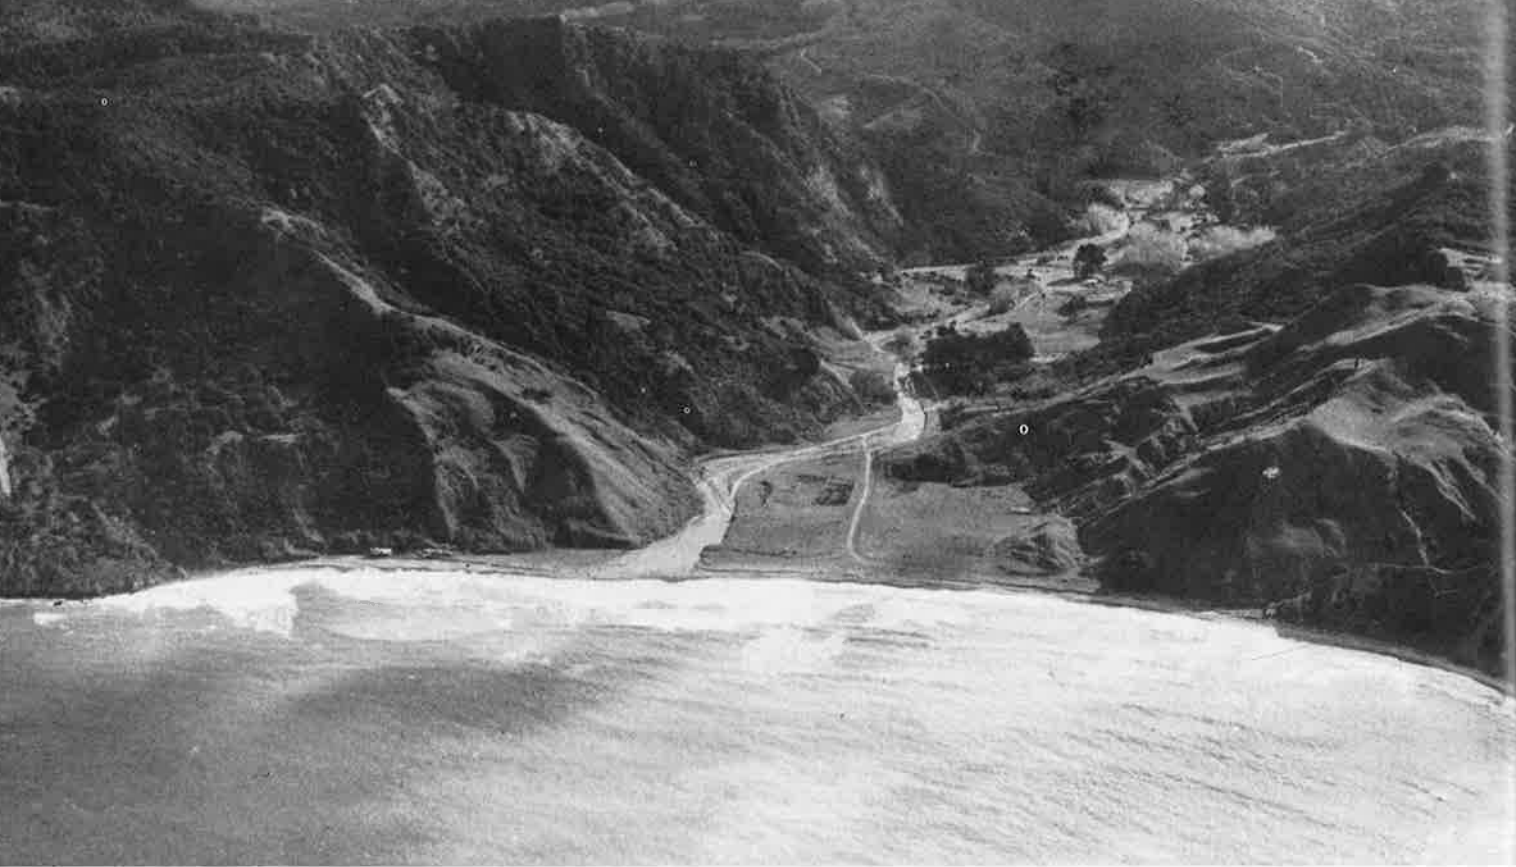
Figure 36 Oblique aerial view of the Whareponga River mouth. Although the river supplies gravel to the beach, the coastline is eroding. [21 May 1979]

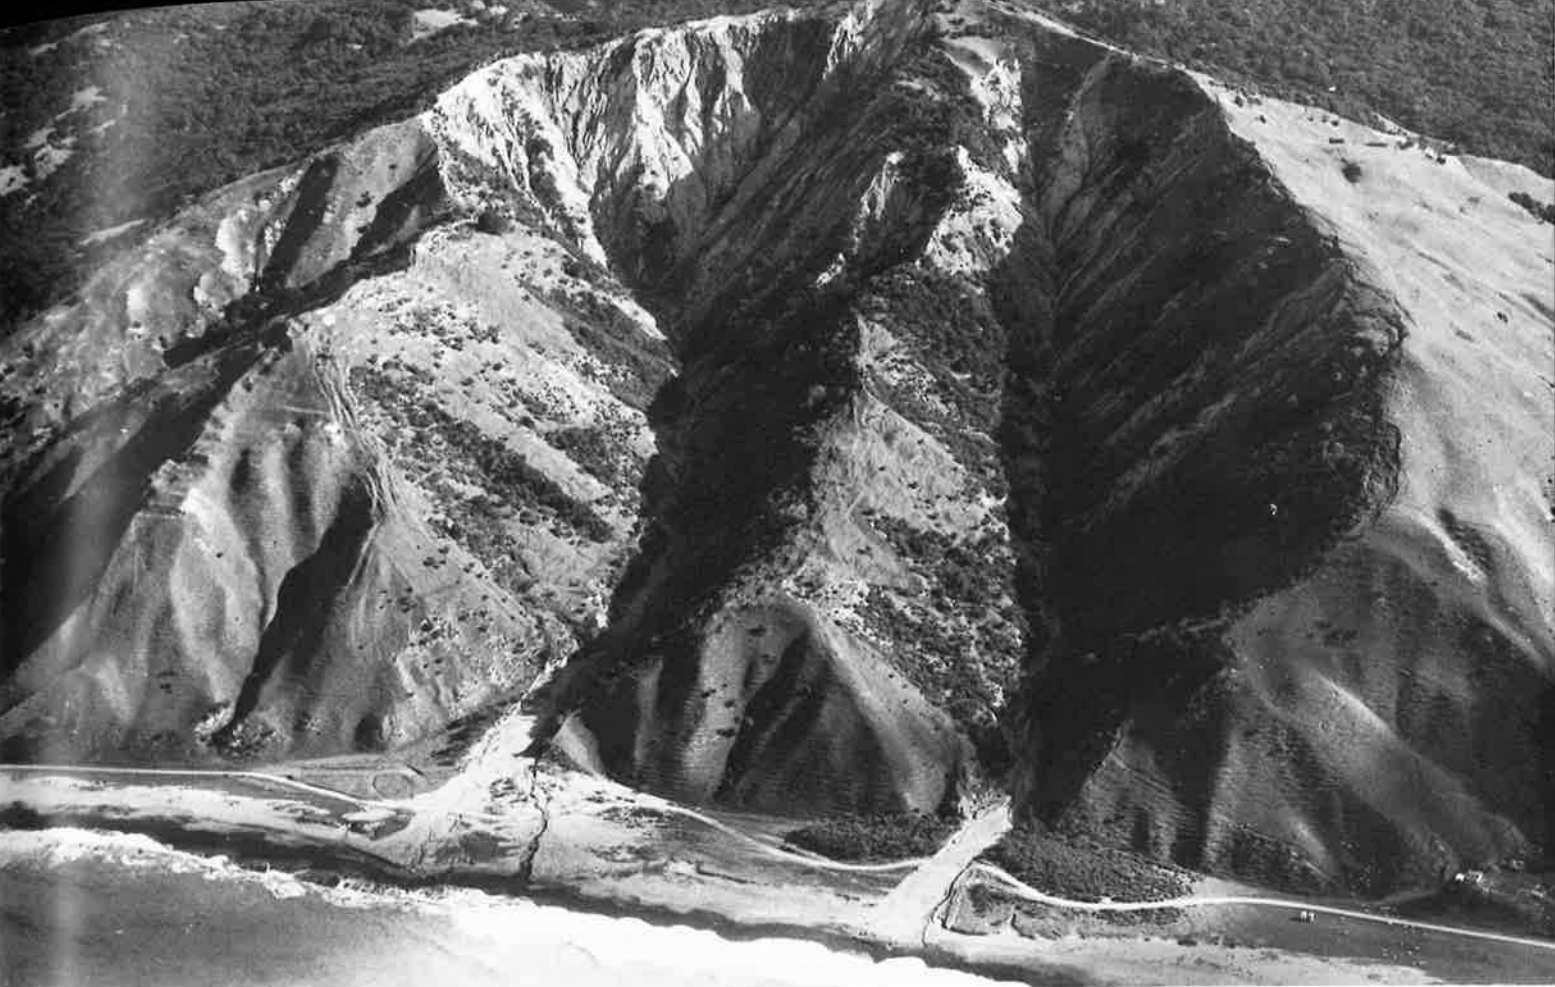
Figure 37 Oblique aerial view of Tuparua, showing two severely eroded Late Tertiary sandstone-siltstone stream catchments. Both streams supply the beach with gravel and sand. In 1910 the beach lay against the toe of the hills. [21 May 1979]

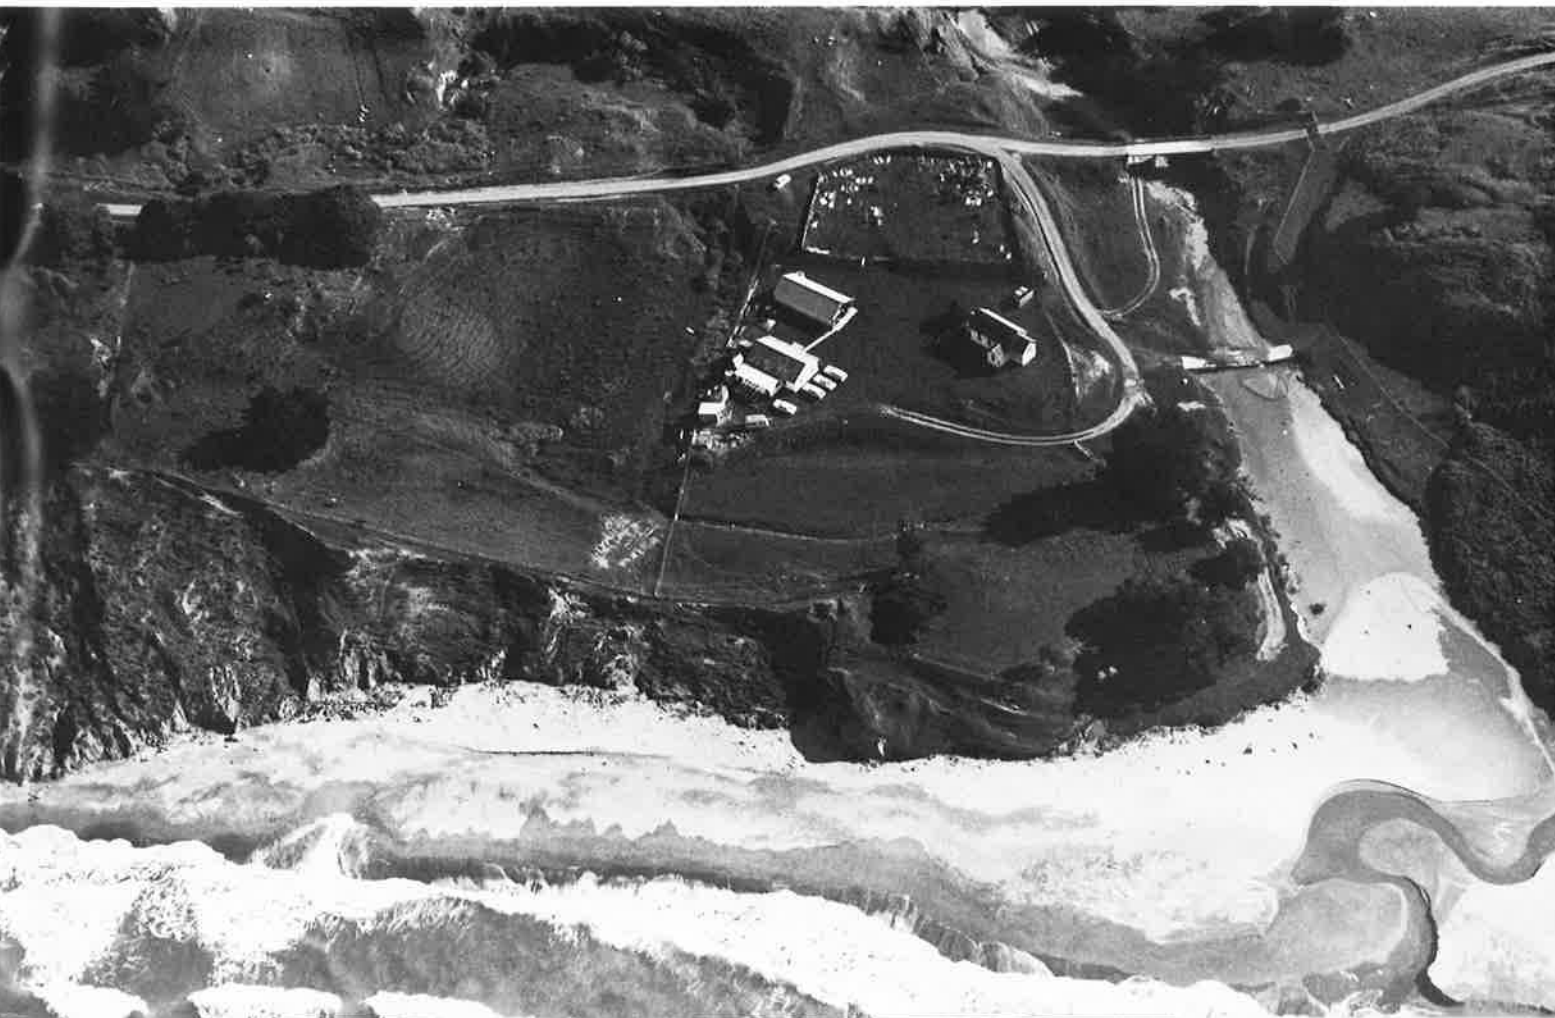
Figure 38 Oblique aerial view of Reporua, showing severe landsliding of seacliffs cut in the intensely deformed Early Tertiary sedimentary rocks. The Reporua Stream shown on the right transports mainly mud. The settlement is the Reporua Marae. [21 May 1979]
