**WELLINGTON
REGIONAL
WATER
BOARD**

**REPORT ON STORM OF
20 December, 1976**

3 February, 1977

STORM OF 20 DECEMBER, 1976

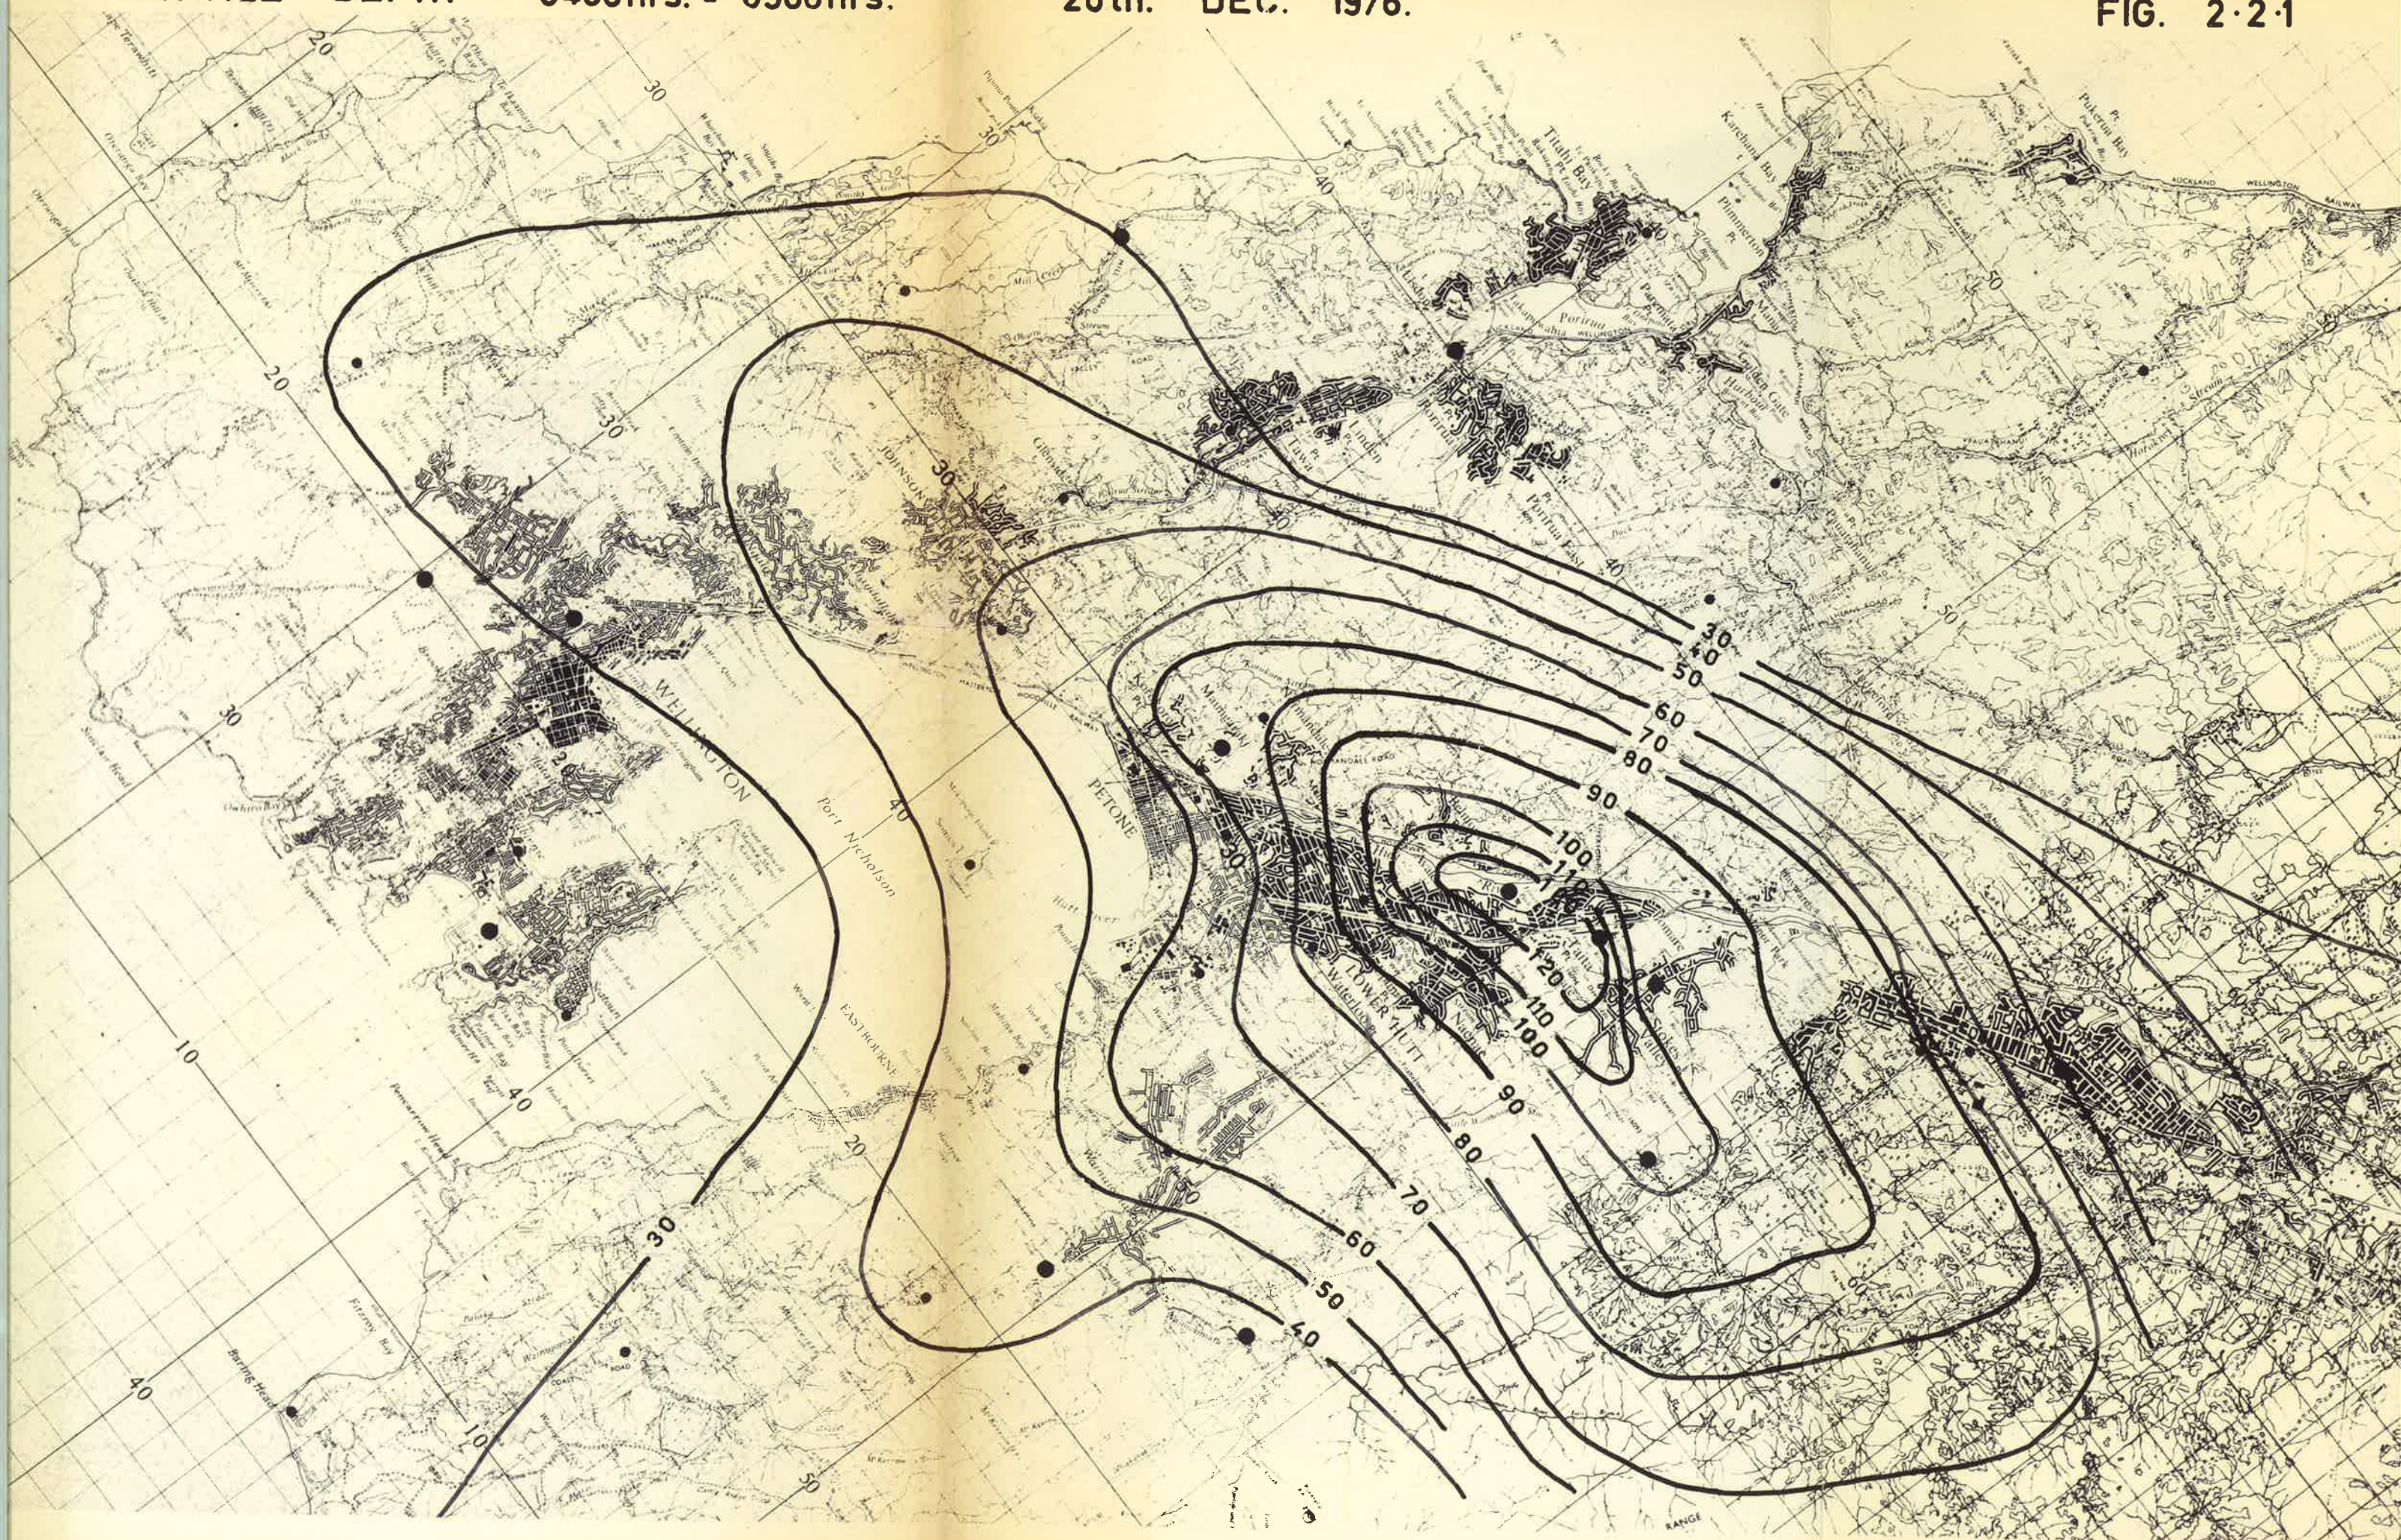
FIG. 2-2-1

In Figure 2.2.1 - lines are drawn showing the distribution over the affected area of accumulated rainfall from the start of the downpour, taken as 0400 hours to 0900 hours when a slight lull occurred.

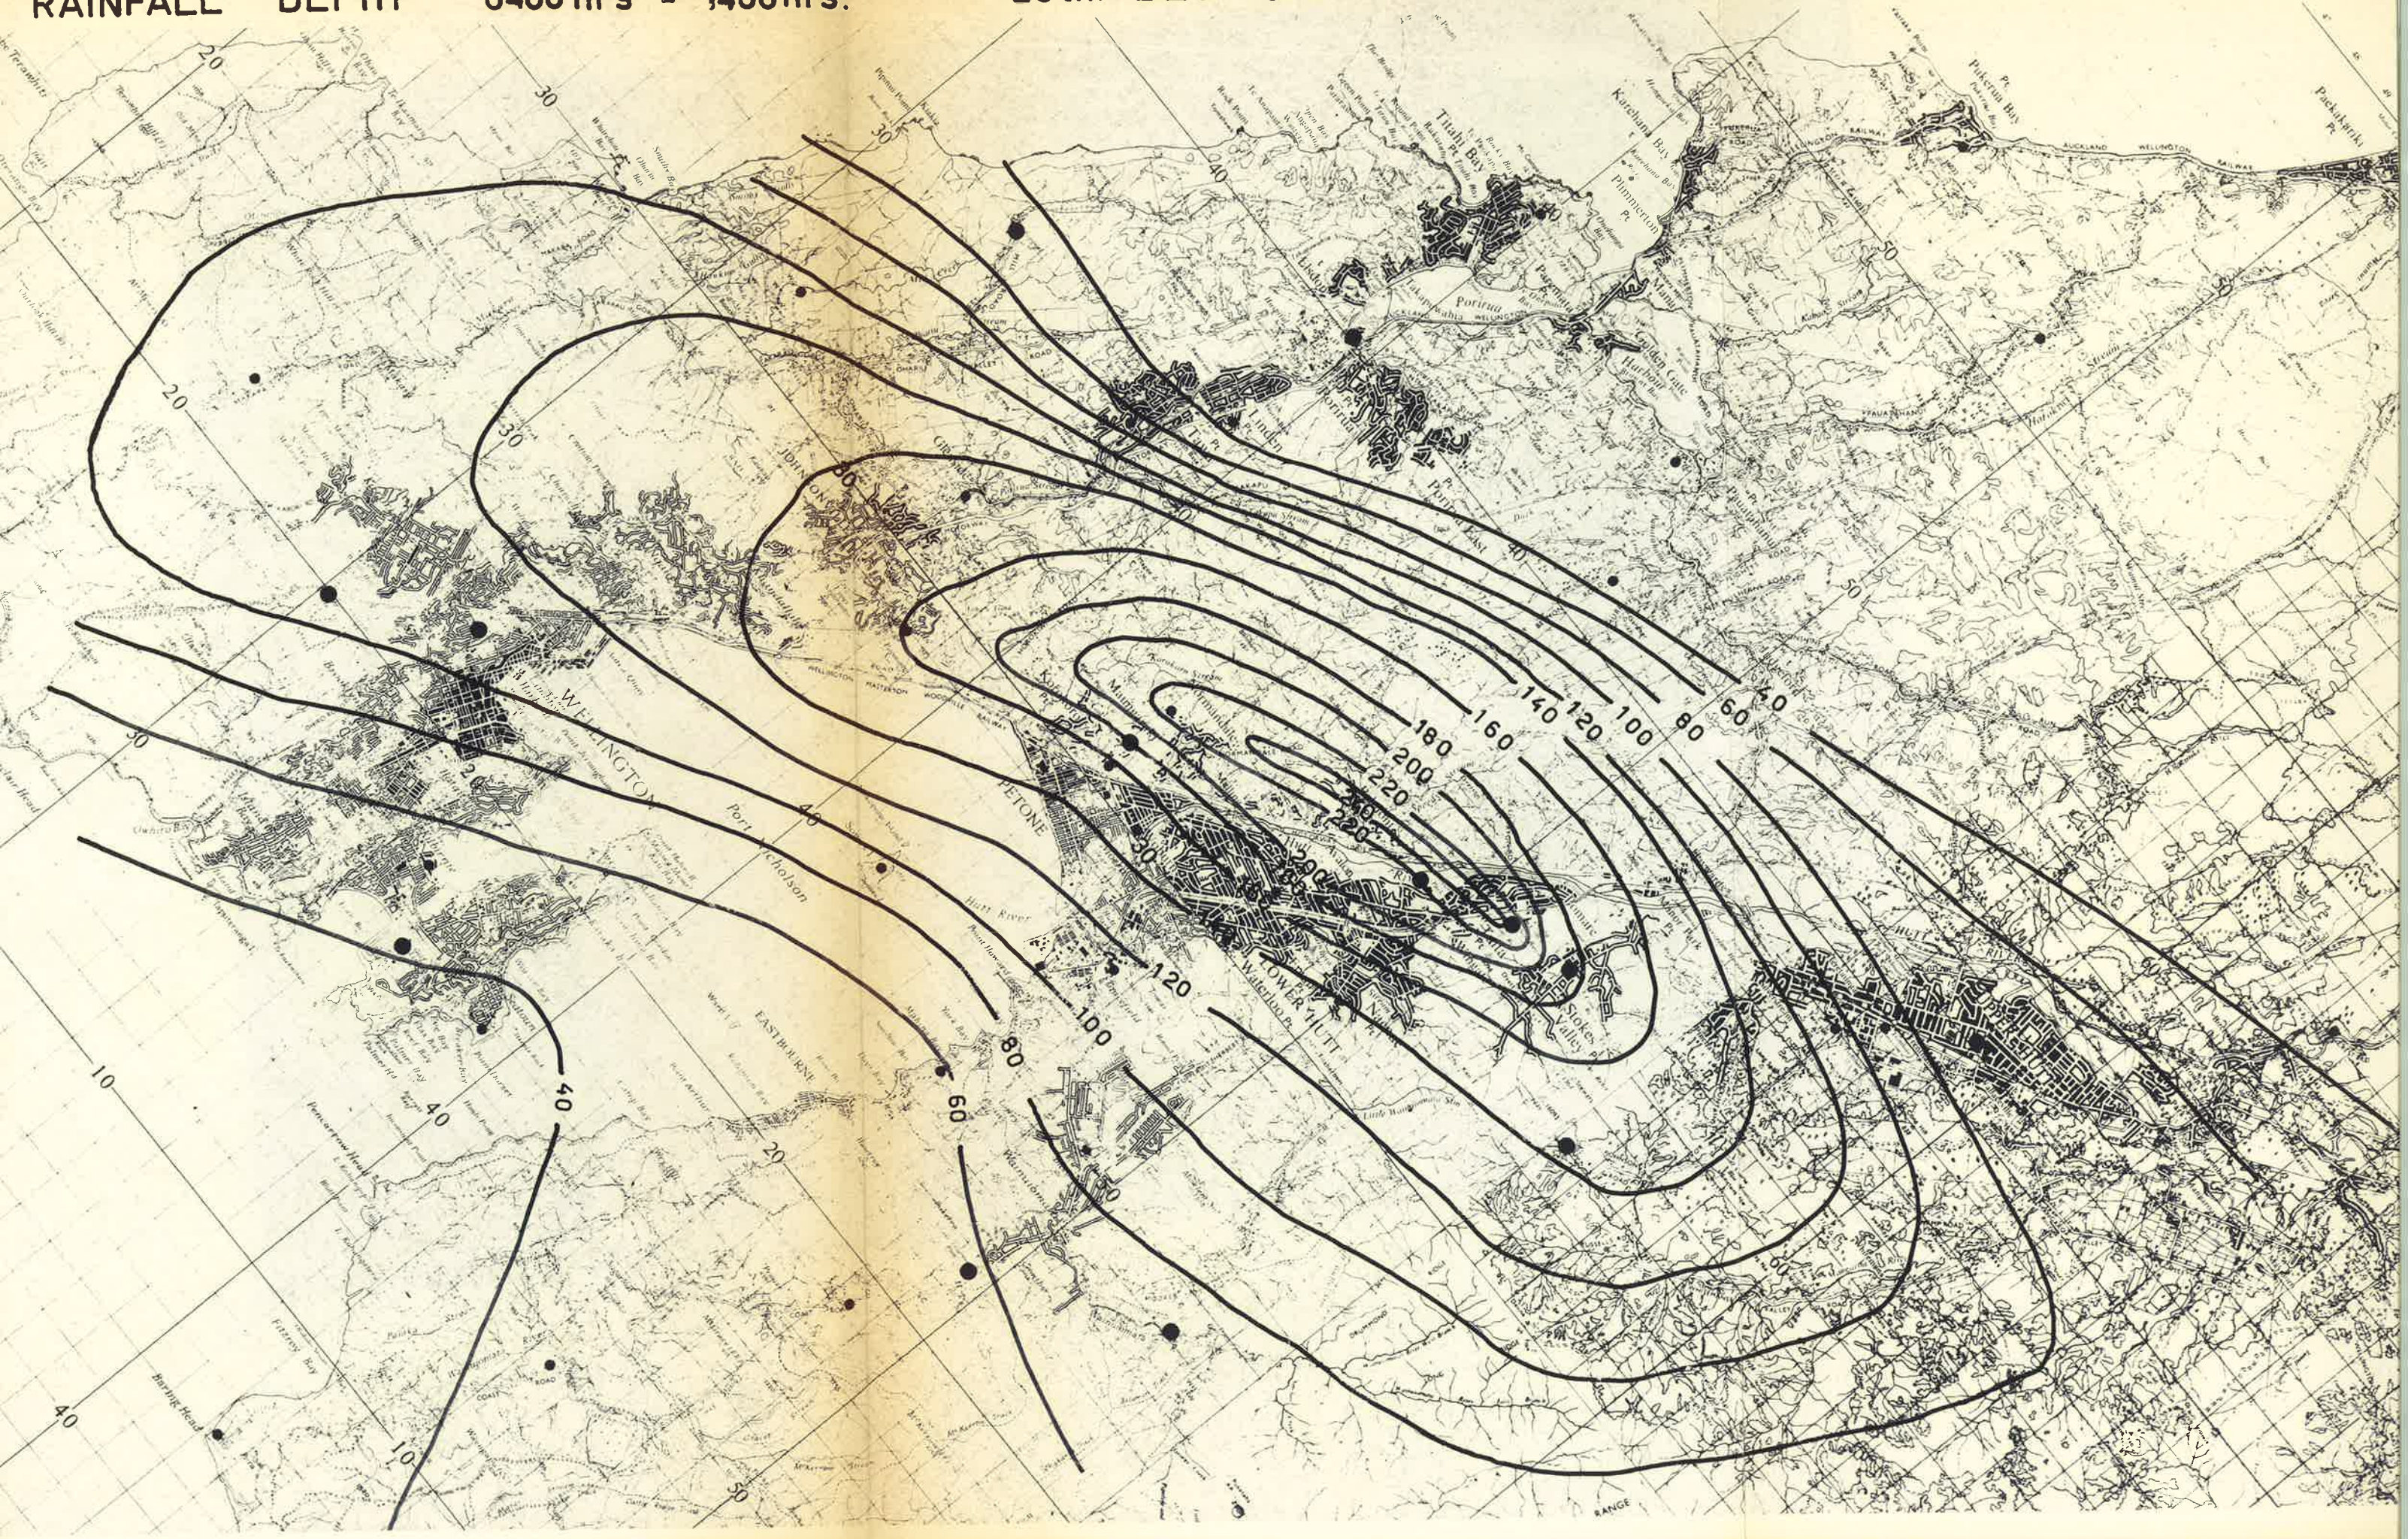
FIG. 2-2-2

Figure 2.2.2 - shows the distribution of accumulated rainfall from the start of the heavy rainfall to 1400 hours. These two five hour periods contained the flood producing rainfall.

RAINFALL DEPTH 0400 hrs - 1400hrs.

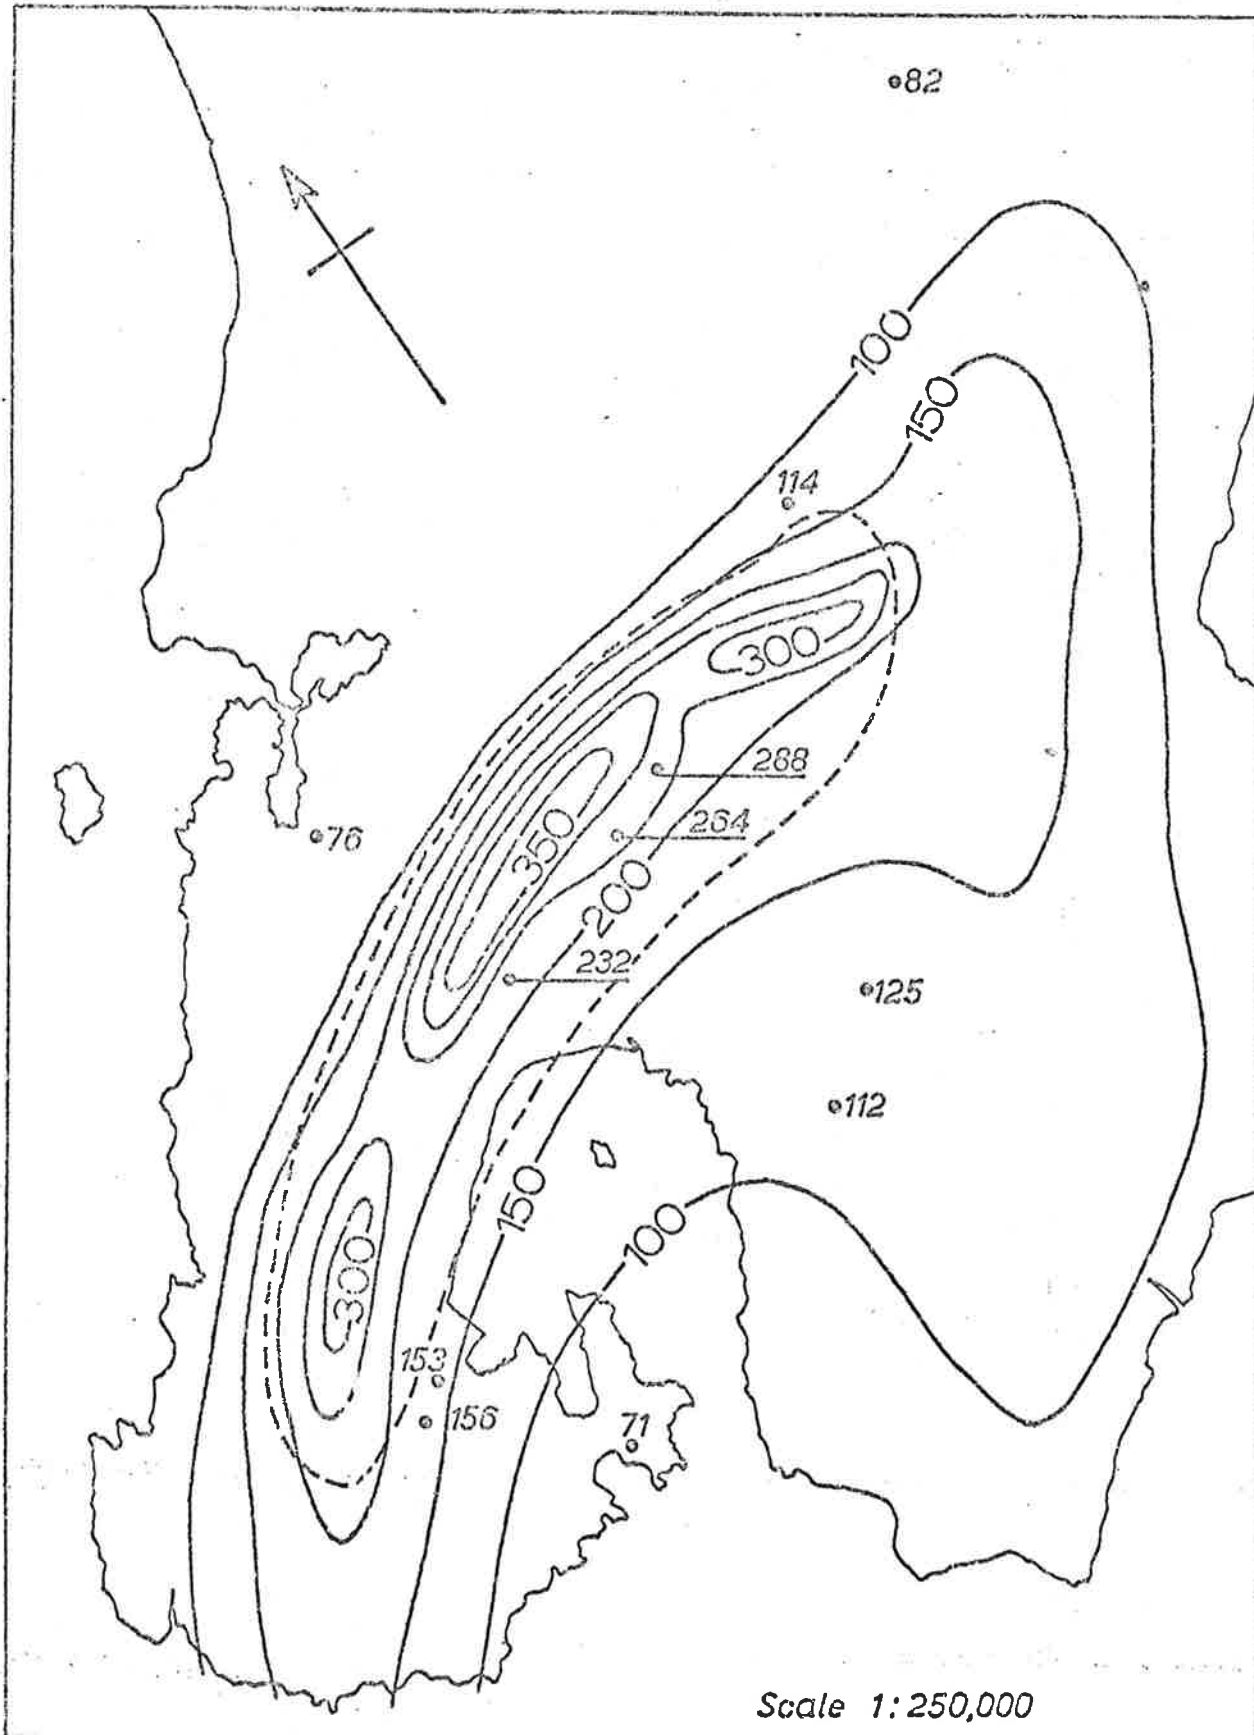
Figure 2.2.4 - shows the maximum rainfall in any 24 hour period during 19 and 20 December 1976.

The maximum rainfall in any 24 hour period during 19 and 20 December 1976. Isohyets are drawn at 50mm intervals from 100mm to 350mm. All points within the dotted line received rainfalls of return period greater than 50 years.

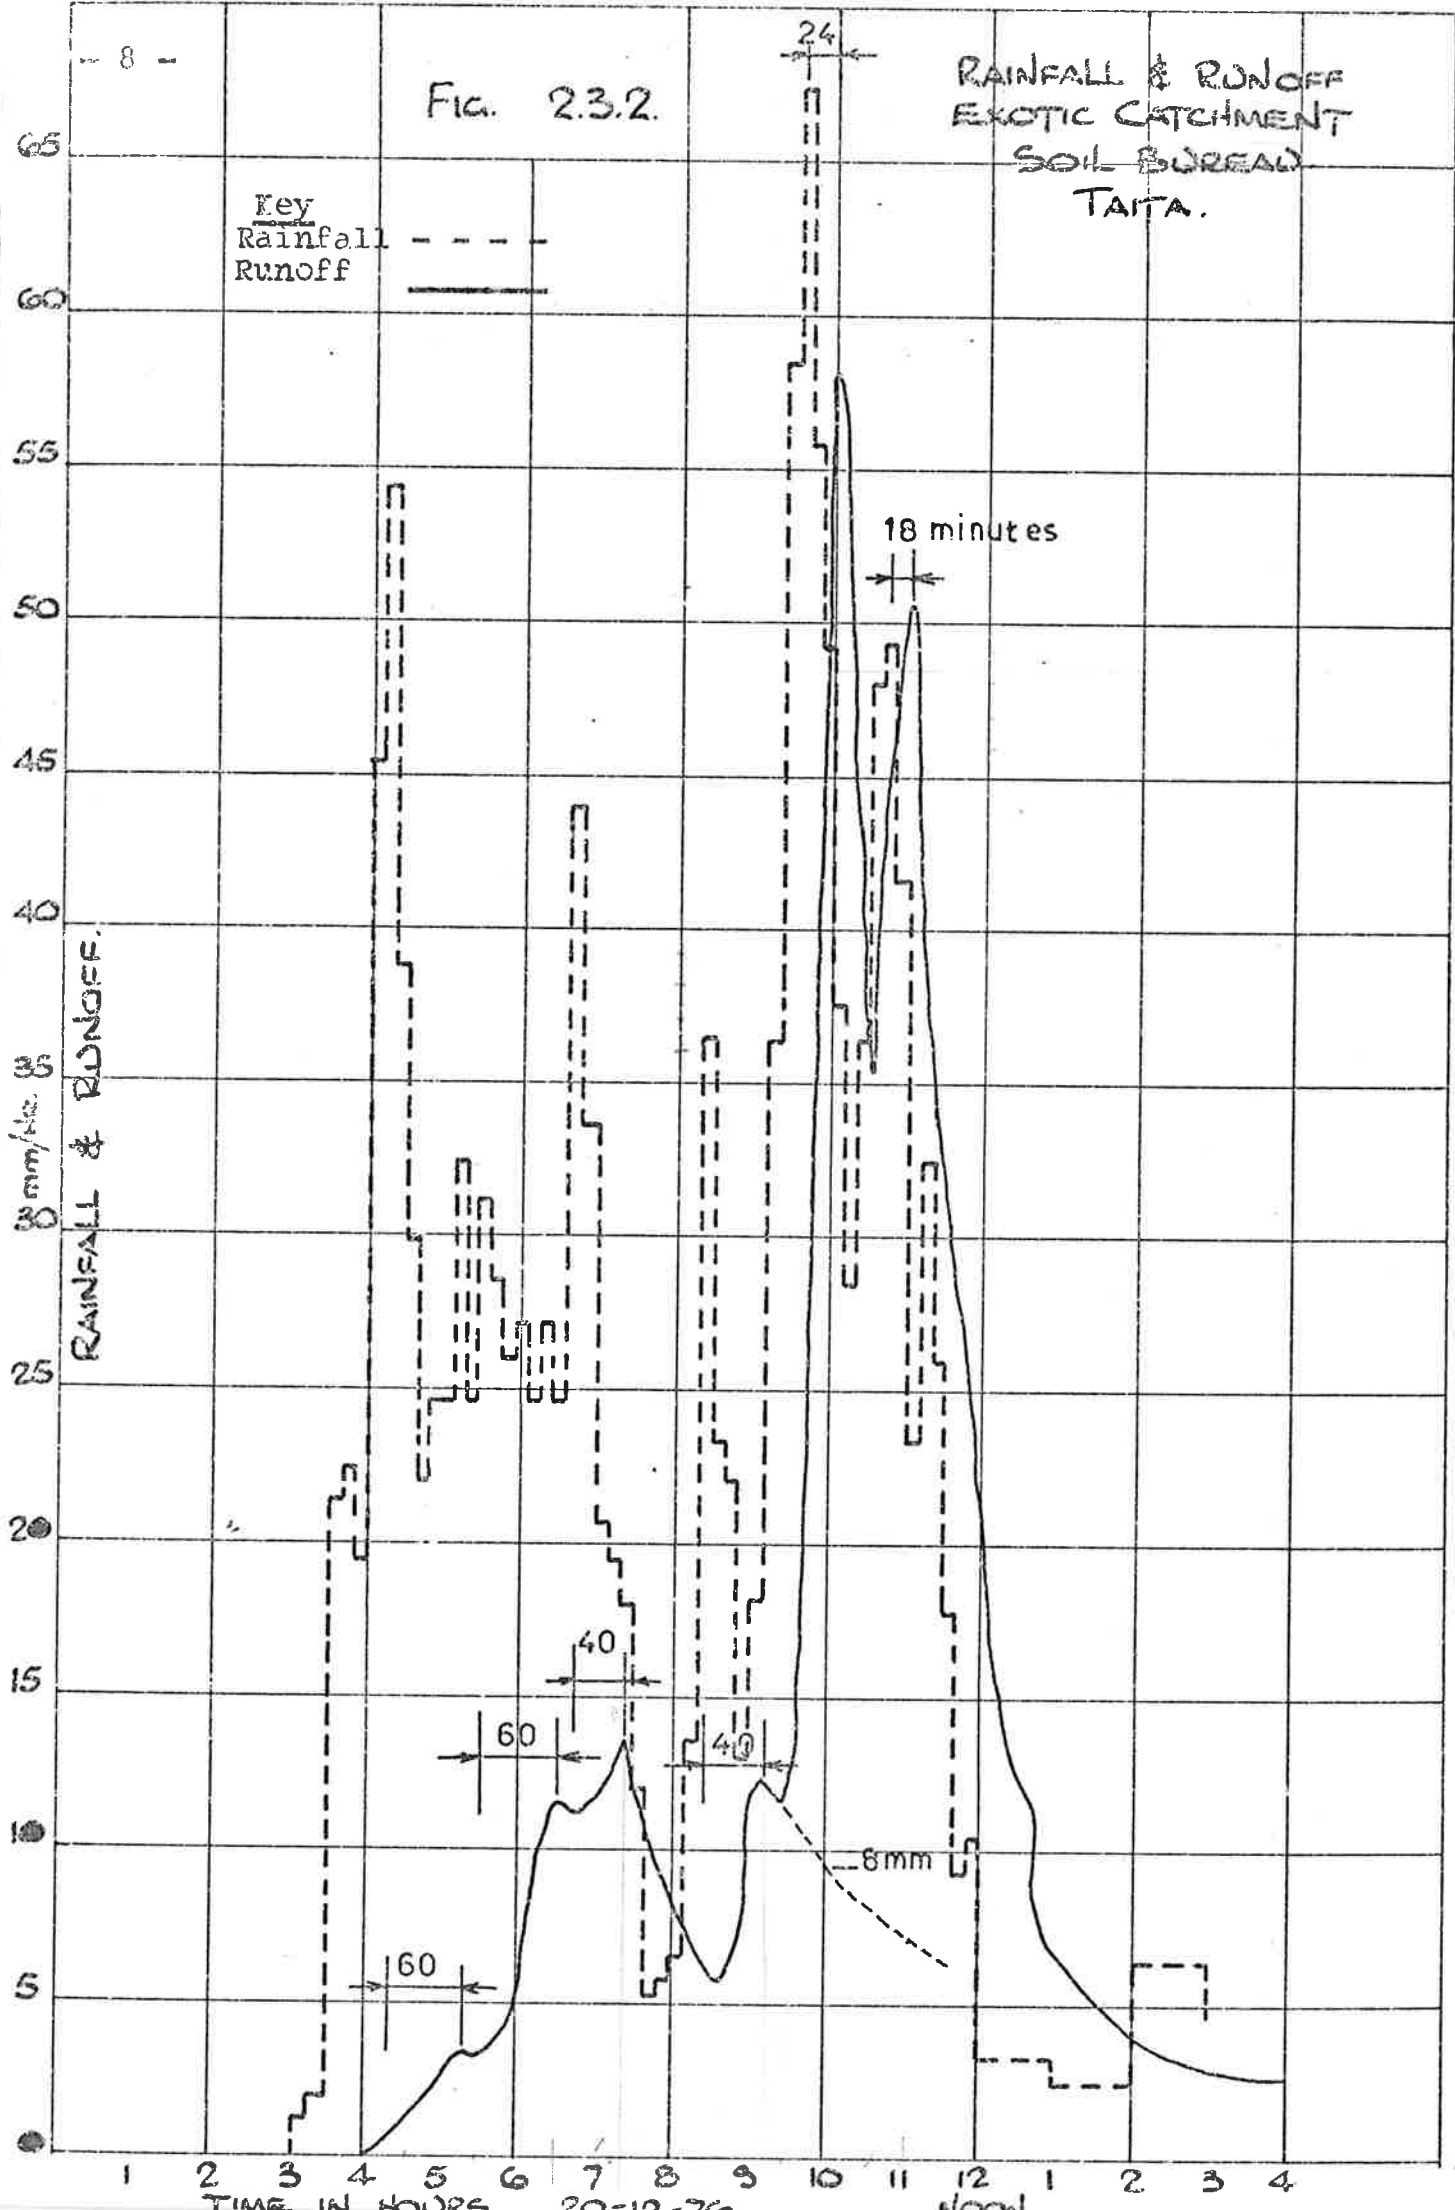
FIG. 2.3.2.

RAINFALL & RUNOFF
EXOTIC CATCHMENT
SOIL BUREAU
TAITA.

A plot of rainfall and corresponding run-off from an experimental catchment at Taita Soil Bureau is shown in Fig. 2.3.2. This is an excellent example of the response of a small catchment to a succession of 'bursts' of heavy rainfall, each having a duration which is significant for the catchment. Although the area is only 4 hectares, larger catchments of a size such as those in the storm affected area will respond similarly. Significant durations will be longer for a larger catchment and intensities lower yielding a lower unit rate of run-off.

There are two major factors affecting peak rates of run-off and both are well illustrated in Fig. 2.3.2. These are firstly, peak rates of rainfall over the significant duration for the catchment and secondly the condition of the catchment at the time of rainfall.

Referring to Fig. 2.3.2 at the onset of heavy rain, a burst of rain at a rate of 54mm/hour occurred. The corresponding catchment run-off peak measured 3mm/hour. A rainfall rate of 44mm/hour occurred at about 7.00 a.m. and this produced a 13mm/hour run-off, a four-fold increase in peak run-off for a lesser rate of rainfall. At this stage, only about 25 per cent of the rainfall had appeared as run-off. After further rain, a burst of almost 70mm/hour occurred and with allowance for some run-off from previous rainfall, say, 8mm/hour, the corresponding peak run-off was 50mm/hour. This represents a peak run-off to rainfall ratio of 0.7 or 70 per cent run-off coefficient. Run-off from the second rainfall period is almost 90 per cent of the total rainfall.

Also illustrated in Fig. 2.3.2 is the reduction in the response time between rainfall burst and run-off peak as the rain continues. This response time is an approximation to the significant duration. Hence the run-off coefficient differs considerably for a 'wet' or 'dry' catchment as does the significant duration.

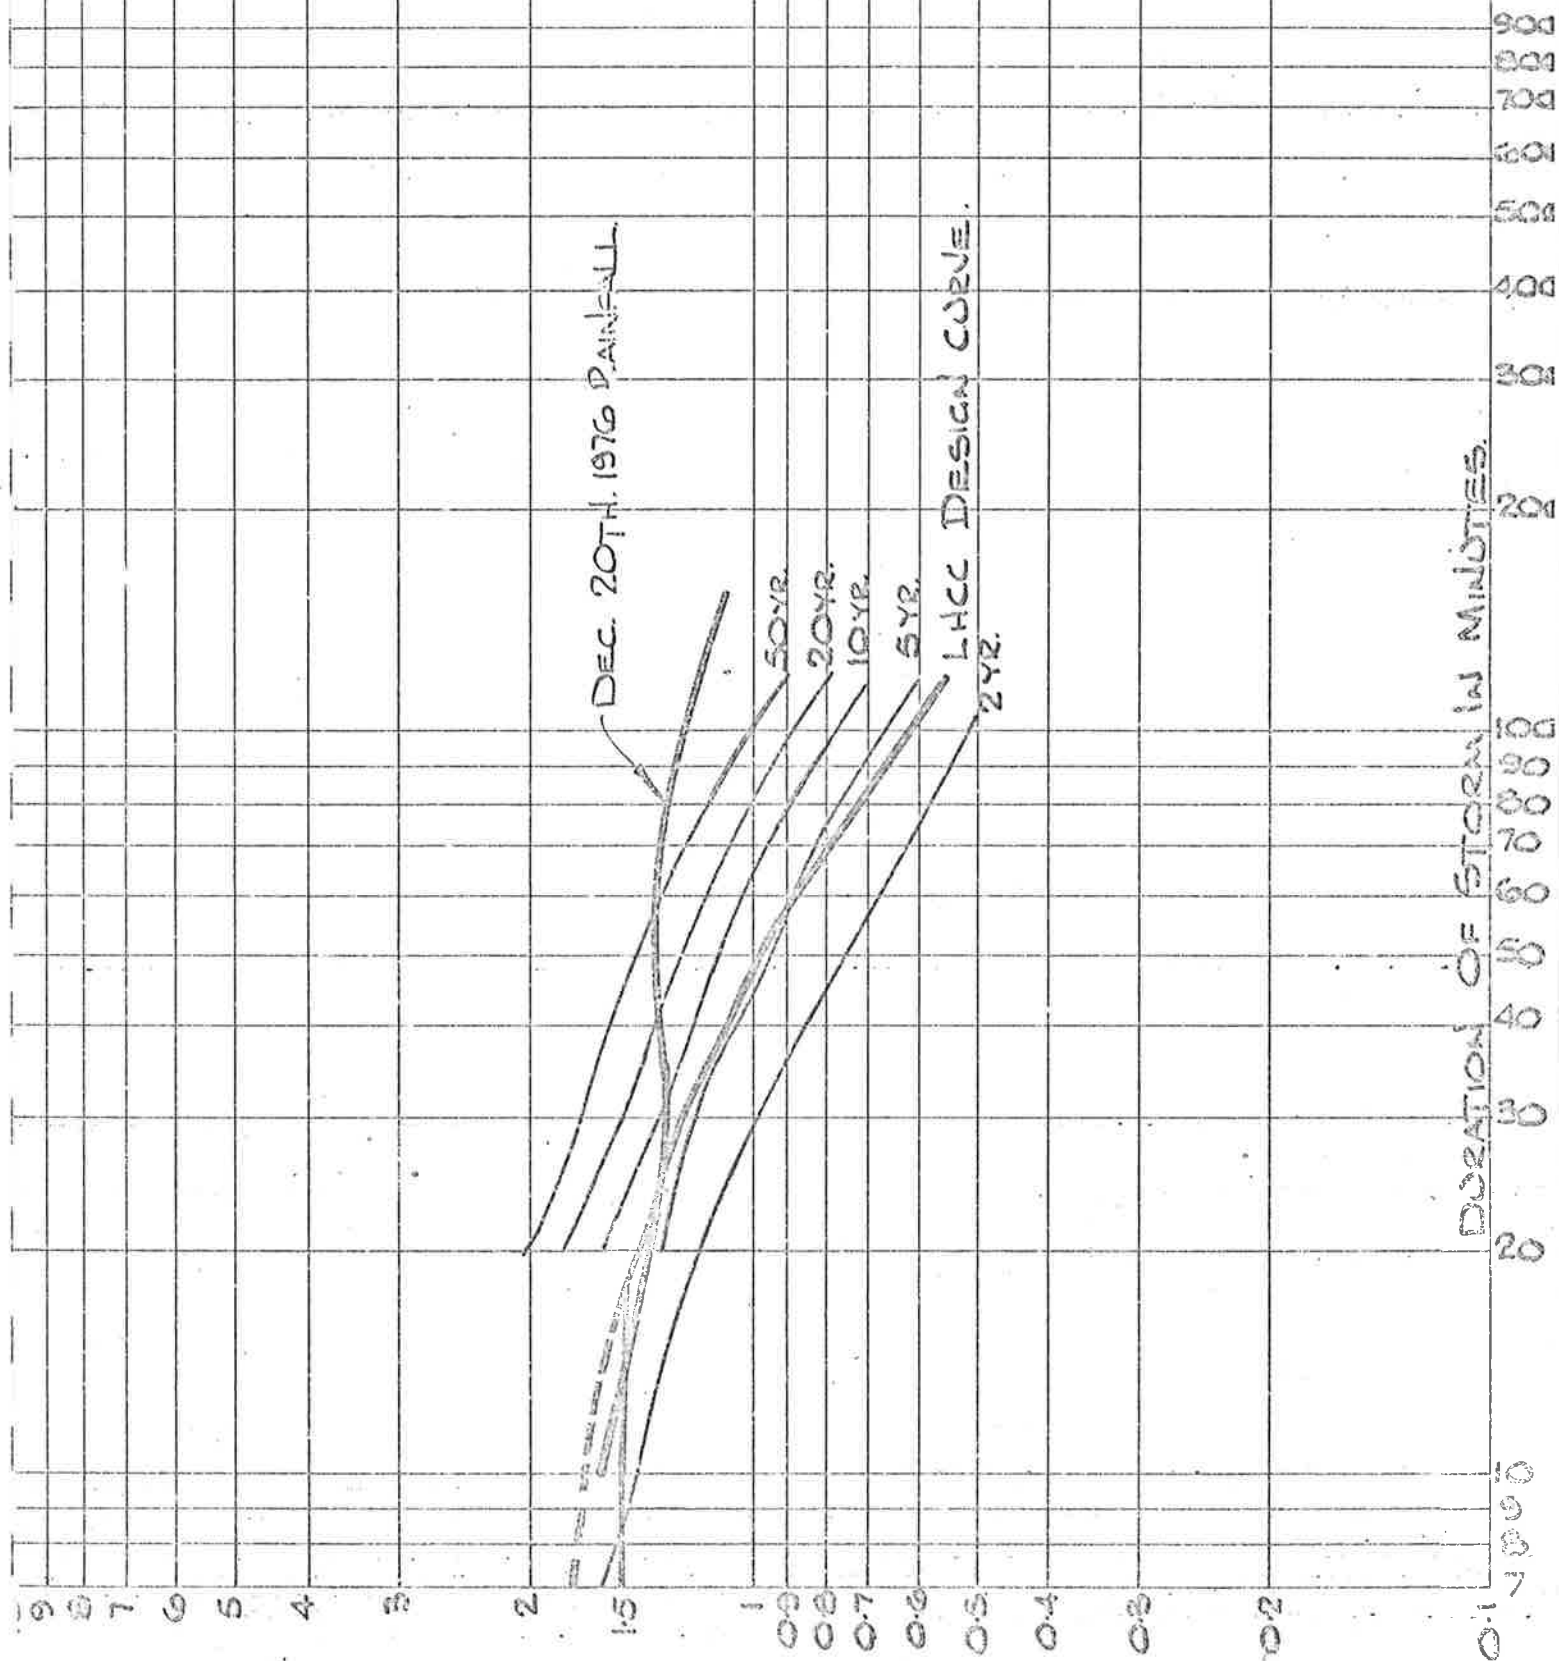
FIG. 2.3.4.

A common basis for design is to estimate the significant duration for the catchment concerned, select for this duration the rainfall intensity for the chosen return period and combine this with a run-off coefficient. The run-off coefficient is selected rather arbitrarily as an 'average' value, and is generally not varied with different return periods. The Wellington City Council design rainfall curve with run-off coefficient table, see Fig. 2.3.3, is an example of this design procedure. The Lower Hutt City Council design rainfall curve is also shown in Fig. 2.3.4.

HUTT VALLEY RAINFALL INTENSITIES.

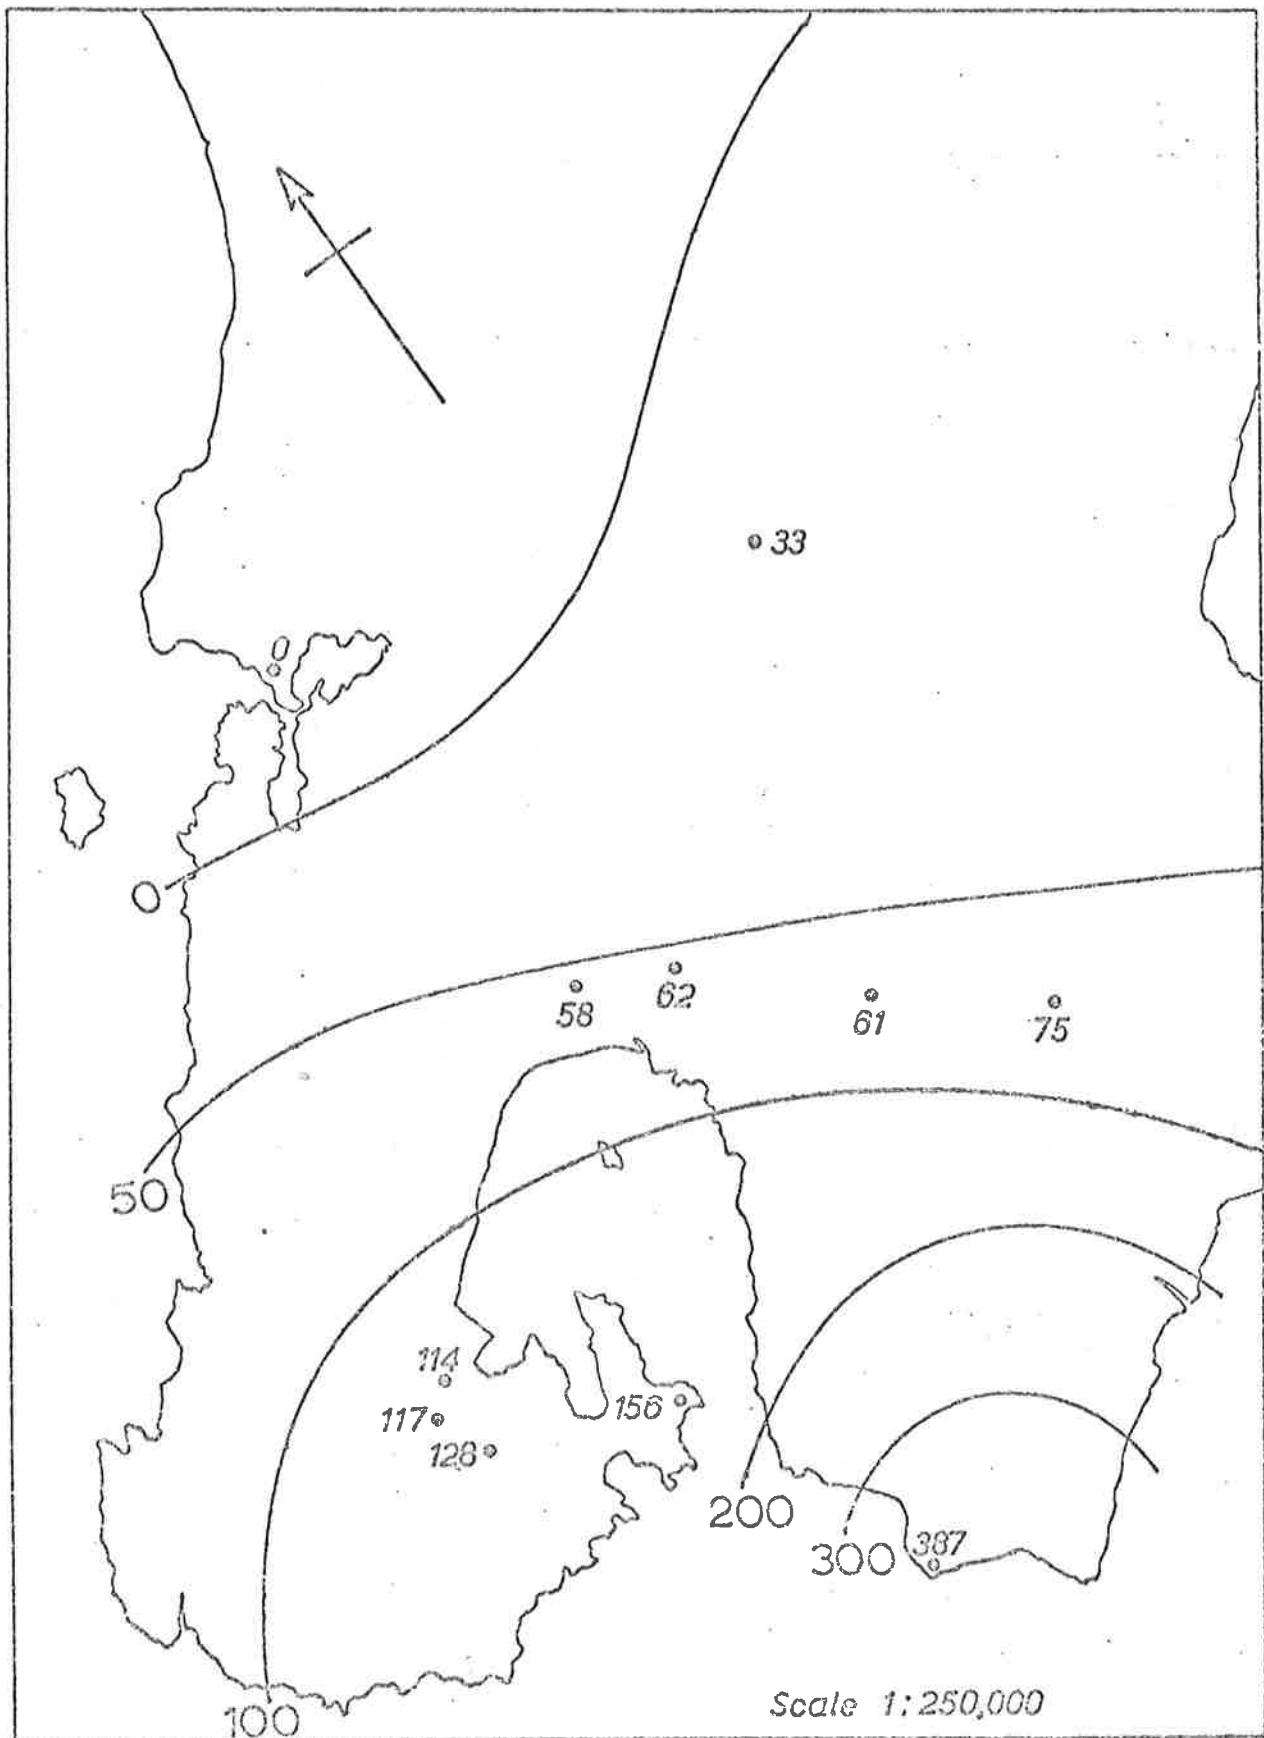
Figure 2.4.1

The rainfall recorded between 0900 hours on 26.12.1939 and 0900 hours on 27.12.1939. Since there are relatively few observations the isoyets (drawn at 0.50mm, 100mm, 200mm and 300mm) must be interpreted as very approximate.

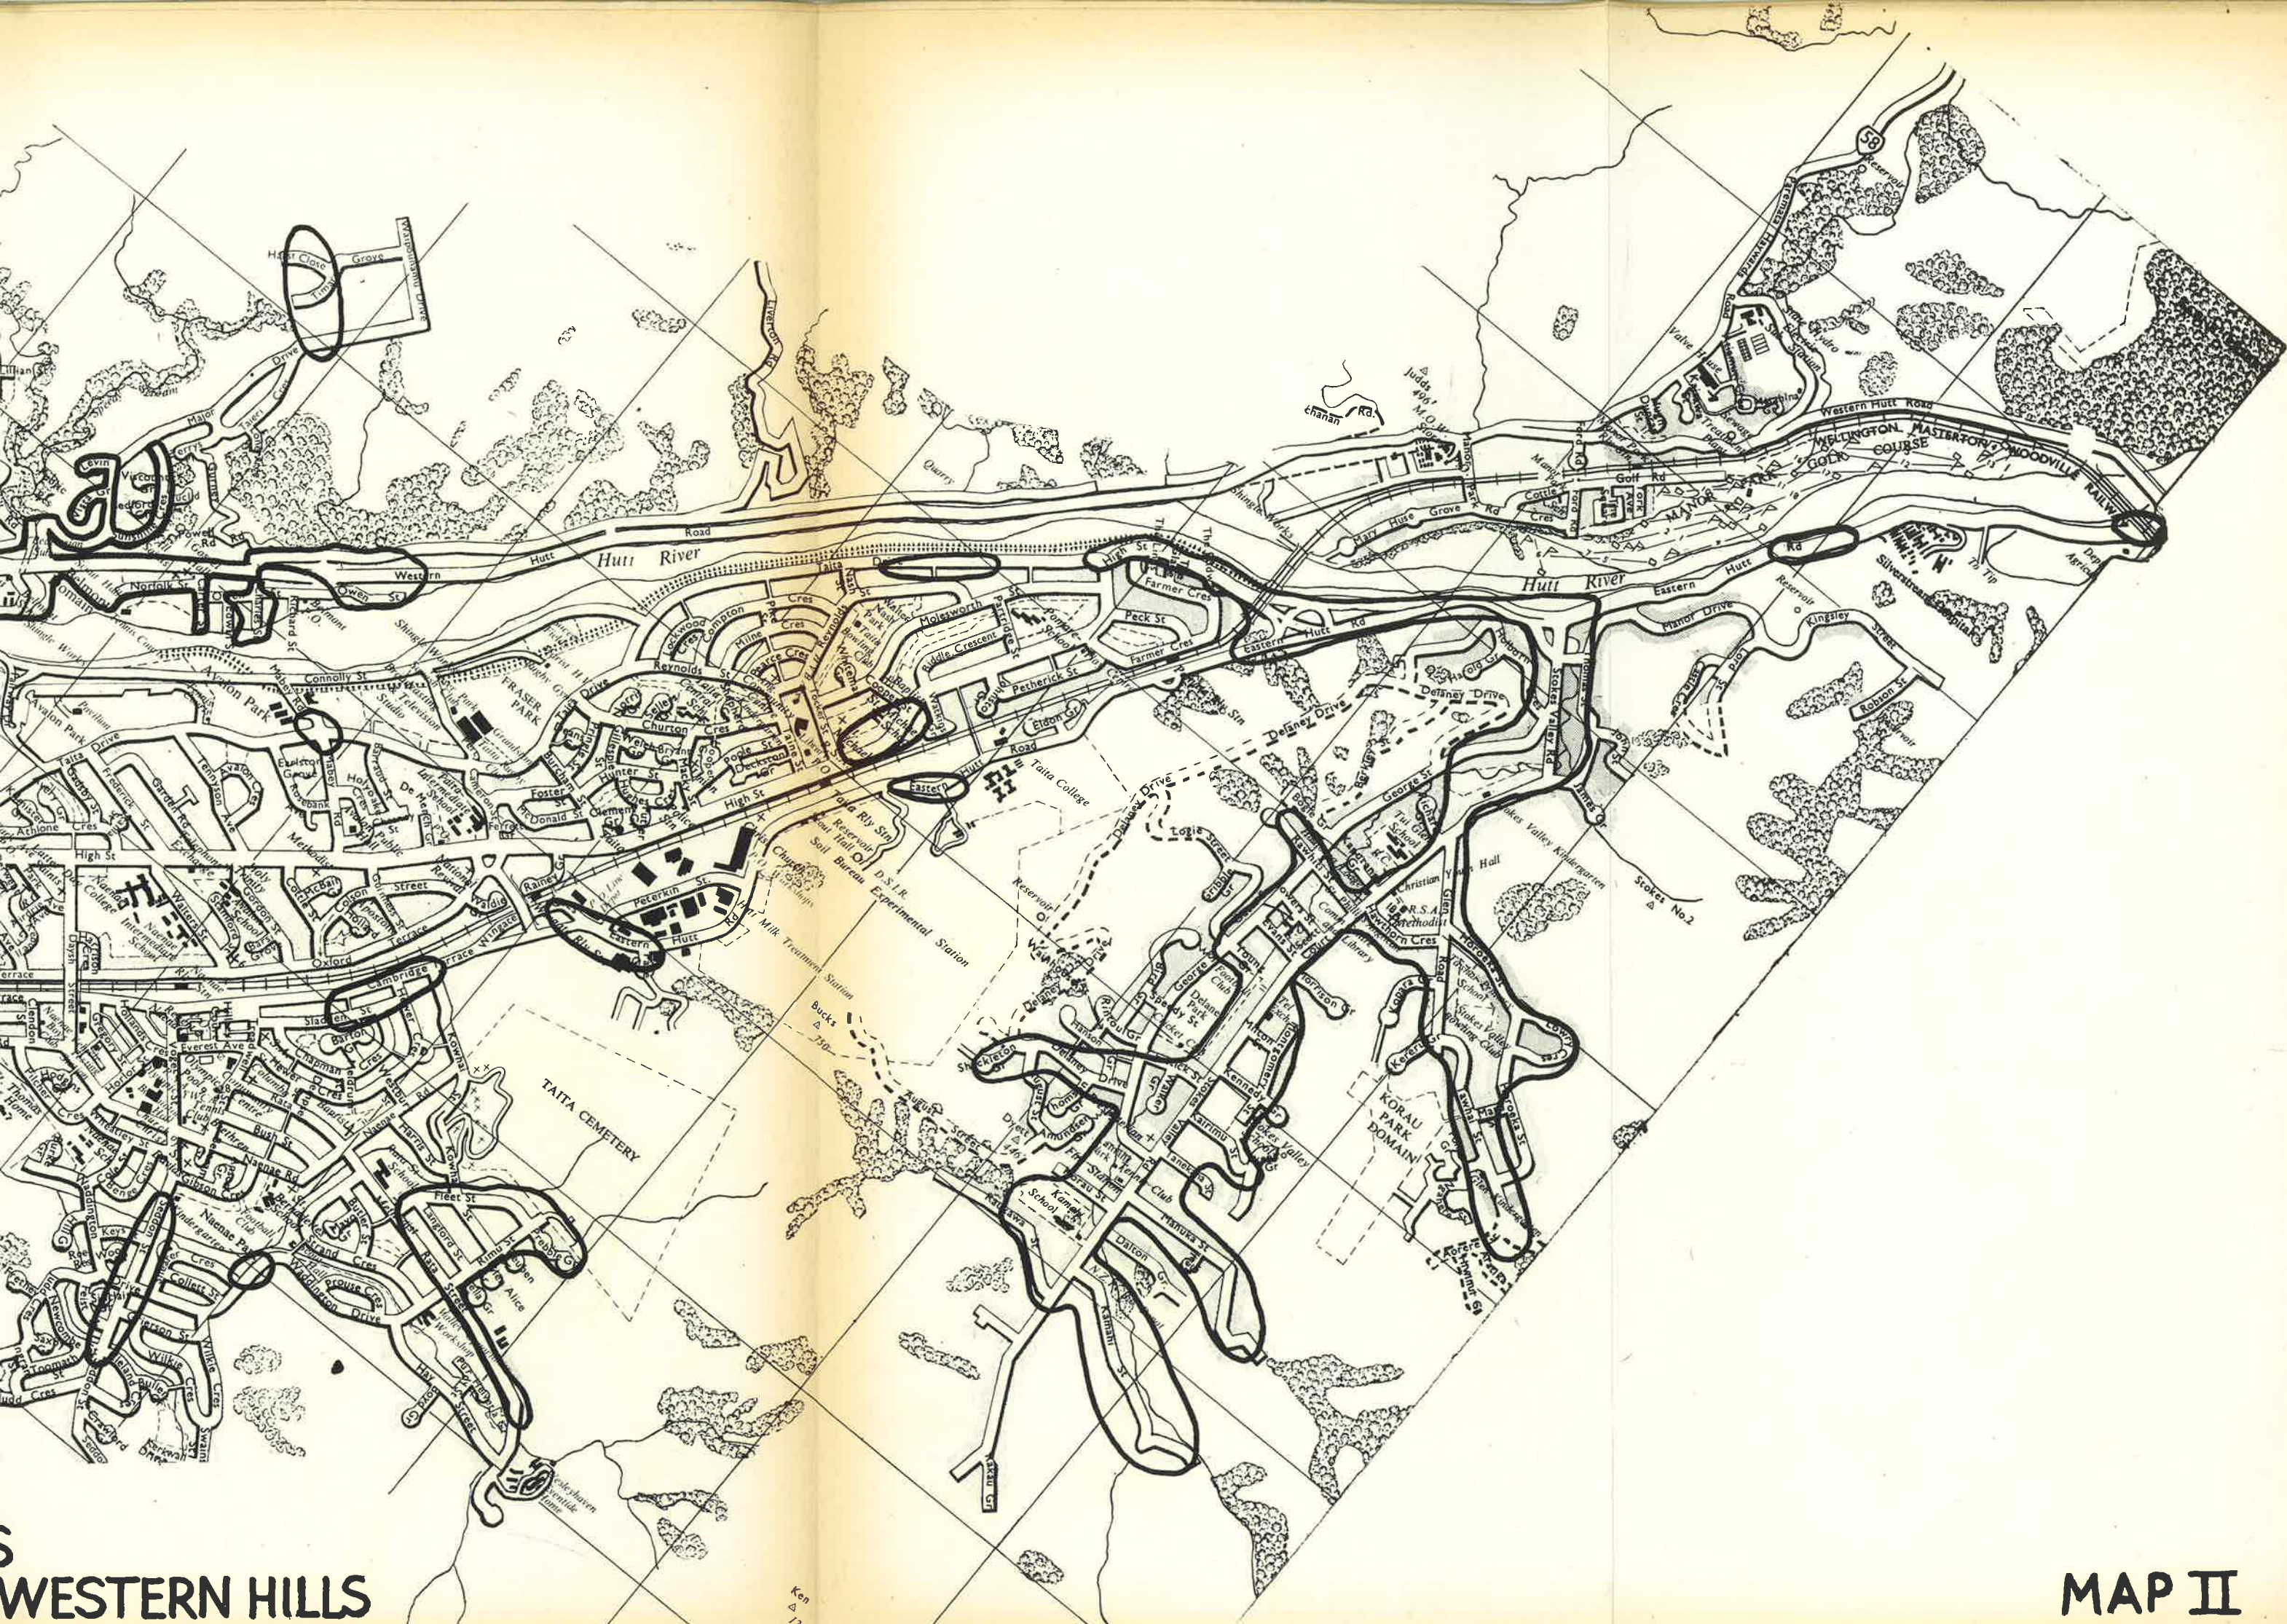
Plan showing
FLOODED AREAS
LOWER HUTT, STOKES VALLEY & WEST
