**MARLBOROUGH
CATCHMENT
BOARD**

REPORT
on the
10th JULY 1983
FLOOD

SEPTEMBER 1983

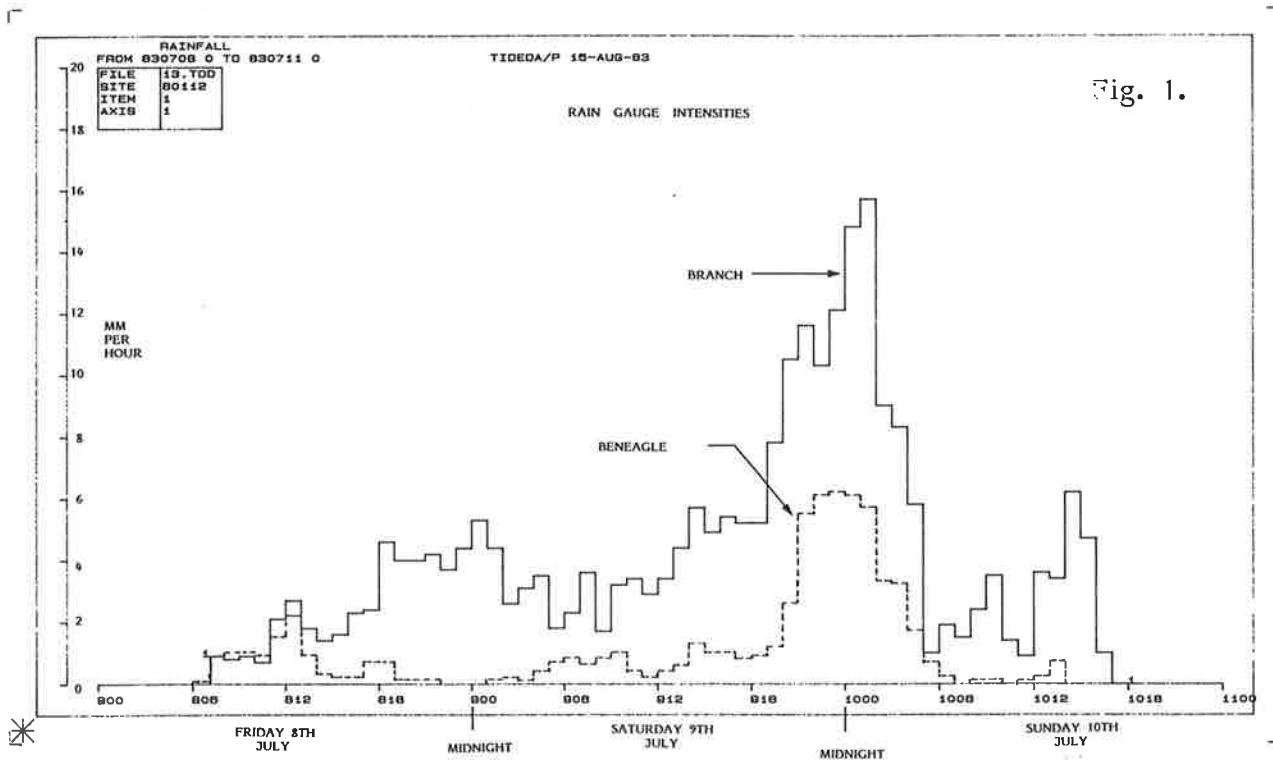
Fig. 1.

Over most of the Marlborough-Nelson-West Coast areas, the rainfall over three days was not exceptional. At the Cobb and at the Waihopai, return periods were between 10-20 years, yet at Wairau Valley were about 50 years. In many places, including Blenheim and the Rai Valley, return periods for the three days were between 2 and 5 years. However, most rain in Marlborough fell over a 48 hour period. More importantly, there was a build up of intensity on Saturday evening culminating in some extreme rain for a short period early on Sunday morning. This is best illustrated by the following rainfall intensity chart which shows the rain at the Branch recorder and at the Beneagle in the Taylor Catchment.

These higher intensities must have a relatively rare return period, but further study is needed to complete this part of the flood assessment.

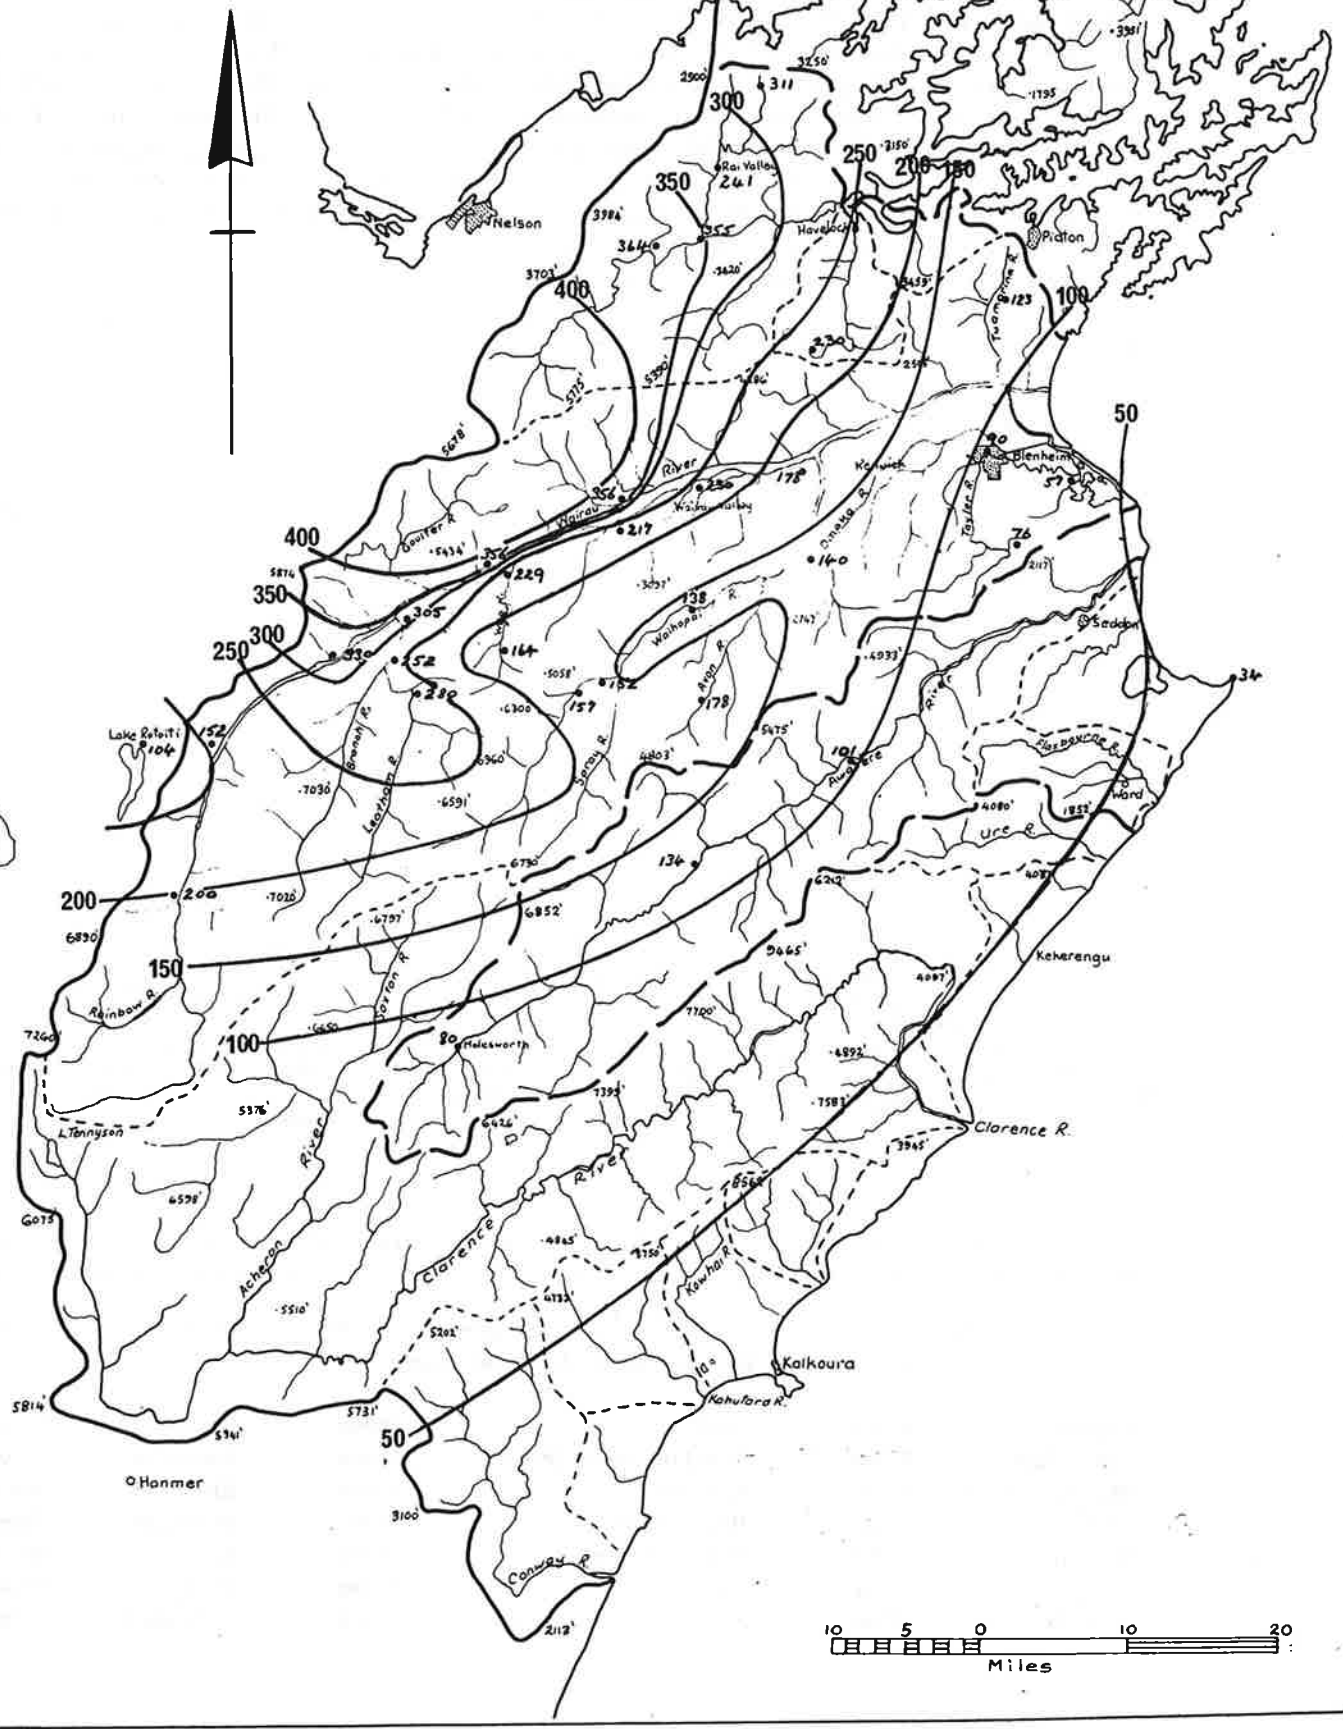
8 - 10 JULY 1983

Rainfall contours (isohyets) are shown on figure 2 for the full rain period. The following are falls over the same period at selected places:

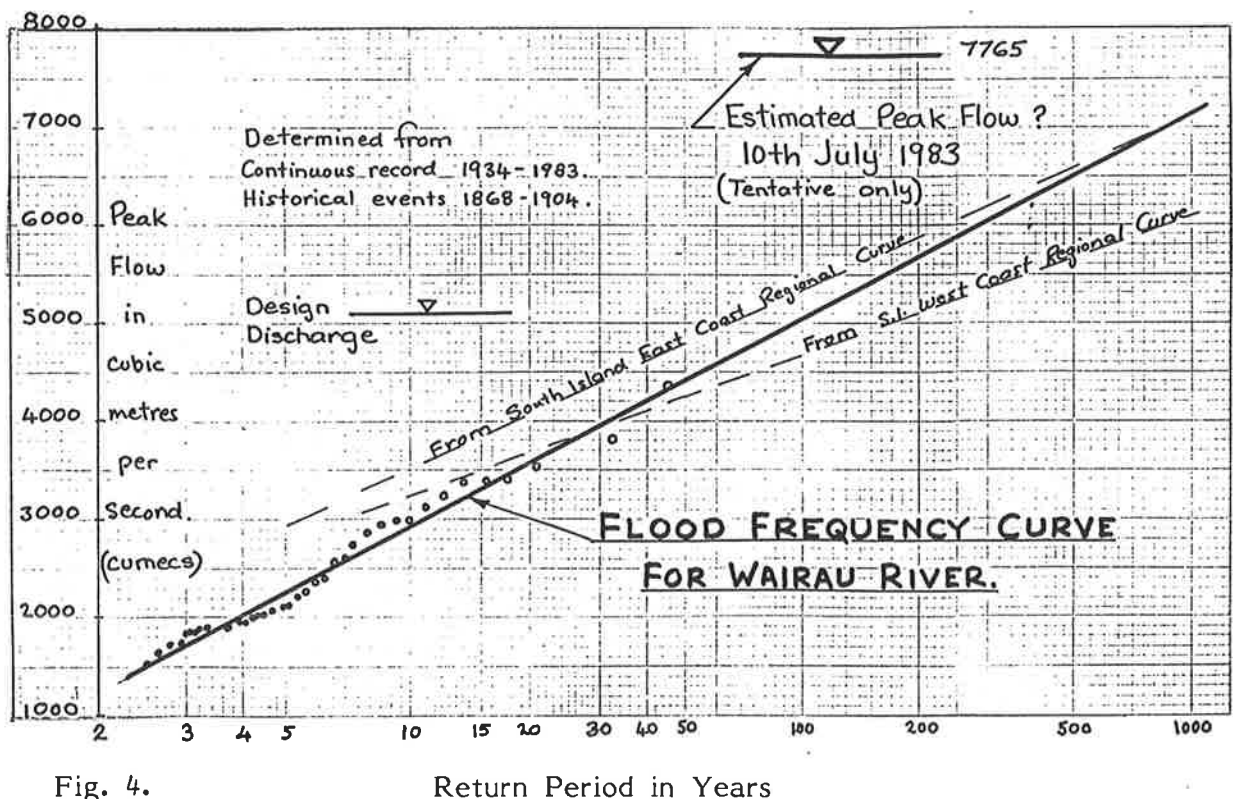
Fig. 4.

Detailed flood records for the Wairau River have been kept for nearly 50 years, and there is a reasonable historic record of major flood events for over 100 years. Only the 1868 flood defies reasonable estimation of its size. By New Zealand standards, this is a good length of record. These records have been rigorously examined and have been compared with estimations from the Regional Flood Frequency Procedures (NWASCO publication No. 57). The Wairau Catchment lies partly in both the South Island West Coast and East Coast regions. The frequency curves are shown on Fig.4.

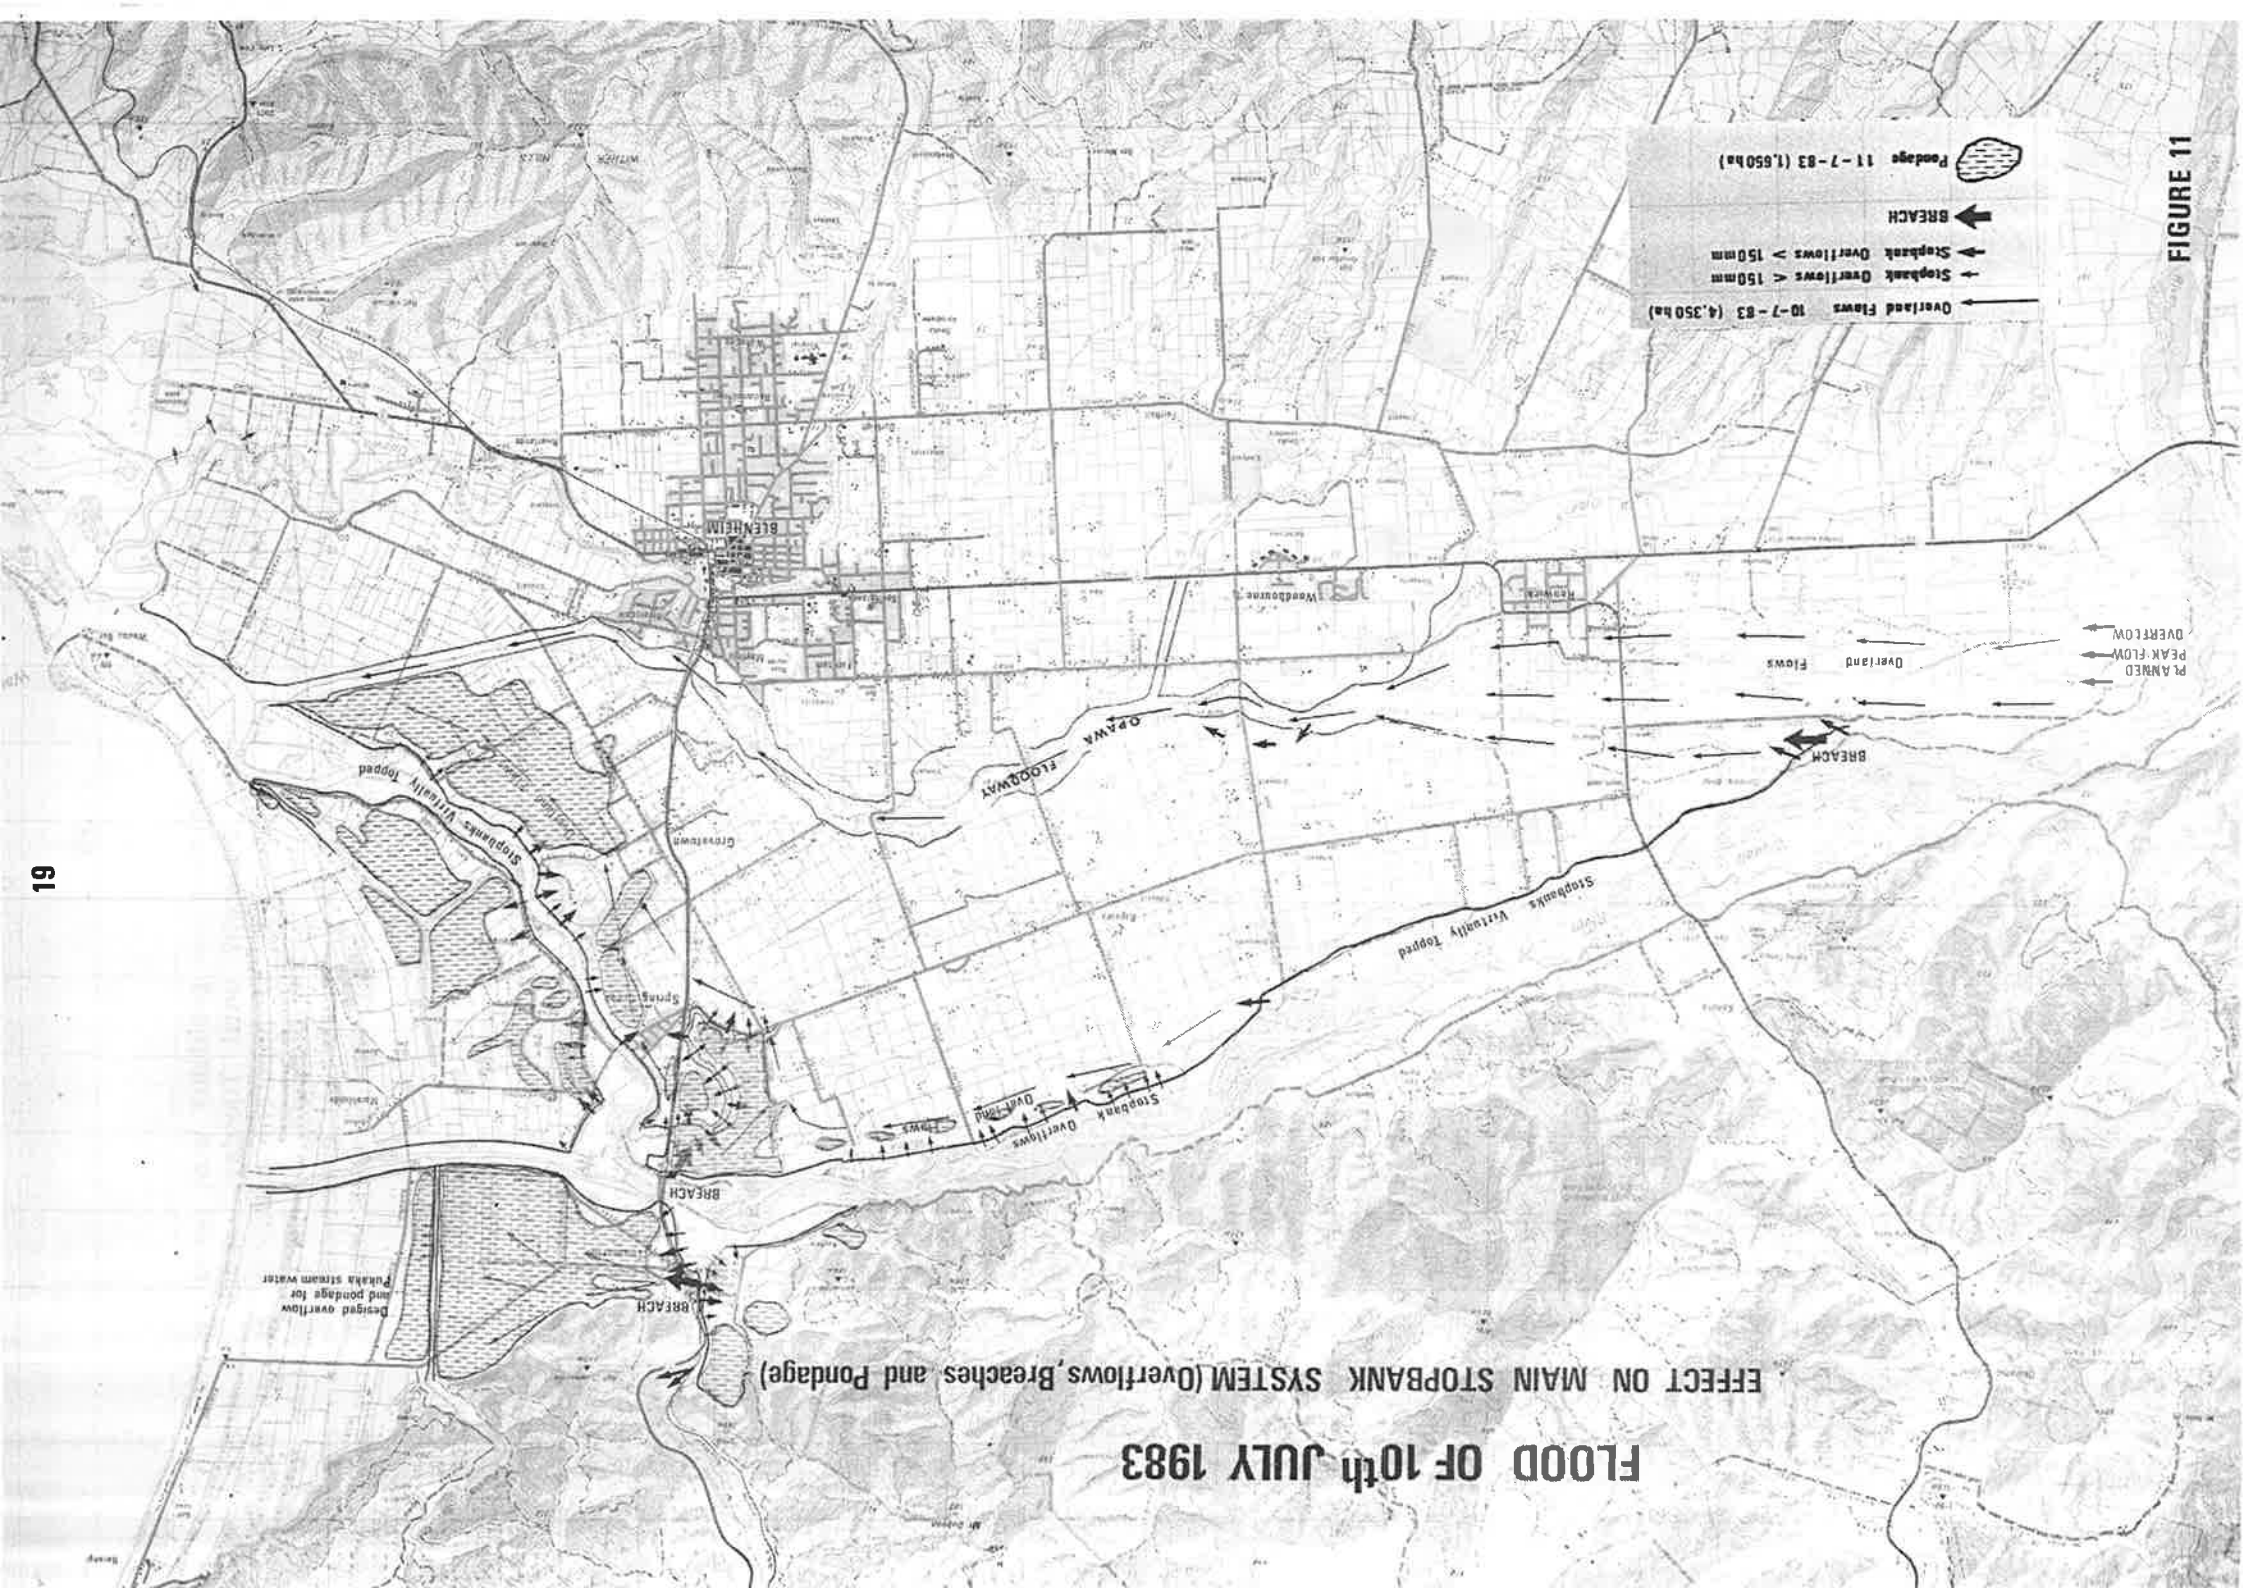
FIGURE 11

Overland Flows 10-7-83 (4,350 ha)

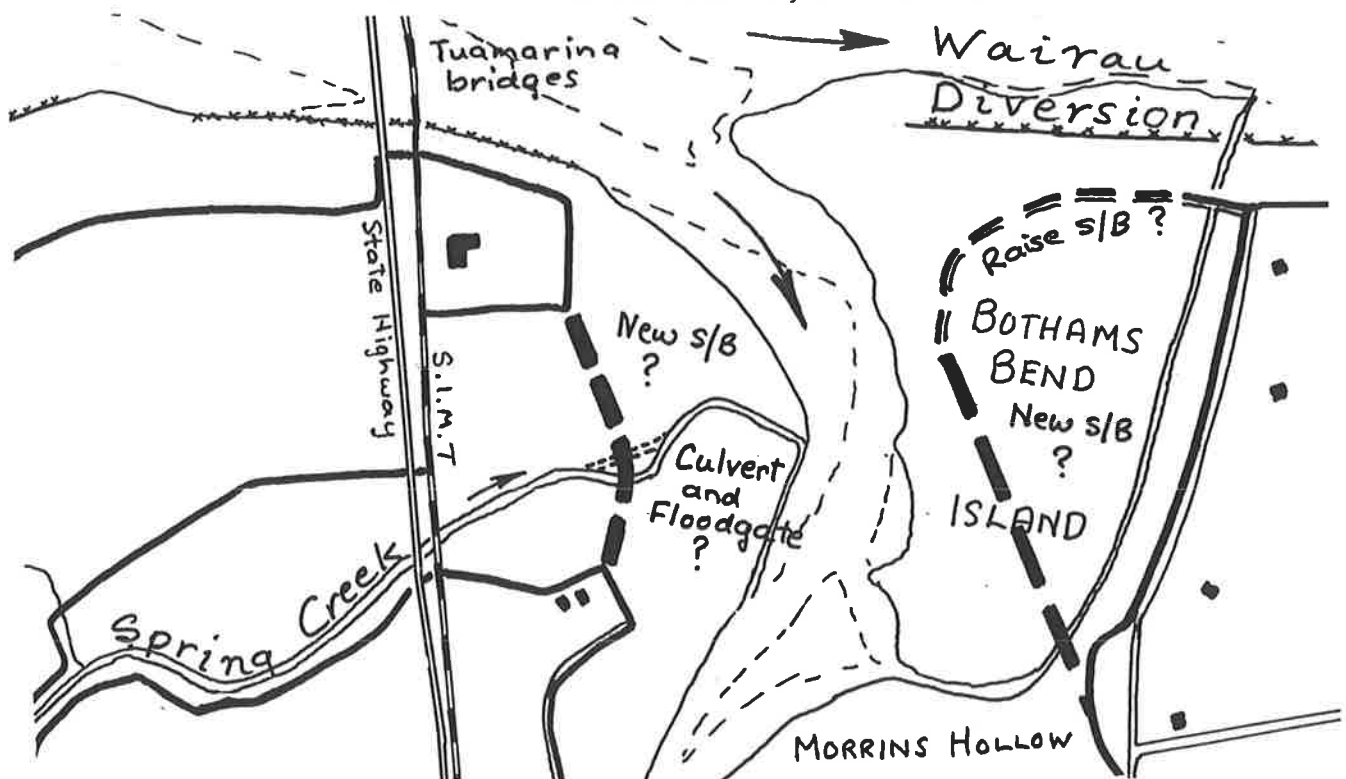
- b) To stopbank off the Spring Creek floodway from the Wairau River by building a 480 m long stopbank between the Peninsular stopbank and the stopbank around the Block Factory and Gills Gravel Plant. Two 1830 mm (6 ft) diameter floodgated culverts would be needed to exclude Wairau floodwater, and there is adequate storage to hold normal Spring Creek flows in the stopbanked area upstream of the culvert. Because of the culvert and floodgates the cost of this proposal is estimated at \$150 000.. (See Figure 2).

At this stage, it seems appropriate to consider the stopbanking off of part of the Island by raising and extending the existing low stopbank on the south of the Diversion across the old channel to join up with the main stopbank at the top of Morrins Hollow at Aberharts. Before this is done, some study is required to ensure that there would be no detrimental effects. See Fig. 2.

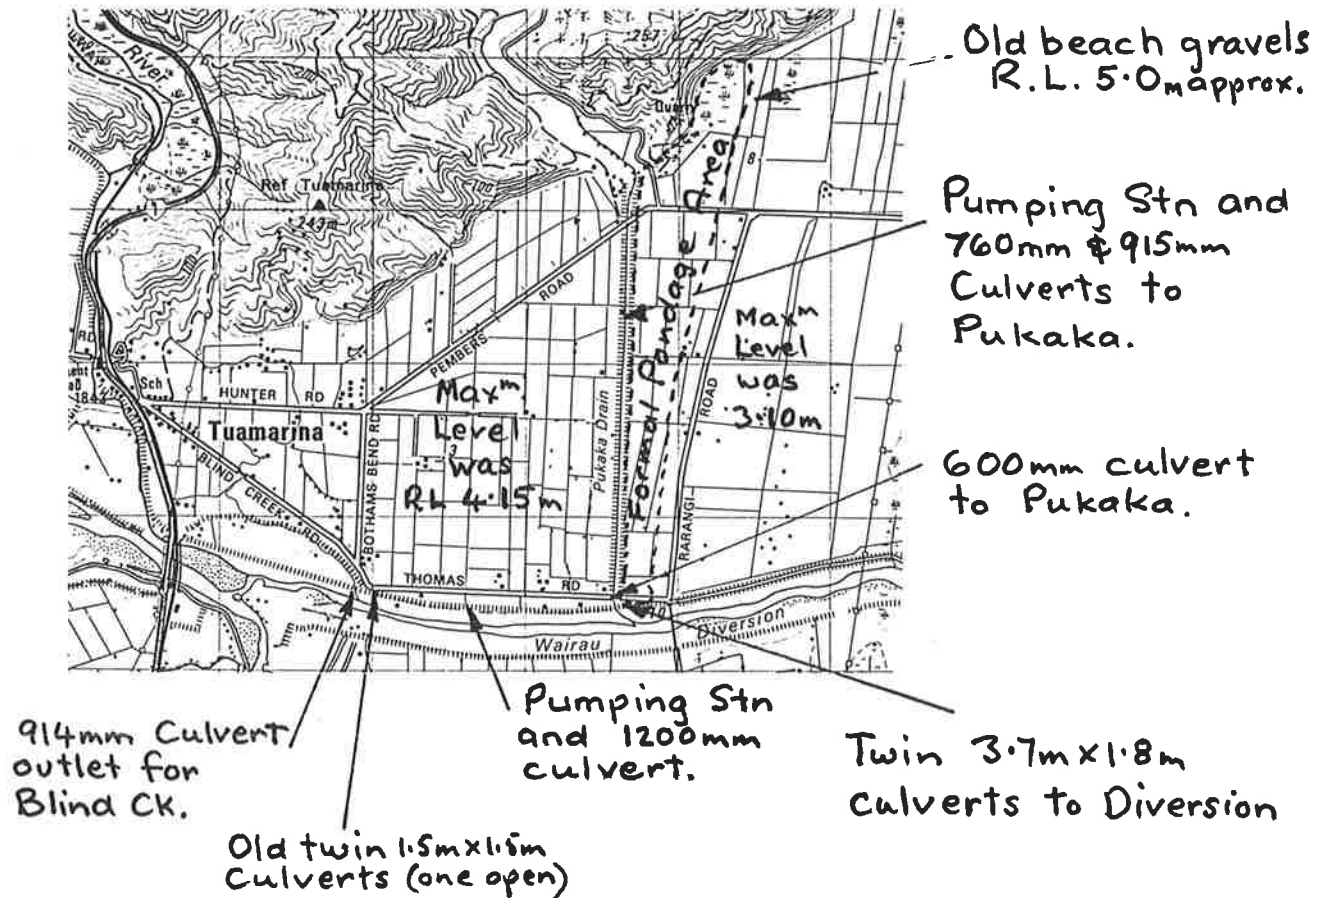
Fig. 4.

While possibilities for improving outfalls from the Pembers Road-Thomas Road area have been suggested, there are none that will significantly change the ponded level of flood overflows. The only practical means of doing this is to make improvements to the stopbanking system. Proposals to do this have been recommended, and can be done very quickly. This lessens the threat of ponding from Wairau overflows which even now is statistically a rare event. Some improvements can be made to the outfall system which as the Diversion develops will become of greater advantage for the normal drainage of the area during major rainstorms. Obviously, closer study and discussion is needed before the Board will be able to make a decision about whether to improve the outfalls, and if so, to what extent.
