FRESHWATER FISHERIES ADVISORY SERVICE

INVESTIGATION REPORT

JOB NO. 30

TITLE OF JOB: An Investigation of Taylors and Bowyers Streams.

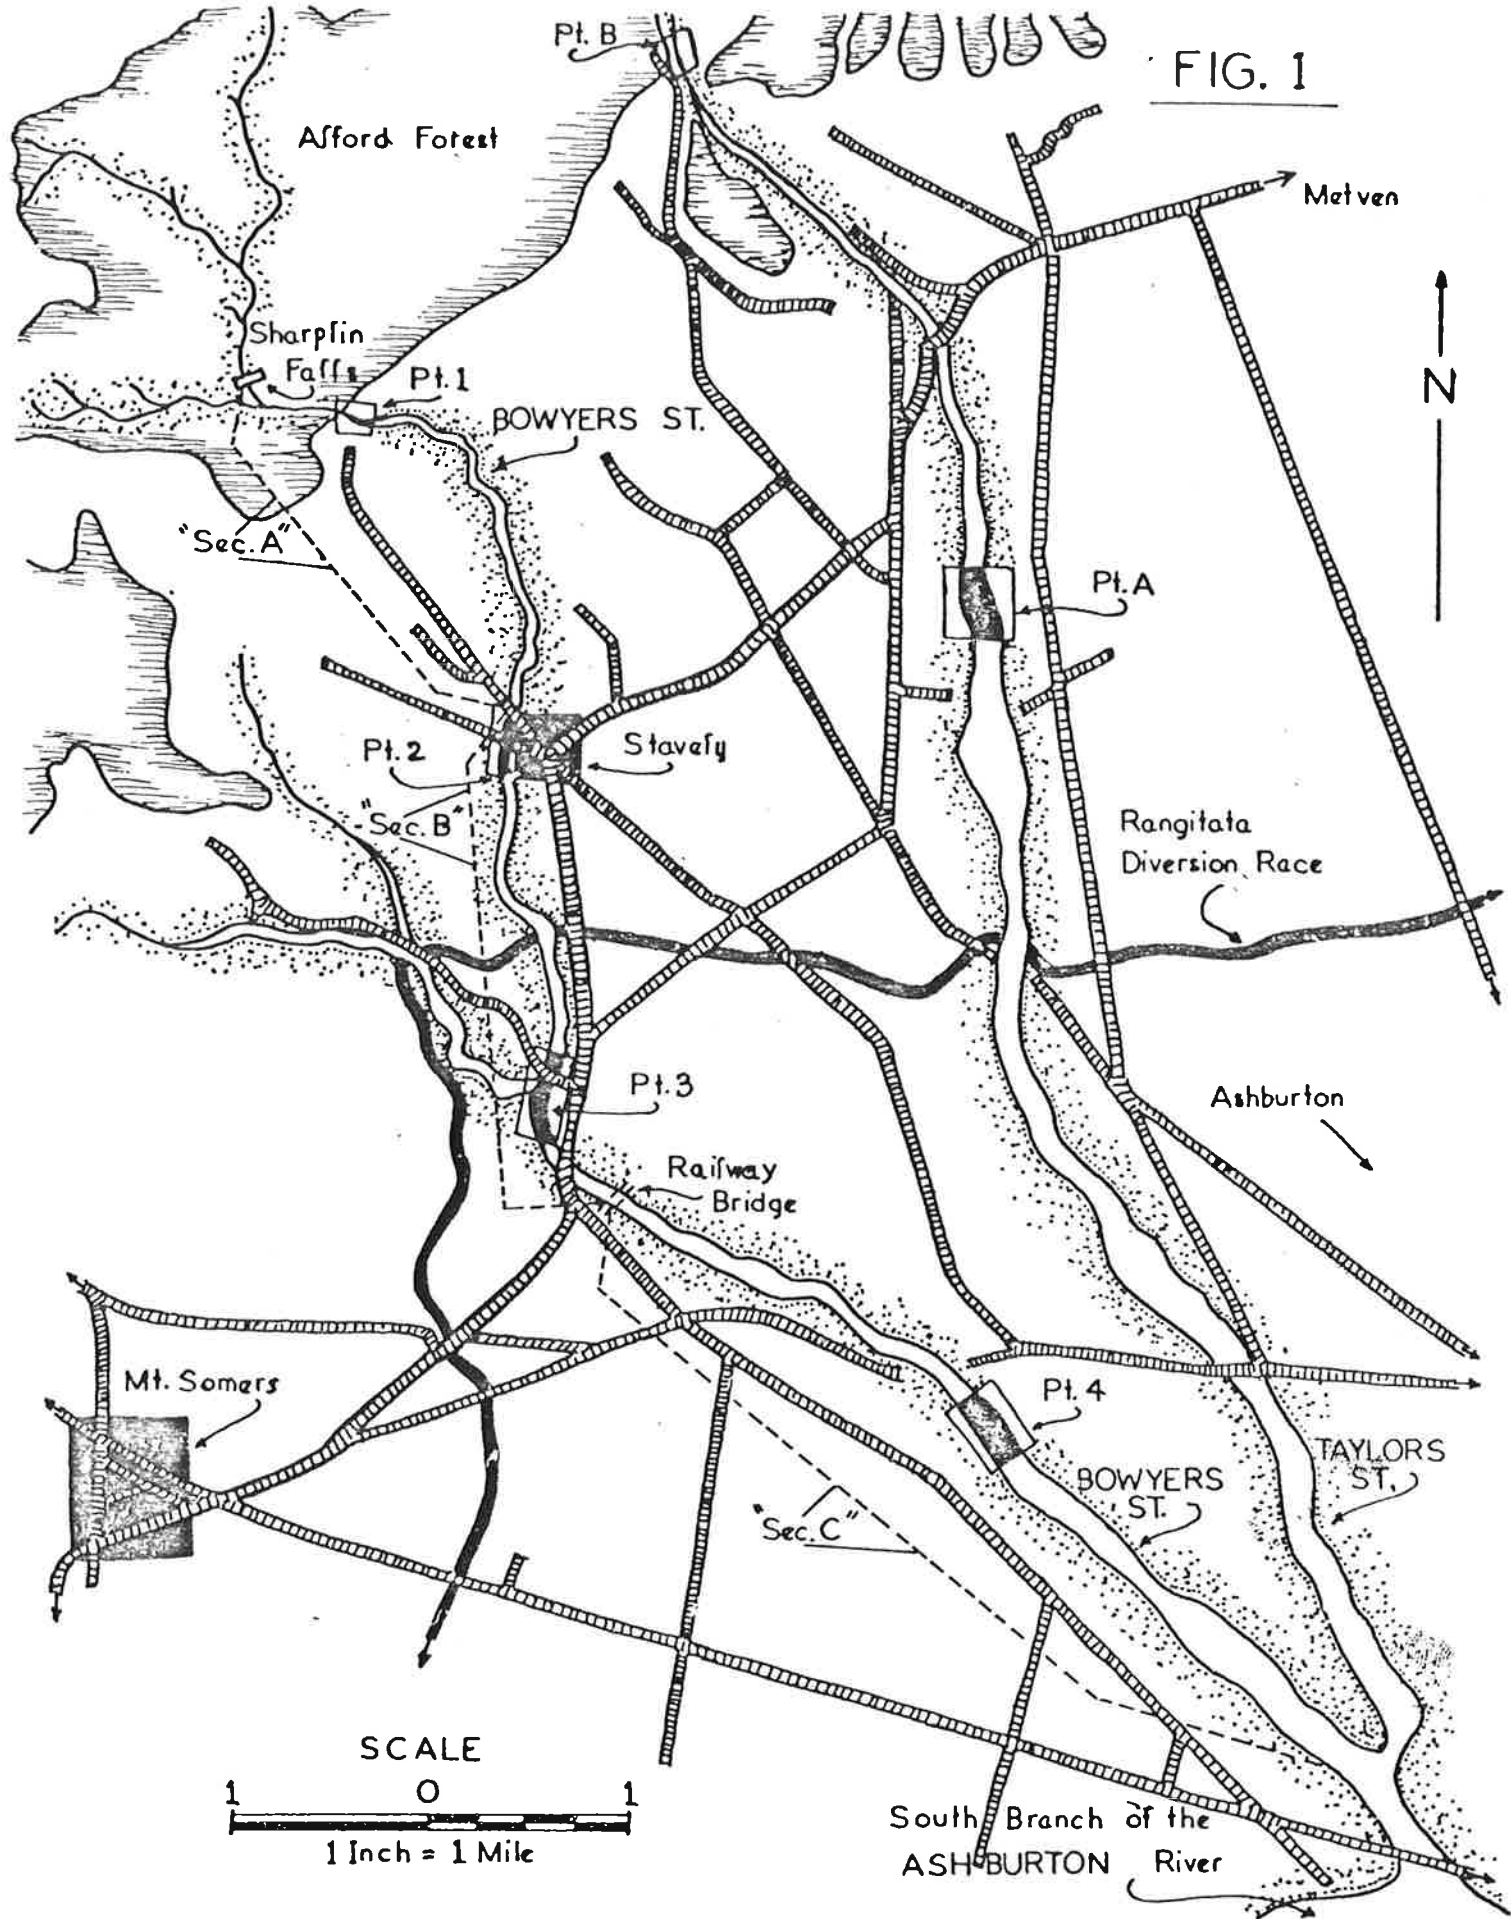
FIG. 1

This stream rises in the hills south of Mount Winterslow and flows through open hills before entering the densely clad Alford Forest. Emerging from the forest it flows parallel to and then gradually converging with Taylors Stream (See Fig. 1.).

The stream was examined from approximately three-quarters of a mile into the forest (Sharplin Falls) down to the confluence with the Taylors Stream. For the purpose of this investigation the stream was divided into three stations: the upper ("A") from Sharplin Falls to Stavely, the middle ("B") from Stavely to the abandoned Railroad Bridge below the School House Road Bridge and the lower ("C") from the Railroad Bridge down to the Confluence.

At point A (Fig. 1) electric fishing was carried out for a considerable distance and although the amount of water flowing made catching the fish an almost impossible task, useful observations could be made. Fish of the year were plentiful wherever cover was available and in the shallow water bordering the main flow. Larger fish are scarce however, and only four fish of catchable size were seen in approximately $\frac{1}{4}$ mile of stream. One of these fish, a brown trout male, was caught, and measured $23\frac{1}{4}$ inches; no other fish approaching this size were seen.

Conditions for electric fishing were better here than in Taylor's Stream and four separate spots were fished over the stream's length (Fig. 1). In all 275 fish were caught, 85% brown trout and 15% quinnat salmon.
